Transport Accident Investigation Commission

Aviation inquiry AO-2020-002 Glider, Schleicher ASK21, ZK-GTG Impact with Terrain Mount Tauhara, Taupō 31 May 2020

November 2023

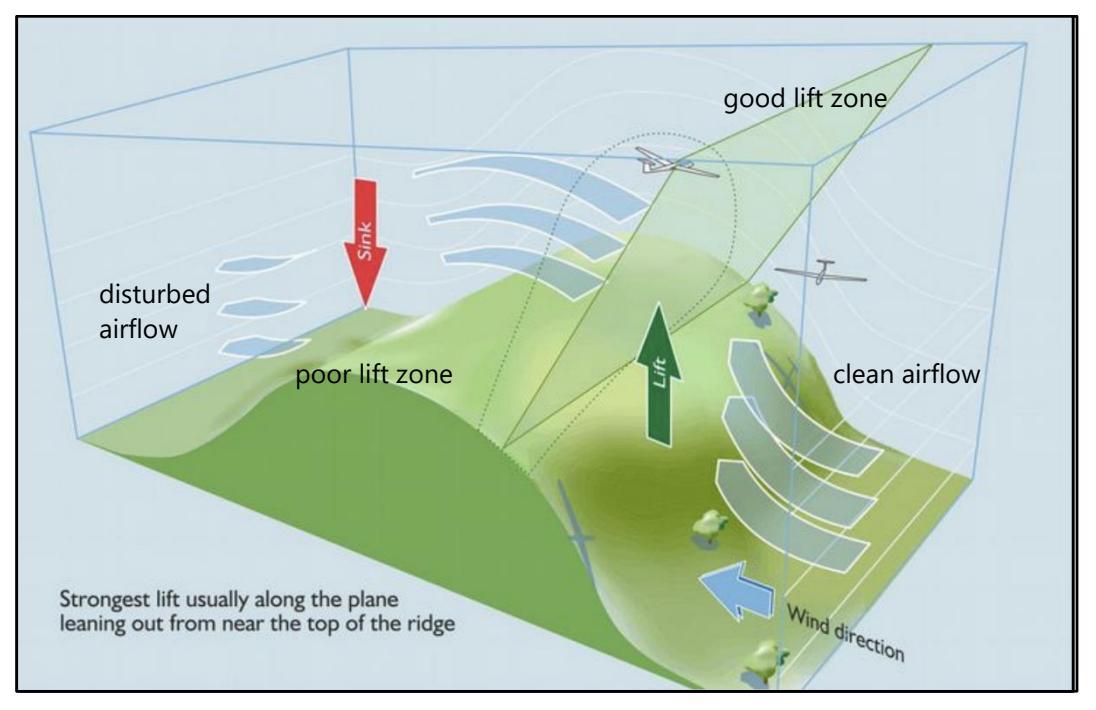
**Figure 7: Using ridge lift** (Graphic copied from a Gliding New Zealand training document)

- 2.33 A glider pilot needs to maintain a forward airspeed so they fly along the face of a ridge then turn and travel back the other way (in beats or regular strokes). The flight path loosely follows a figure-eight shape, with all turns away from the ridge and out into the wind. The lift is strongest slightly upwind of the ridge face, as shown in Figure 7.

- 3.21 On the accident flight the instructor flew just downwind of the ridge face in the poor lift zone (*see* Figure 3 and Figure 7). The glider's very low height above the mountain top reduced the instructor's margin to manoeuvre the glider away from the mountain. Additionally, the downwind position resulted in the glider flying in the wind shadow<sup>23</sup> of the mountain, and being exposed to a more disturbed airflow and possibly turbulence. These factors **very likely** contributed to the glider's impact with the terrain.
