Aviation inquiry AO-2020-003

Eurocopter EC120-B, ZK-HEK

Loss of control in flight and collision with terrain

March 2023

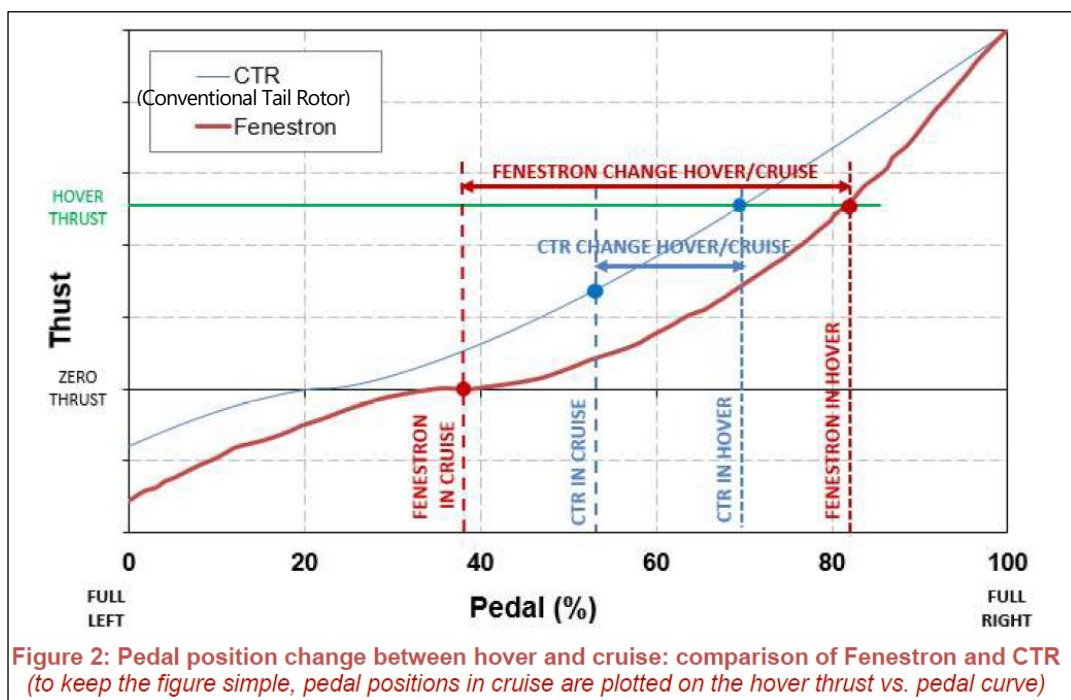
Figure 7: Pedal position

Transitioning from cruise to hover flight on a helicopter equipped with a Fenestron requires adding more right pedal than with a conventional tail rotor.²⁴

The notice also included a diagram showing a comparison between a conventional tail rotor and a Fenestron when in hover and in cruise (see figure 7).

- 3.22. From a pilot's perspective, the designed differences between a Fenestron tail rotor and a conventional tail rotor are most noticeable in the tail rotor pedal inputs required as a helicopter is accelerated from a hover to cruise flight and back to a hover. For a conventional tail rotor, the relationship between tail rotor pedal input and tail rotor thrust is near linear. By comparison, when a Fenestron equipped helicopter is slowed to the hover, a pilot needs to apply a larger amount of tail rotor pedal for the same amount of tail rotor thrust (see figure 7).

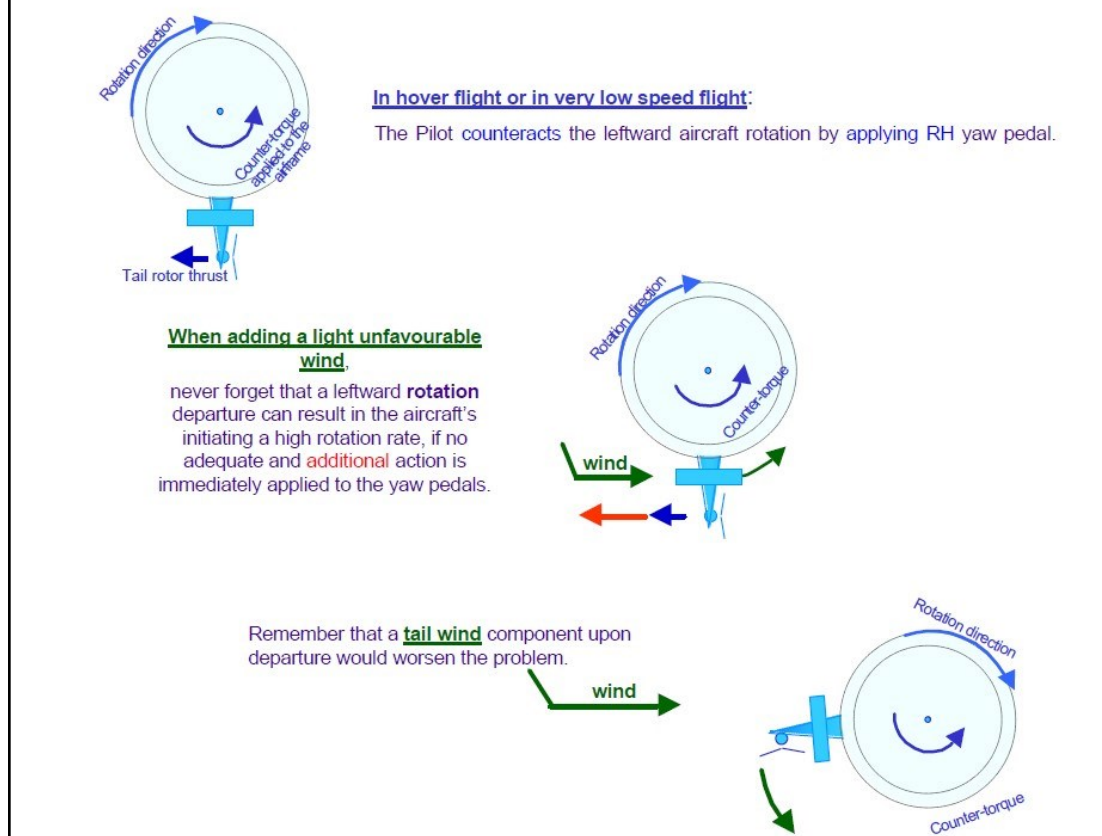
Figure 8: Tail rotor control

- 3.31. Out-of-wind approaches, however, can offer some advantages. For a helicopter with a main rotor that turns clockwise, like ZK-HEK, approaching a landing area with the wind on the right side of a helicopter can reduce the power required for an approach. As the helicopter is slowed, it will attempt to yaw right into the prevailing wind. This results in a pilot needing to use left pedal to continue to align the helicopter with the approach path. Left pedal reduces the power demand on the engine. It also ensures there is sufficient right pedal available when power is increased approaching the hover (see figure 8).

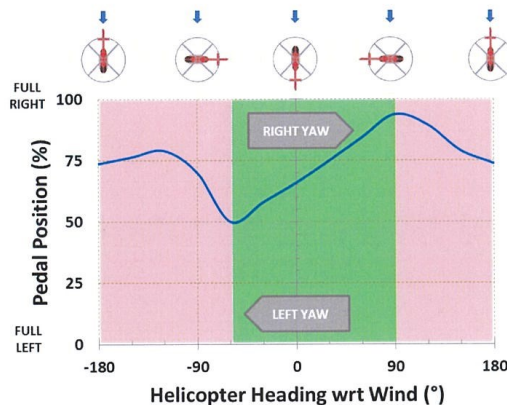
Figure 1: Example of hover pedal curve

An example is provided in **Figure 1**. The well-known critical azimuth, which gives the smallest pedal margin, corresponds in this Figure to about +90° heading (wind coming from the left hand side with respect to the helicopter).

Where a headwind is present (green area in **Figure 1**) the helicopter is stable in yaw. If a gust alters the heading of the helicopter, from 0° to -10° for example, the pedal position is now above the curve (the heading was brought to -10° with the pedal position that existed at 0°). The helicopter yaws right until it crosses the trim curve, which happens at the initial 0° heading. Shifted away from the trim position, it comes back to it.

On the opposite side of Figure 1 the red area represents an area of a yaw instability. When the helicopter is shifted from its trim position, it moves further away until a stable headwind condition is found. This tailwind instability is well known by helicopter pilots who are aware that yaw must be very carefully controlled when the wind approaches from behind (tailwind).

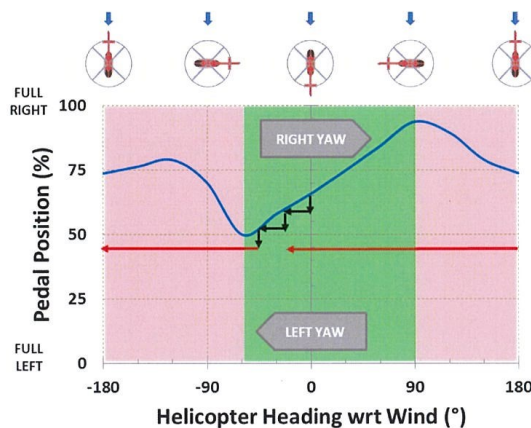
Figure 2: Starting an Unanticipated Left Yaw

This is illustrated in the graph in Figure 2. Starting from 0° wind heading, a left pedal step is made (indicated by a vertical black arrow). This brings the control position below the trim curve and the helicopter therefore rotates to the left until it crosses the trim curve, where it stops. In headwind conditions, pedal provides an attitude command: a control step mainly produces a heading step.

A second left pedal step is included in Figure 2. It has a similar effect to the first pedal step, leading to a second heading step.

The gap between the current pedal position (red arrow) and the blue trim curve gives an indication of the encountered yaw rate. In the Figure 2 example, after passing the minimum of the blue curve (about -60° heading), that gap increases drastically. It is not due to a pedal input, but to a trim position that is moving away. The pilot has no indication of this changing trim position and the resulting yaw acceleration is therefore wrongly perceived as being uncommanded, attributable to some external factor.

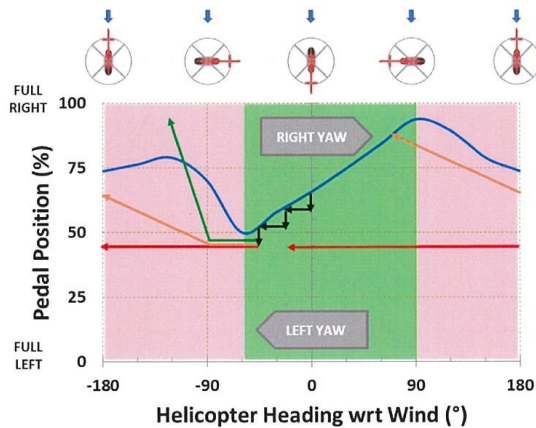
Figure 3: Recovering from an Unanticipated Left Yaw

Following unanticipated left yaw occurrence depicted in **Figure 2**, three recovery strategies have been plotted in **Figure 3**. Here, the pilot is assumed to have been caught unaware by the helicopter's behavior and reacted late in the vicinity of a -90° heading.

The most probable reason for accidents following unanticipated yaw events is a late and too limited pedal input. The pedal curve shows that this cannot stop the yaw in the short term. During an unanticipated yaw event, the tail rotor remains fully effective and provides the best chance to recover. Yaw rate and wind conditions reduce its thrust if it is at a constant pitch. There must be counterbalance by a huge pitch increase. The only warning the pilot may get of potential loss of control is the onset of unanticipated yaw.

The key feature of an unanticipated left yaw recovery is large amplitude right pedal input. Recovery may not be immediate, but will occur if the pilot persists in maintaining right pedal. In some instances, the pilot re-centered the pedal before entering again a right pedal input. This cannot help and only delays recovery from the yaw. If the yaw deceleration is not enough, more right pedal must be added, reaching the pedal end-stop if necessary.

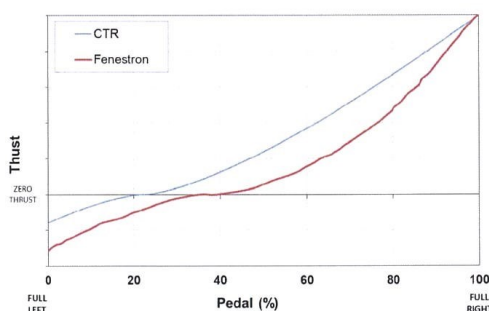
Figure 1: Comparison of Fenestron and CTR in hover

Figure 1 shows how the thrust varies with the pedal position on a Fenestron and on a conventional tail rotor in hover conditions.

The change of slope in the vicinity of zero thrust is more pronounced on the Fenestron curve than on the CTR curve.

The CTR curve is more linear. The effect of a control input is almost constant in the whole pedal range, while it significantly varies for the Fenestron. The slope, and thus the perceived efficiency of the control, is much larger when coming close to full right pedal stop.

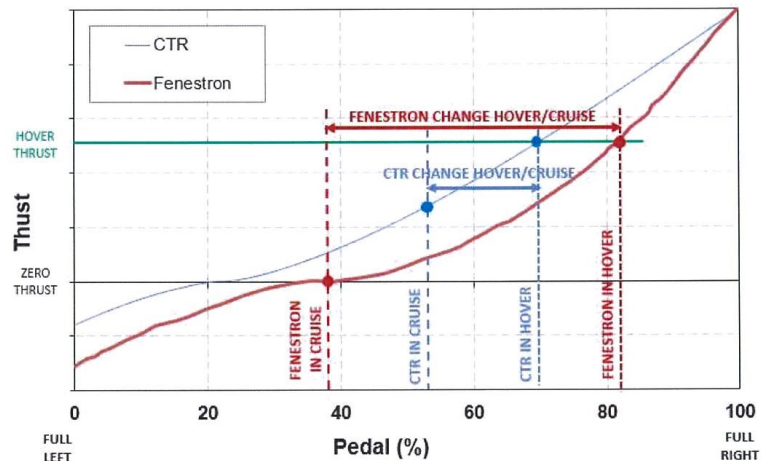
Figure 2: Pedal position change between hover and cruise: comparison of Fenestron and CTR
(to keep the figure simple, pedal positions in cruise are plotted on the hover thrust vs. pedal curve)

There is a similar effect on conventional tail rotors. Due to its design, the fin has also some incidence and unloads the tail rotor. However, this is usually much weaker than in the case of a Fenestron, as shown in **Figure 2**.

The same thrust is required in hover, regardless of the anti-torque device. However, there is more right pedal on a Fenestron due to the differences highlighted in the previous part. The pedal position in cruise is more left with a Fenestron that is at zero thrust than with a CTR that is only partially unloaded.
