Transport Accident
Investigation
Commission

Final report

***Aviation inquiry A0-2021-001
Kavanagh Balloons E-260, ZK-FBK
Hard landing and ejection of occupants
Wakatipu Basin, near Arrowtown
9 July 2021***

May 2023

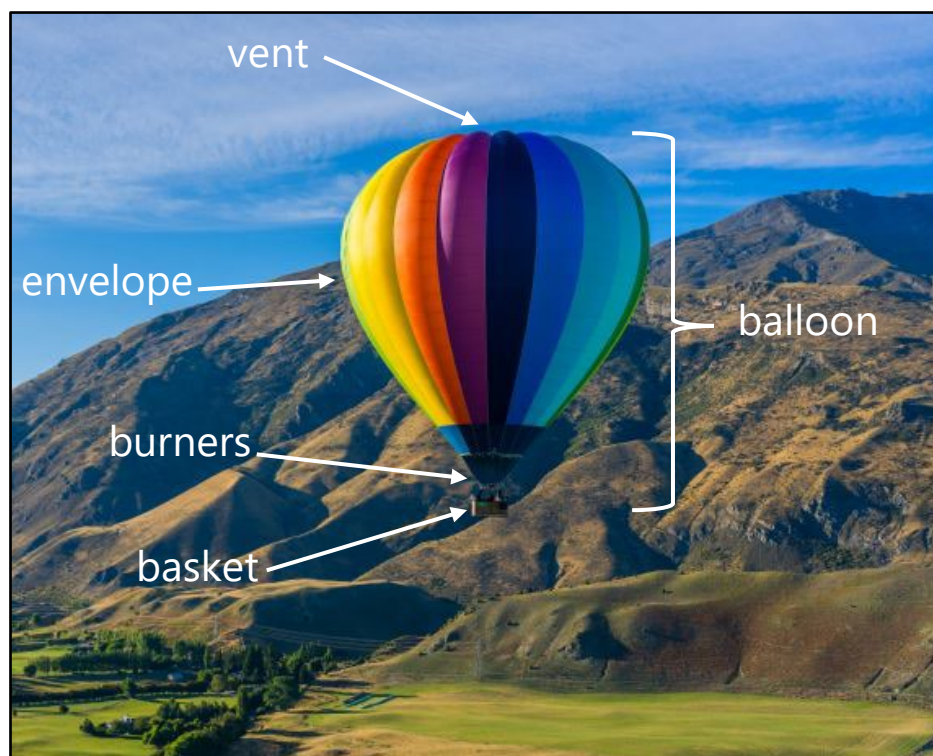
Figure 3: Balloon components

- 2.1. On Friday 9 July 2021, Kavanagh Balloons E-260 ZK-FBK (the balloon) (see Figure 3), owned and operated by Sunrise Balloon Adventures (the operator), was booked to fly 10 passengers on a scenic flight around the Wakatipu Basin. At 0635 the pilot checked the weather conditions and forecast and made an initial decision to continue with preparations for the flight. The pilot contacted the crew chief, who travelled to the operator's base. Together they discussed the weather conditions and decided the flight was to proceed.

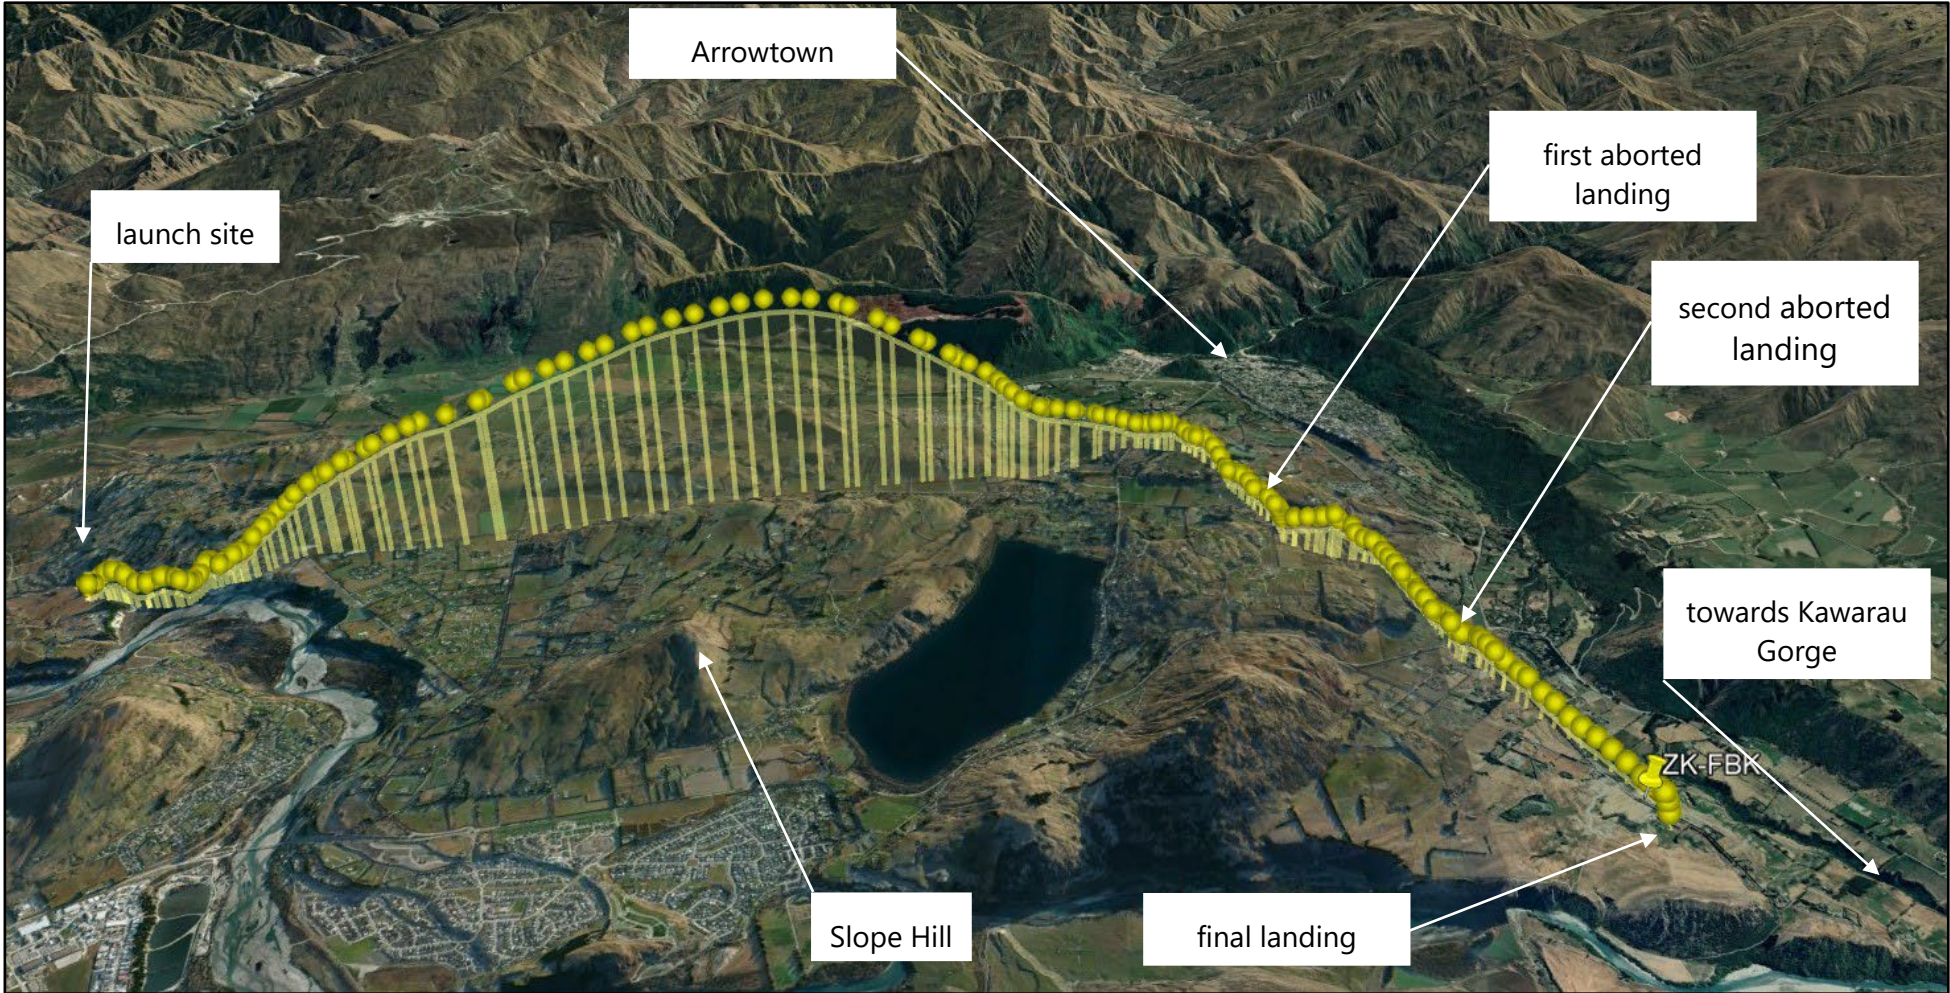
Figure 4: Flightpath of ZK-FBK

- 2.5. The flight proceeded normally, initially climbing to about 6000 feet (1830 metres [m]) above mean sea level, or about 5000 feet (1500 m) above the Wakatipu Basin (see Figure 4). At this stage the pilot took several photographs of the basket occupants using a remotely controlled camera that was suspended away from the basket. The camera control malfunctioned, but the camera continued to record video. The recording included sound.

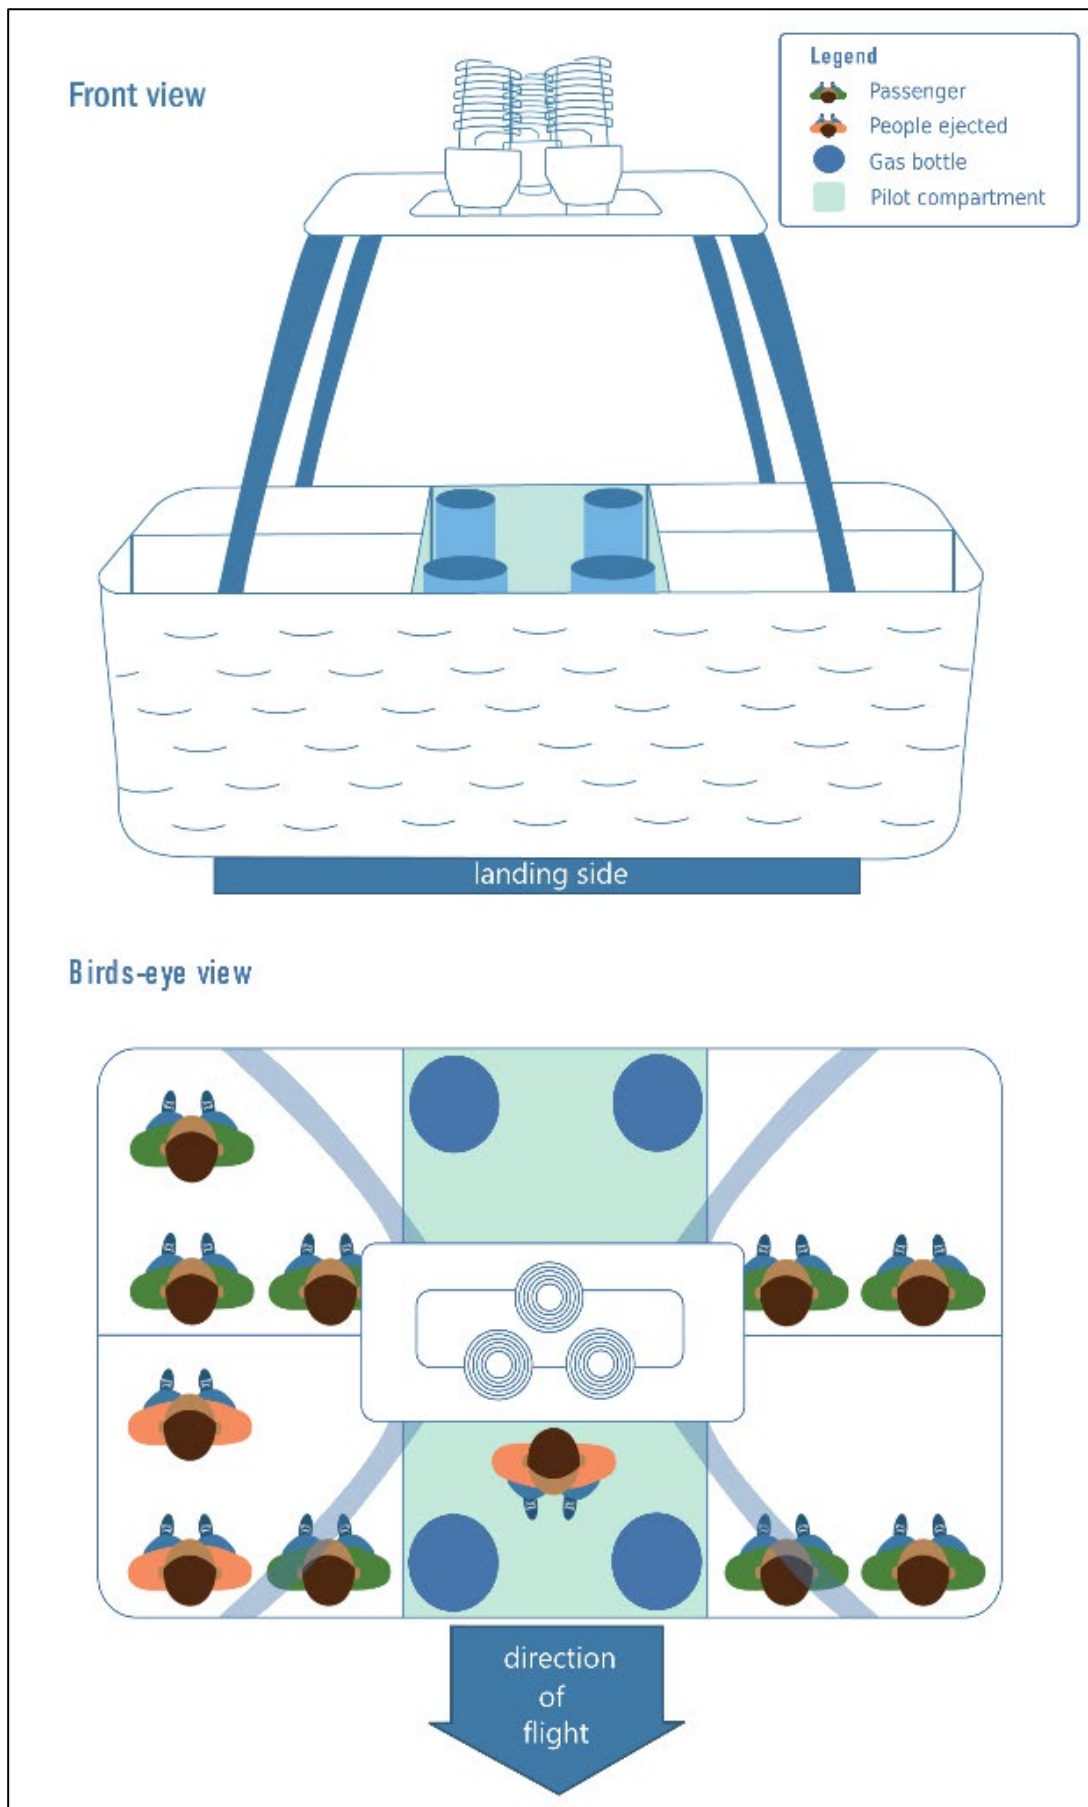
Figure 7: Balloon configuration

- 2.20. The basket was of a 'double-T' construction, with four passenger compartments and the pilot's compartment in the centre (see Figure 7). According to the flight manual, each passenger compartment was approved to hold four persons. The passenger compartments were fitted with rope handles for passengers to hold on to when landing. The mandatory equipment list contained in the balloon's flight manual included a requirement for 'an approved pilot restraint fitted to the basket'.¹¹ The basket for ZK-FBK was equipped with a pilot restraint harness, installed at manufacture and still fitted at the time of the occurrence flight.

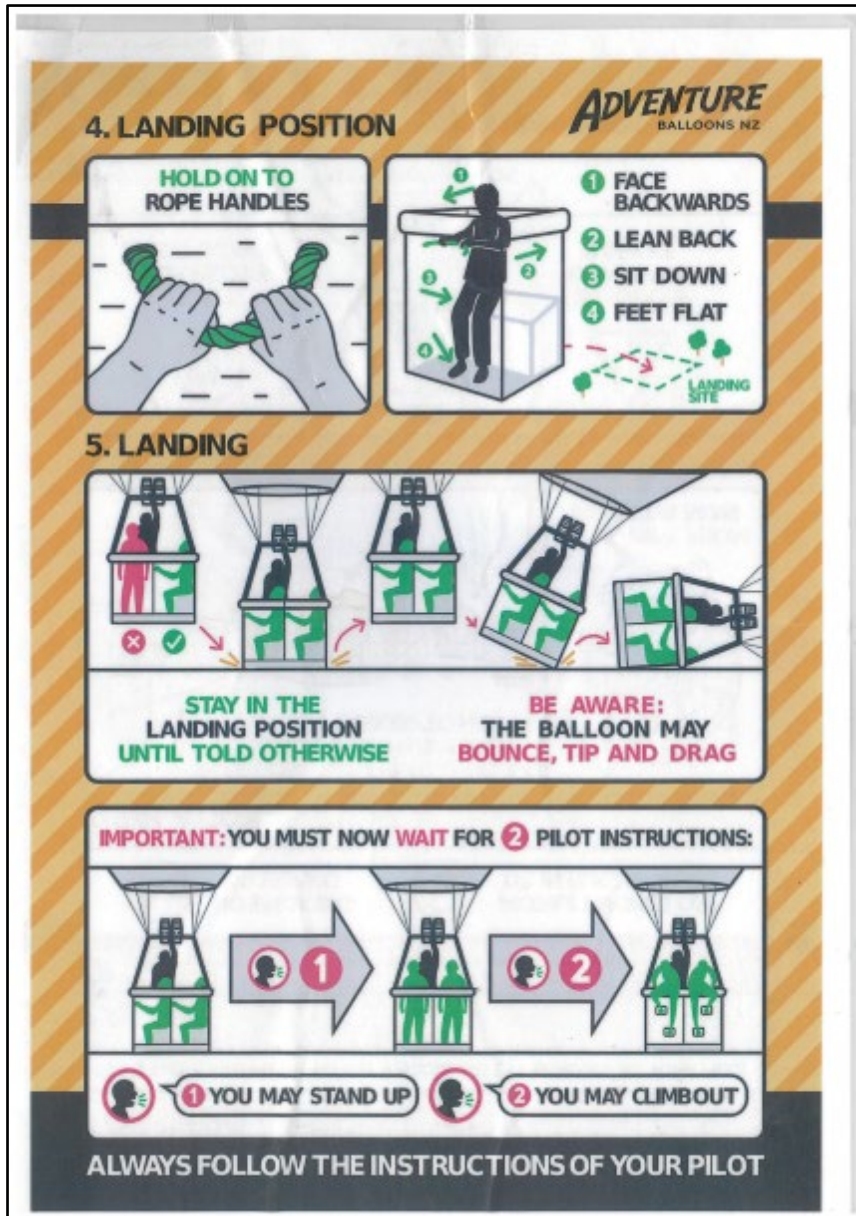
Figure 10: Passenger briefing card

- 3.23. Before the flight, the pilot of ZK-MET had gathered the passengers together and ensured they were listening before delivering the safety briefing. The safety briefing card passed to the passengers had contained mainly diagrams that clearly showed the crouched landing position and rope handles (see Figure 10). The passengers also had

- 3.24. These two occurrences highlight the benefits of operators taking all practical steps in preparation for flights. These steps include ensuring passengers are attentive to briefings and, ideally, briefing cards are provided in support. Briefing cards should contain enough diagrams to ensure the safety messages are clearly understood regardless of any language challenges. Ensuring that passengers practise the landing position not only tells the pilot that the passengers have been listening, but also, and importantly, reinforces the key lessons. Any urgency situations or concerns should not be downplayed, as this could lead passengers to under-appreciate the risks, which may in turn lead to their not being prepared as appropriate.
