Transport Accident
Investigation
Commission

Final Report

Aviation inquiry A0-2021-003
Airbus Helicopters AS350 B3e, ZK-ITD
Loss of control in flight
Lammerlaw Range,
40 km northwest of Dunedin Aerodrome
16 September 2021

November 2023

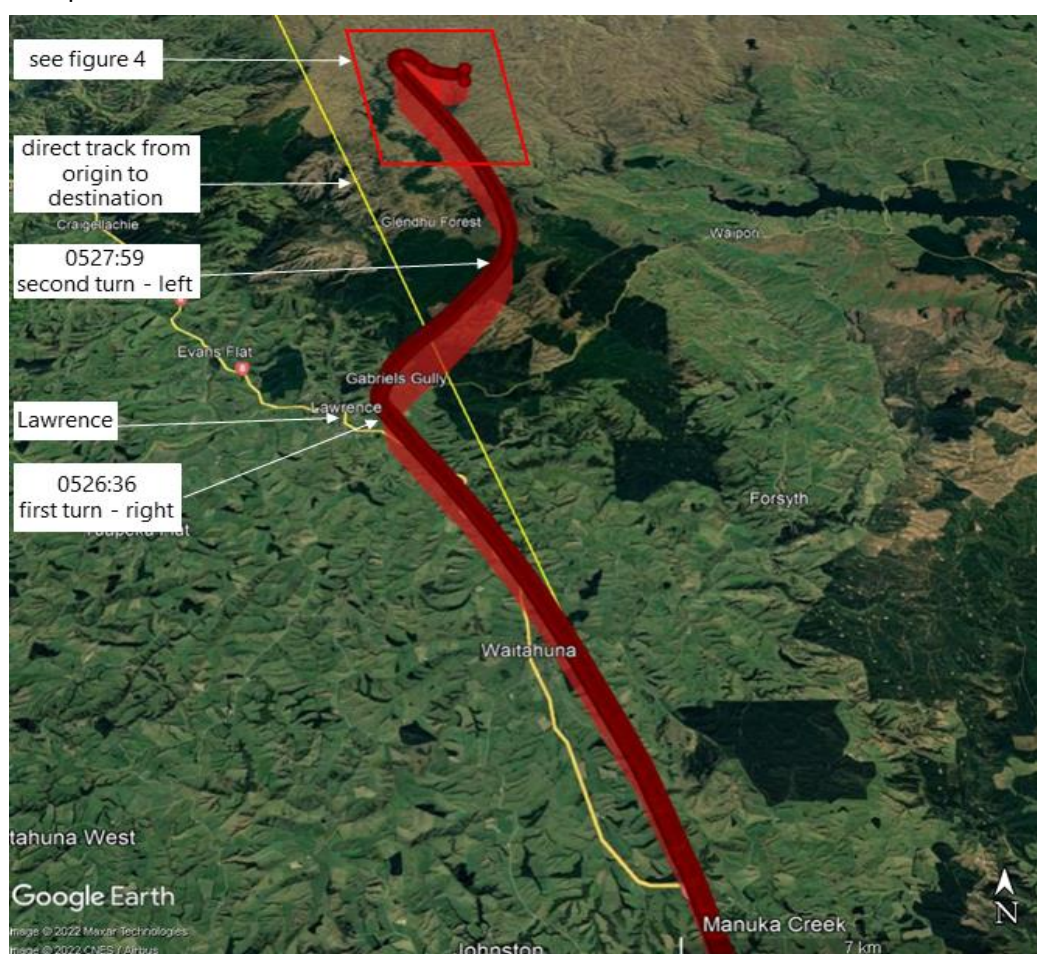
Figure 3: Flight path, approaching Lawrence

2.2. The flight path of the helicopter was recorded by the Airways New Zealand Automatic Dependent Surveillance – Broadcast (ADS-B) system. At 0526:36 the helicopter made a right turn immediately before the township of Lawrence (see Figure 3) at an altitude of 6475 feet (ft) (2000 metres (m)) above mean sea level (amsl). This was the first in a series of turns in the next four minutes.

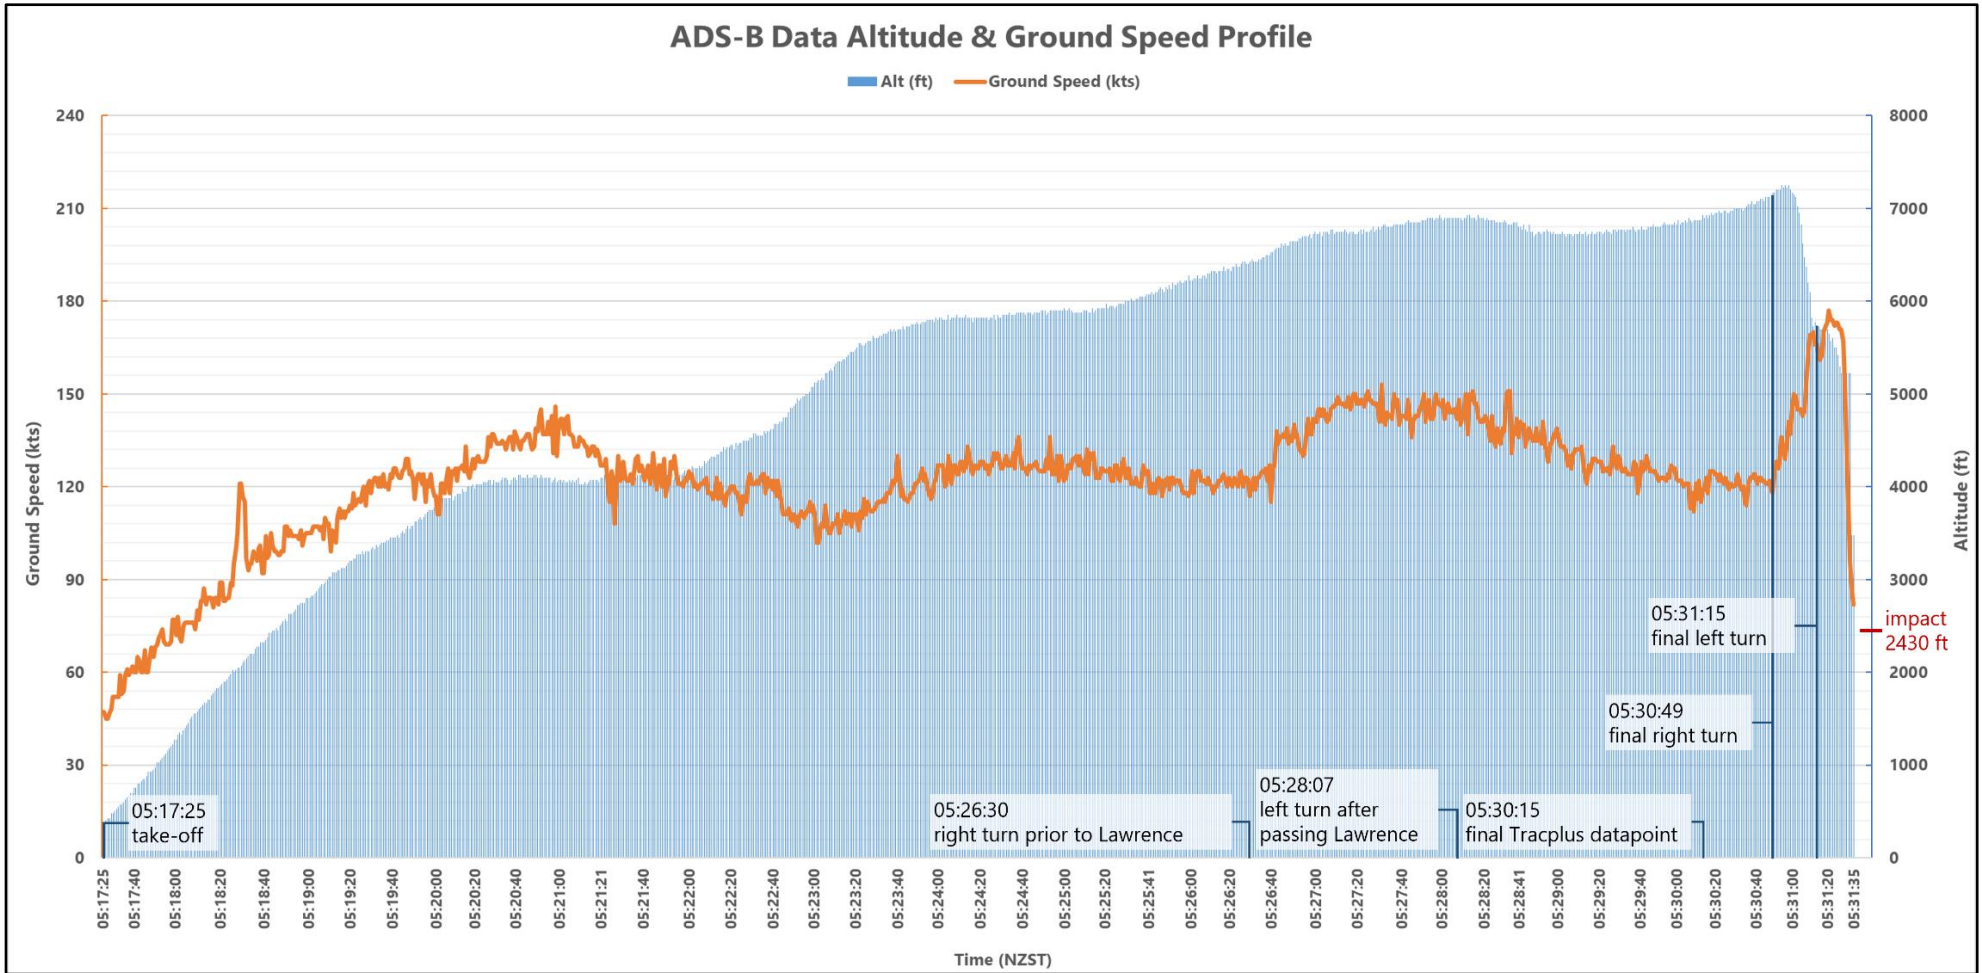
Figure 5: Flight detail and timeline

of about 2430 ft (740 m). See Figure 5 for the flight timeline, with altitude and airspeed.

- 3.38. Approaching Lawrence, a definite and deliberate course change was made. Initially there was a turn to the right through 53 degrees, taking 20 seconds. The rate of turn equated to 159 degrees a minute, slightly less than a rate one turn⁴⁸. The helicopter climbed about 200 ft (60 m) during the turn, at a climb rate of about 600 ft per minute (182 m per minute). While the climb rate was higher than ideal with reduced visual cues, it was consistent with the climb rate before the turn (see Figure 5).
