# **Final Report**

***Aviation inquiry AO-2021-003***  
***Airbus Helicopters AS350 B3e, ZK-ITD***  
***Loss of control in flight***  
***Lammerlaw Range,***  
***40 km northwest of Dunedin Aerodrome***  
***16 September 2021***

**June 2025**

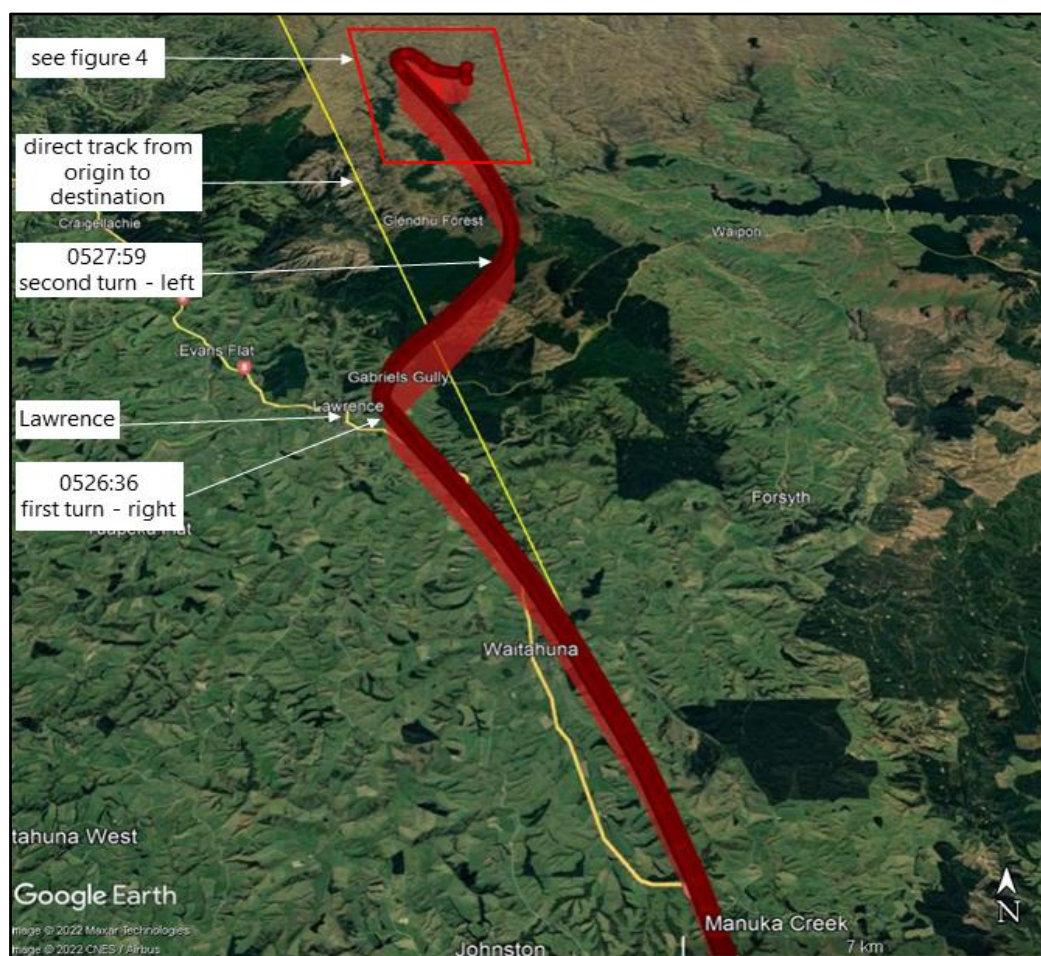
**Figure 3: Flight path, approaching Lawrence**

- 2.2. The flight path of the helicopter was recorded by the Airways New Zealand (Airways) Automatic Dependent Surveillance – Broadcast (ADS-B) system. At 0526:36 the helicopter made a right turn immediately before the township of Lawrence (see **Error! Reference source not found.**) at an altitude of 6475 feet (ft) (2000 metres [m]) above mean sea level (AMSL). This was the first in a series of turns in the next four minutes.

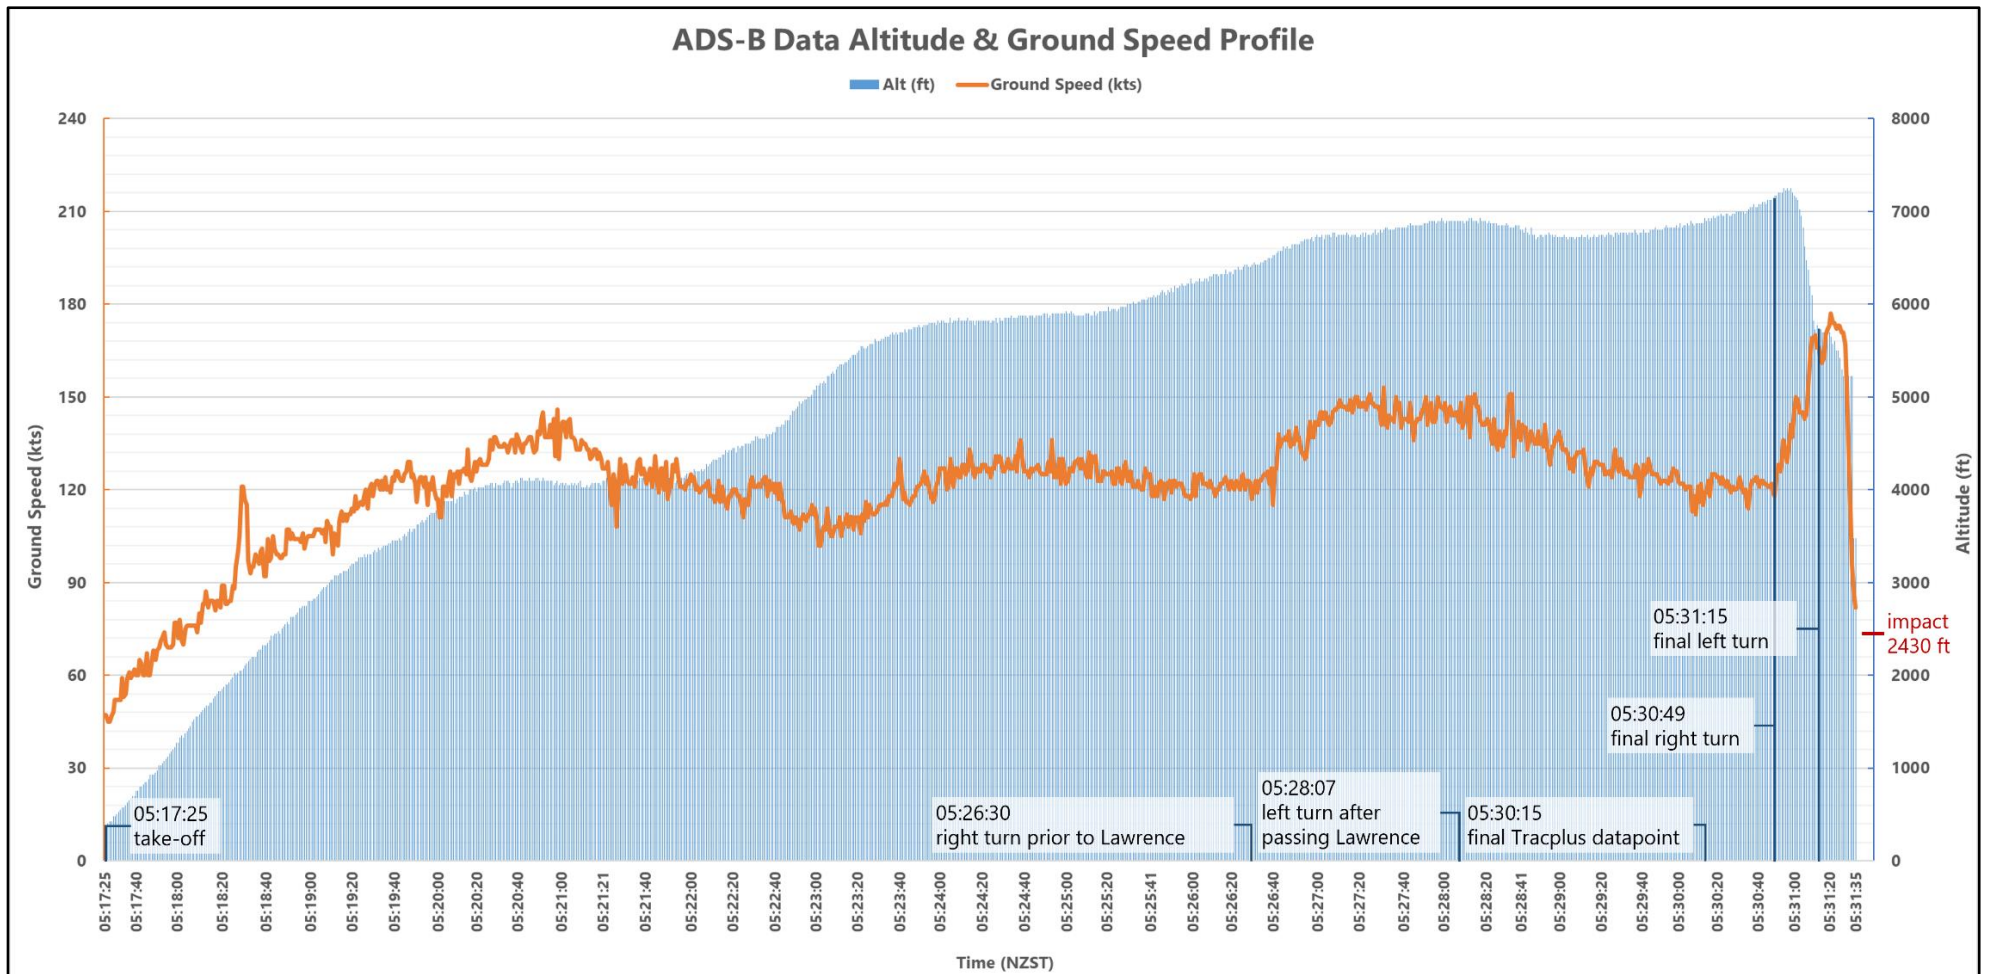
**Figure 5: Flight detail and timeline**

- 2.3. The last ADS-B data point was received at 0531:35. At that time the helicopter was at an altitude of 3475 ft (1060 m) AMSL and on a track of 293° (see Figure 4). There were several data points recorded after this time; however, they were determined to be 'coasted'<sup>5</sup> data points and not from the helicopter. Moments later the helicopter struck the ground in a near vertical nose-down attitude, at an elevation of about 2430 ft (740 m). See Figure 5 for the flight timeline, with altitude and airspeed.

- 3.44. Approaching Lawrence, a definite and deliberate course change was made. Initially there was a turn to the right through 53°, taking 20 seconds. The rate of turn equated to 159° a minute, slightly less than a rate one turn<sup>46</sup>. The helicopter climbed about 200 ft (60 m) during the turn, at a climb rate of about 600 ft per minute (182 m per minute). While the climb rate was higher than ideal with reduced visual cues, it was consistent with the climb rate before the turn (see Figure 5).

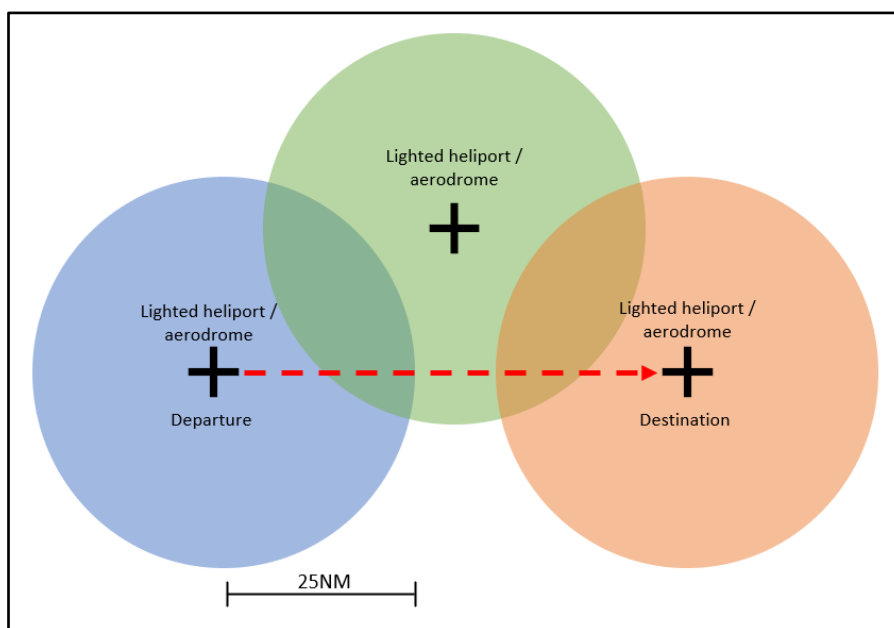
**Figure 12: Illustration of 25 NM restriction**

- 3.58. The Commission found ambiguity existed around what was permitted under the night VFR rules and guidance.
- 3.59. Ambiguity, regardless of intention, creates opportunities for differing interpretations – including for rules to be read to allow the most leniency possible.
- 3.60. The wording of AC61-5 is ambiguous in light of the rules regarding what a pilot who was restricted to operations within 25 NM of a lighted heliport or aerodrome was permitted to do. It is unclear whether such a pilot could transit from point A to point B provided they were always within 25 NM of any lighted heliport or aerodrome (ie, the departure and destination were within 50 NM). There is further ambiguity around whether a third intermediate lighted heliport or aerodrome could be used as a waypoint en route to facilitate even longer flights at night (see Figure 12).

- 3.61. The Commission sought clarification from the CAA on the above interpretation of the CARs. The CAA responded that while AC61-5 could be clearer, the intent was that a pilot travelling beyond 25 NM from their point of departure at night would require the higher standards of the night cross-country rating.

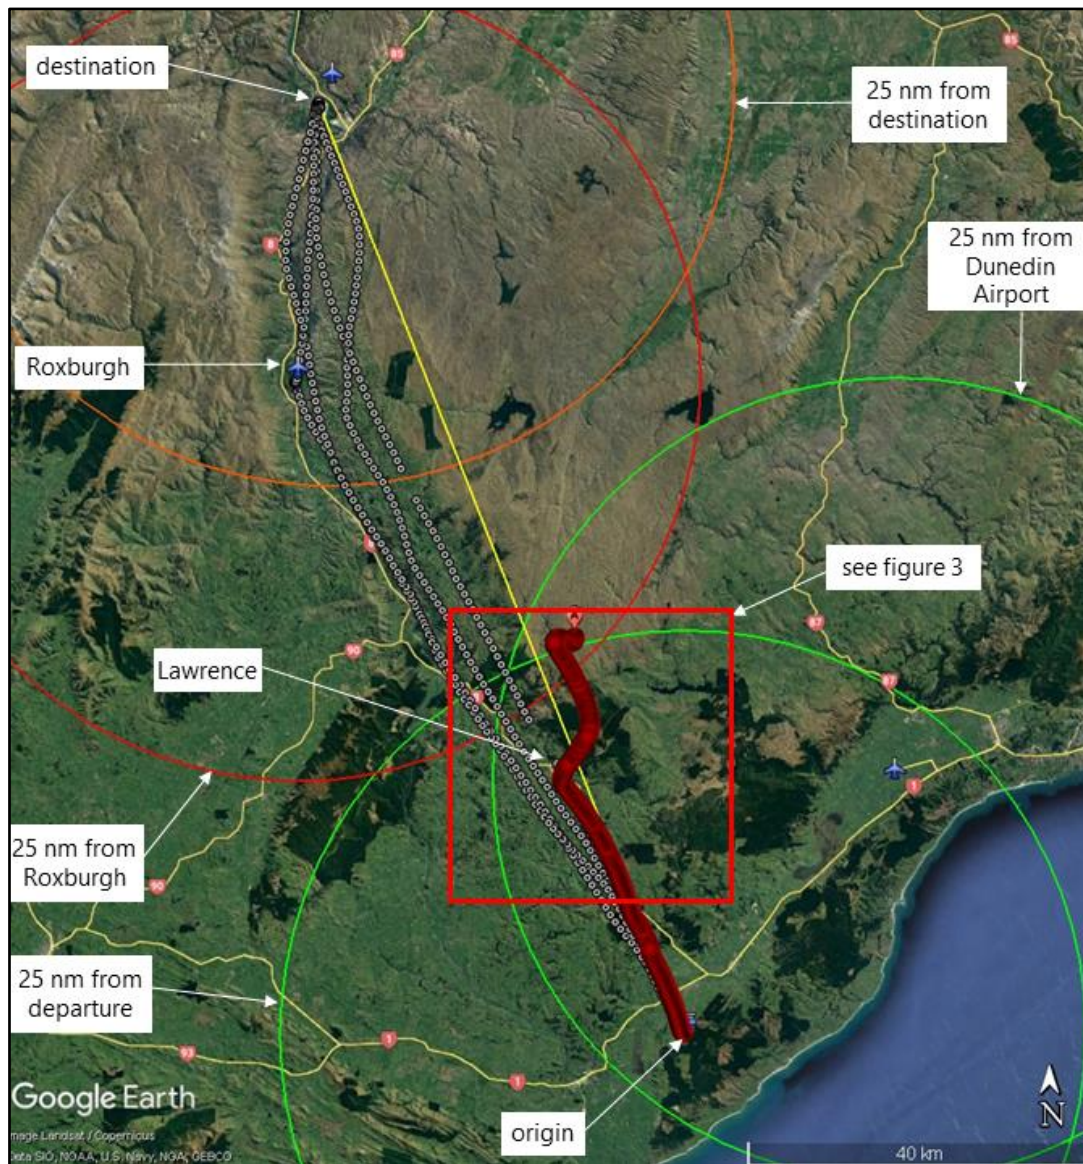
**Figure 13: Flight path with 25 NM range rings**

- 3.63. The operator advised the Commission that as the flight was within 21 NM of Dunedin, and then used Roxburgh and Alexandra for short 'hops' within 25 NM of each other meant that in their view there was no requirement for a night cross-country rating for this flight (see Figure 13). The operator's interpretation of AC61-5 appears to be different from CAA's own interpretation of the intent of AC61-5, as stated by the CAA to Commission investigators.
