Transport Accident
Investigation
Commission

Final report

***Aviation inquiry AO-2022-001
Ultramagic Balloons, N-250, ZK-MET
Pilot ejection from basket on landing
Lyndhurst, near Methven
1 January 2022***

May 2023

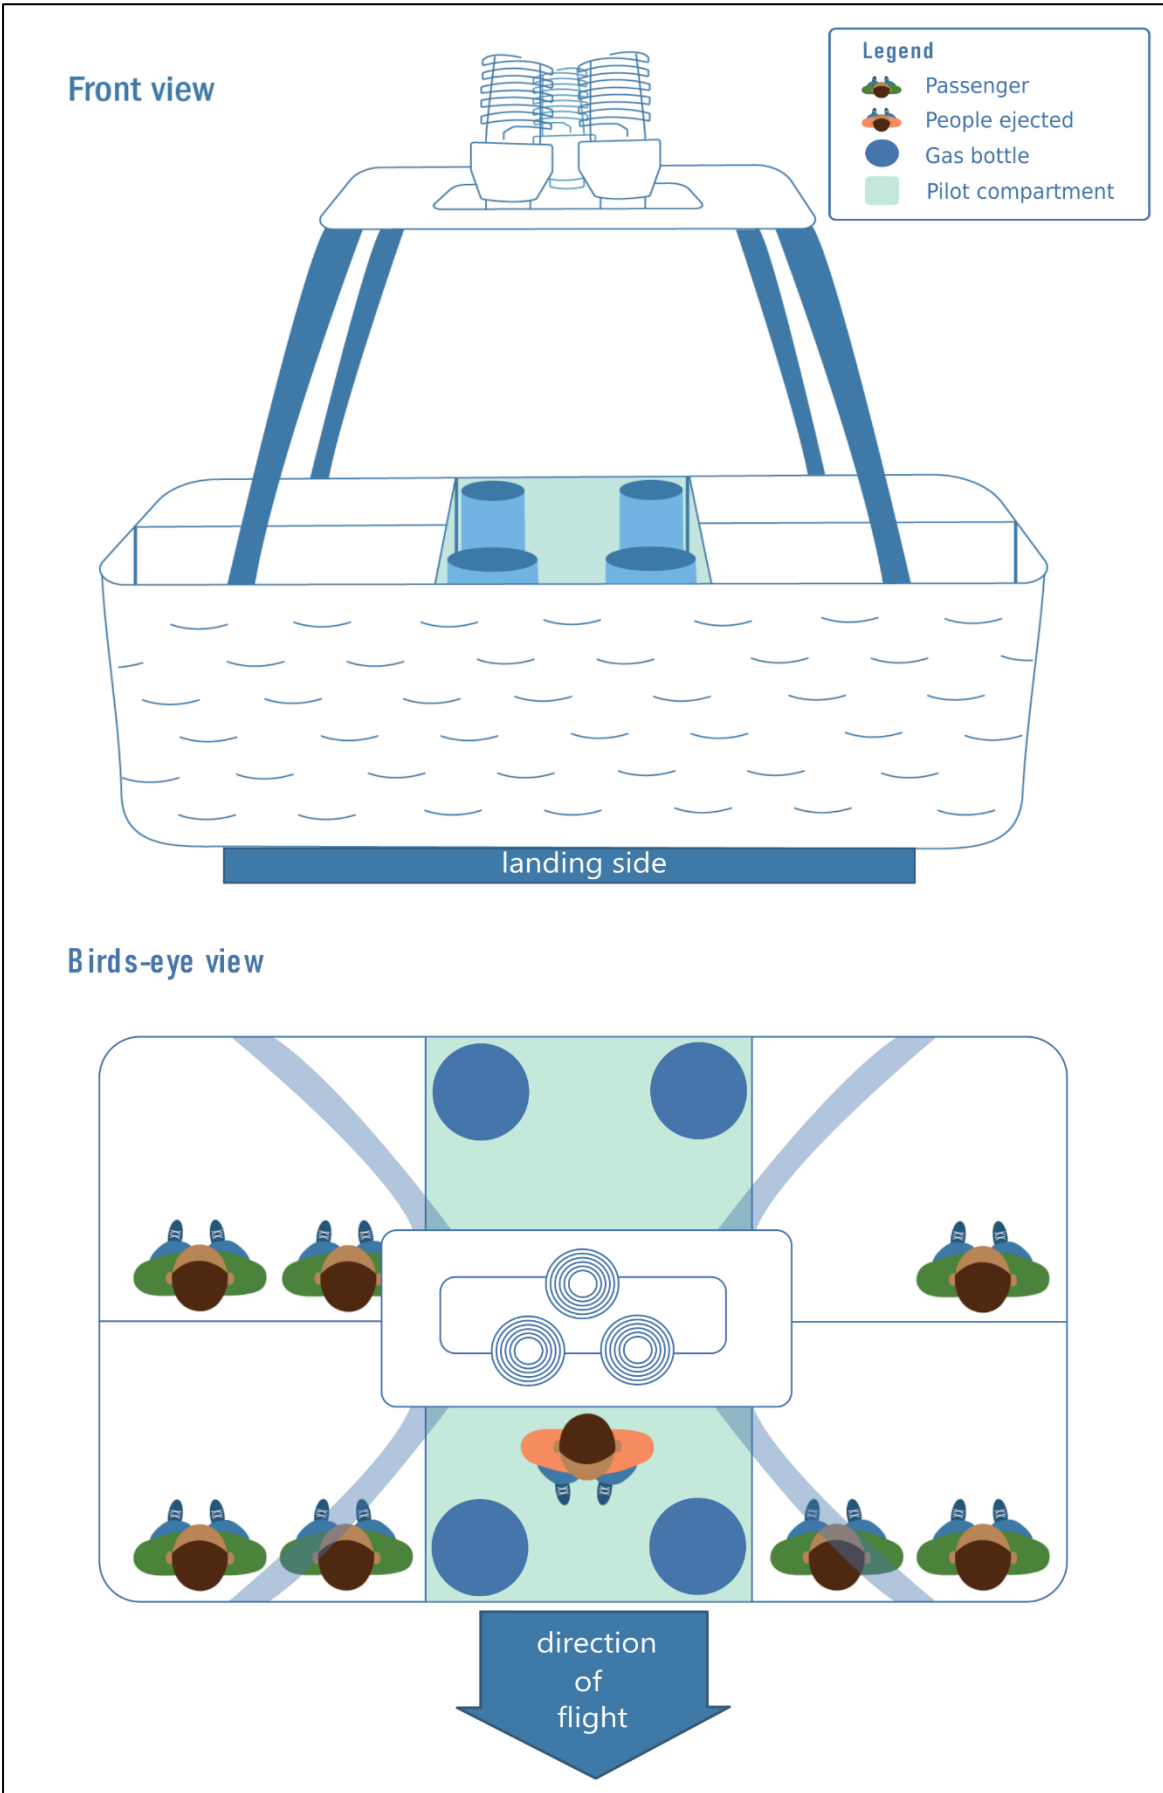
Figure 6: Illustration of a double T basket

- 2.24. ZK-MET was an Ultramagic Balloons, N-250 hot air balloon, manufactured in Spain in 2020 and imported new to New Zealand the same year.
- 2.25. The basket was a double T partitioned basket with four passenger compartments, capable of taking up to 12 passengers. The pilot stood in the centre partition with the gas bottles and control lines.⁸ See Figure 6.
- 2.26. The engine consisted of three combination blast/whisper burners with four liquified-petroleum-gas fuel tanks giving a nominal endurance of greater than three hours.
- 2.27. The basket was fitted with a dedicated pilot restraint harness, installed at manufacture. The pilot restraint harness consisted of a waist belt with a quick-release mechanism, which was attached via an adjustable strop to a dedicated hard point on the floor of the basket. See Figure 7.
