# Final report Tuhinga whakamutunga

Aviation inquiry AO-2022-002 Robinson R22, ZK-HEQ Loss of control in flight Karamea, West Coast 2 January 2022

December 2023

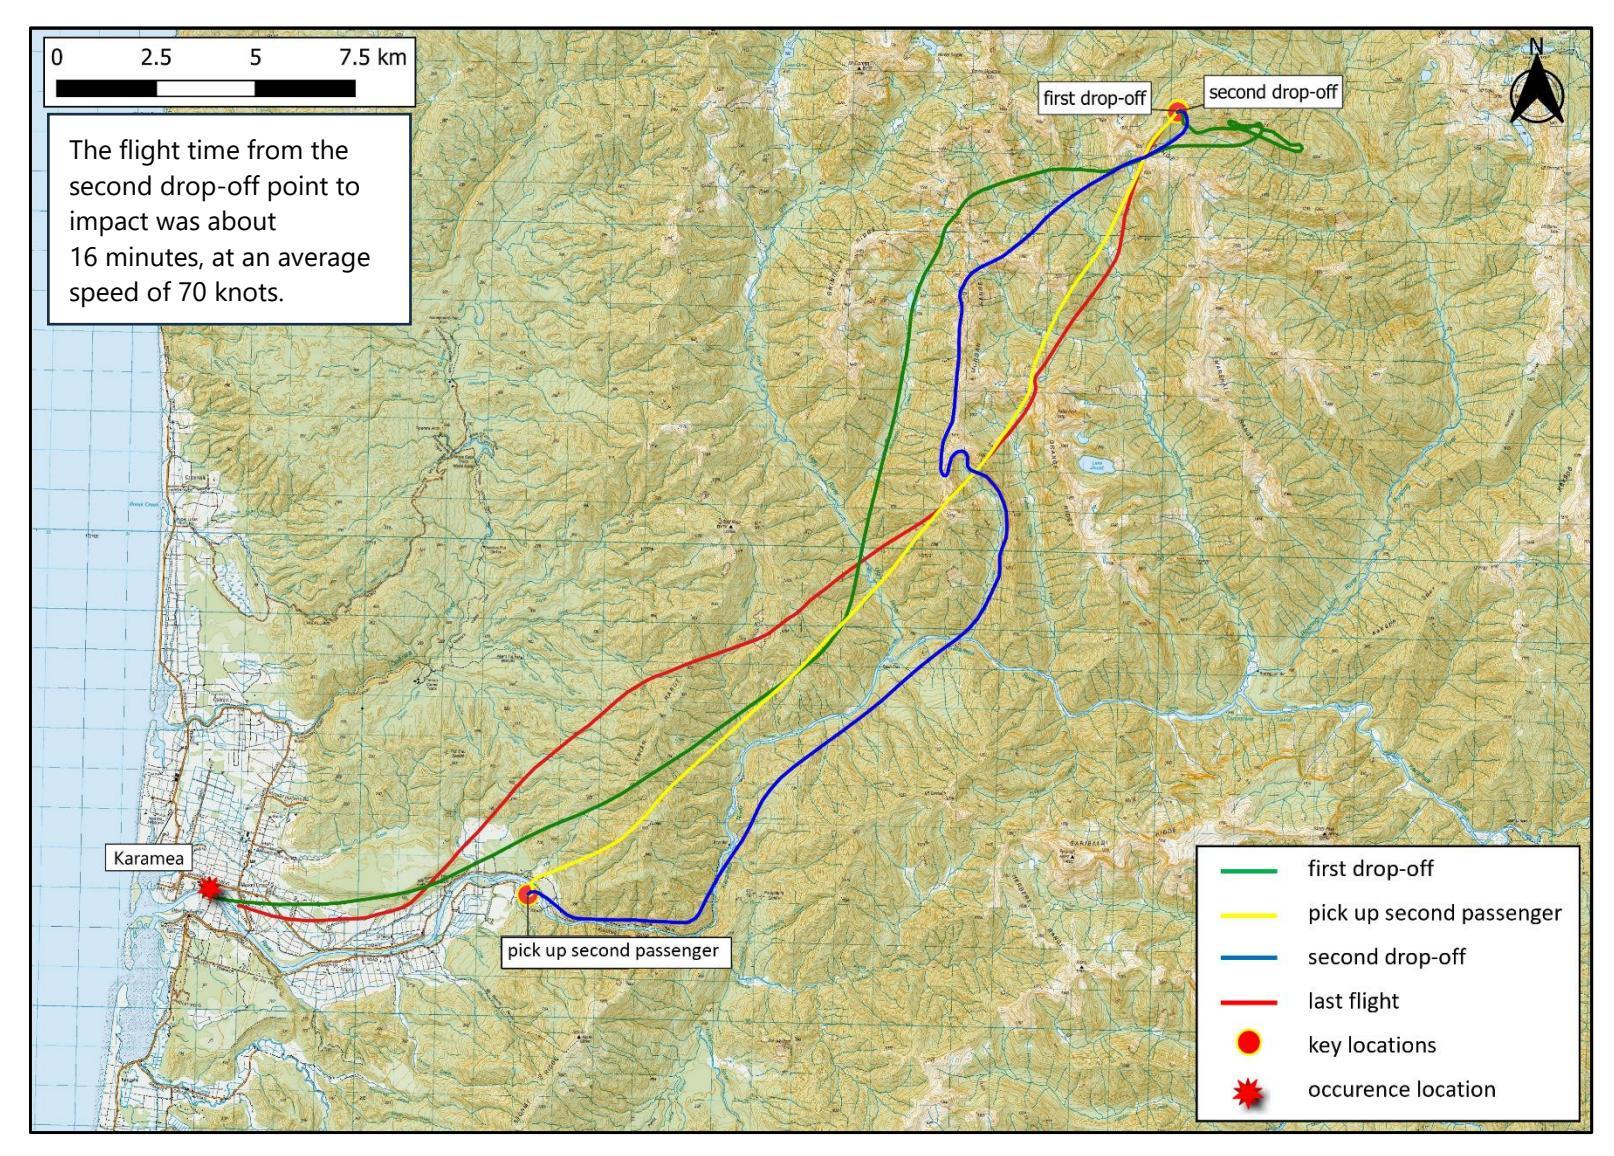
Figure 3: Helicopter flight tracks

- 2.2. The first flight, during which the passenger took photographs of the Karamea township, was six minutes long. The second flight, comprised of four sectors, dropped off two passengers who were to go hunting in Kahurangi National Park (*see* Figure 3).

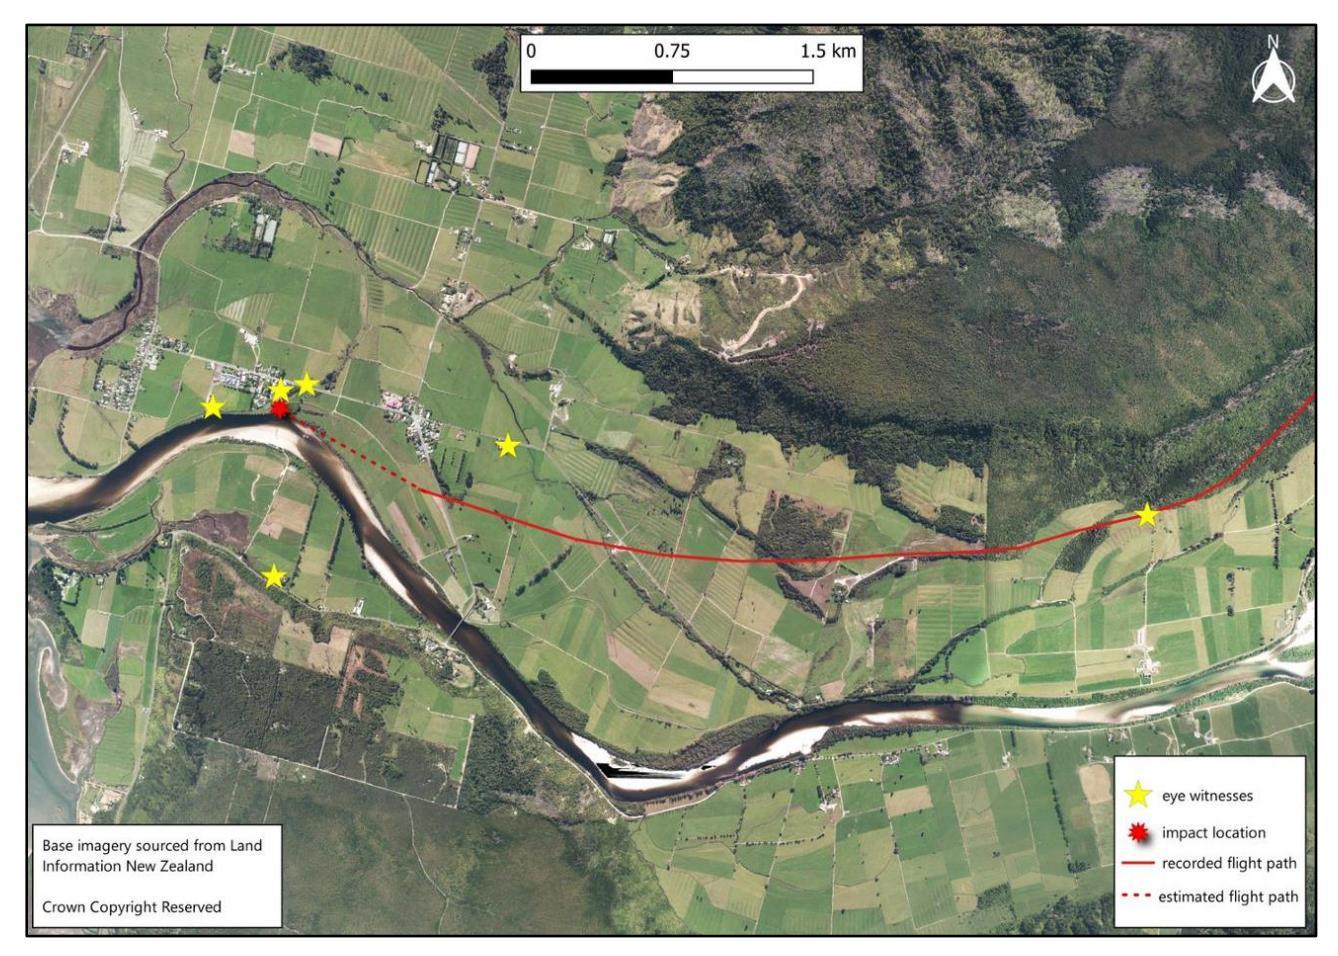
Figure 4: The last three minutes of the accident flight, showing witness locations

- 2.6. After considering their options, the pilot chose to continue the flight to Karamea, which was about 16 minutes long.
- 2.7. Witnesses familiar with the local pilot and helicopter observed the helicopter flying past them, flying slower and lower than usual and on a different flight path from usual (*see* Figure 4). The witnesses also said the sound was distinctly different from normal; some said it sounded like the rescue helicopter<sup>5</sup> that flew into Karamea occasionally.

- 2.9. At 1557, witnesses observed the helicopter pitching up and down abruptly and rotating to the right. During this sequence the empennage assembly<sup>6</sup> and other objects were seen falling off the helicopter. The helicopter fell to the ground almost vertically in a right skid-low attitude<sup>7</sup> and the engine became silent after impact.
- 2.10. Witnesses on the ground responded immediately to the accident. They released the pilot from their aircraft restraint and moved them away from the helicopter. The pilot was severely injured and was air lifted to Nelson Hospital.

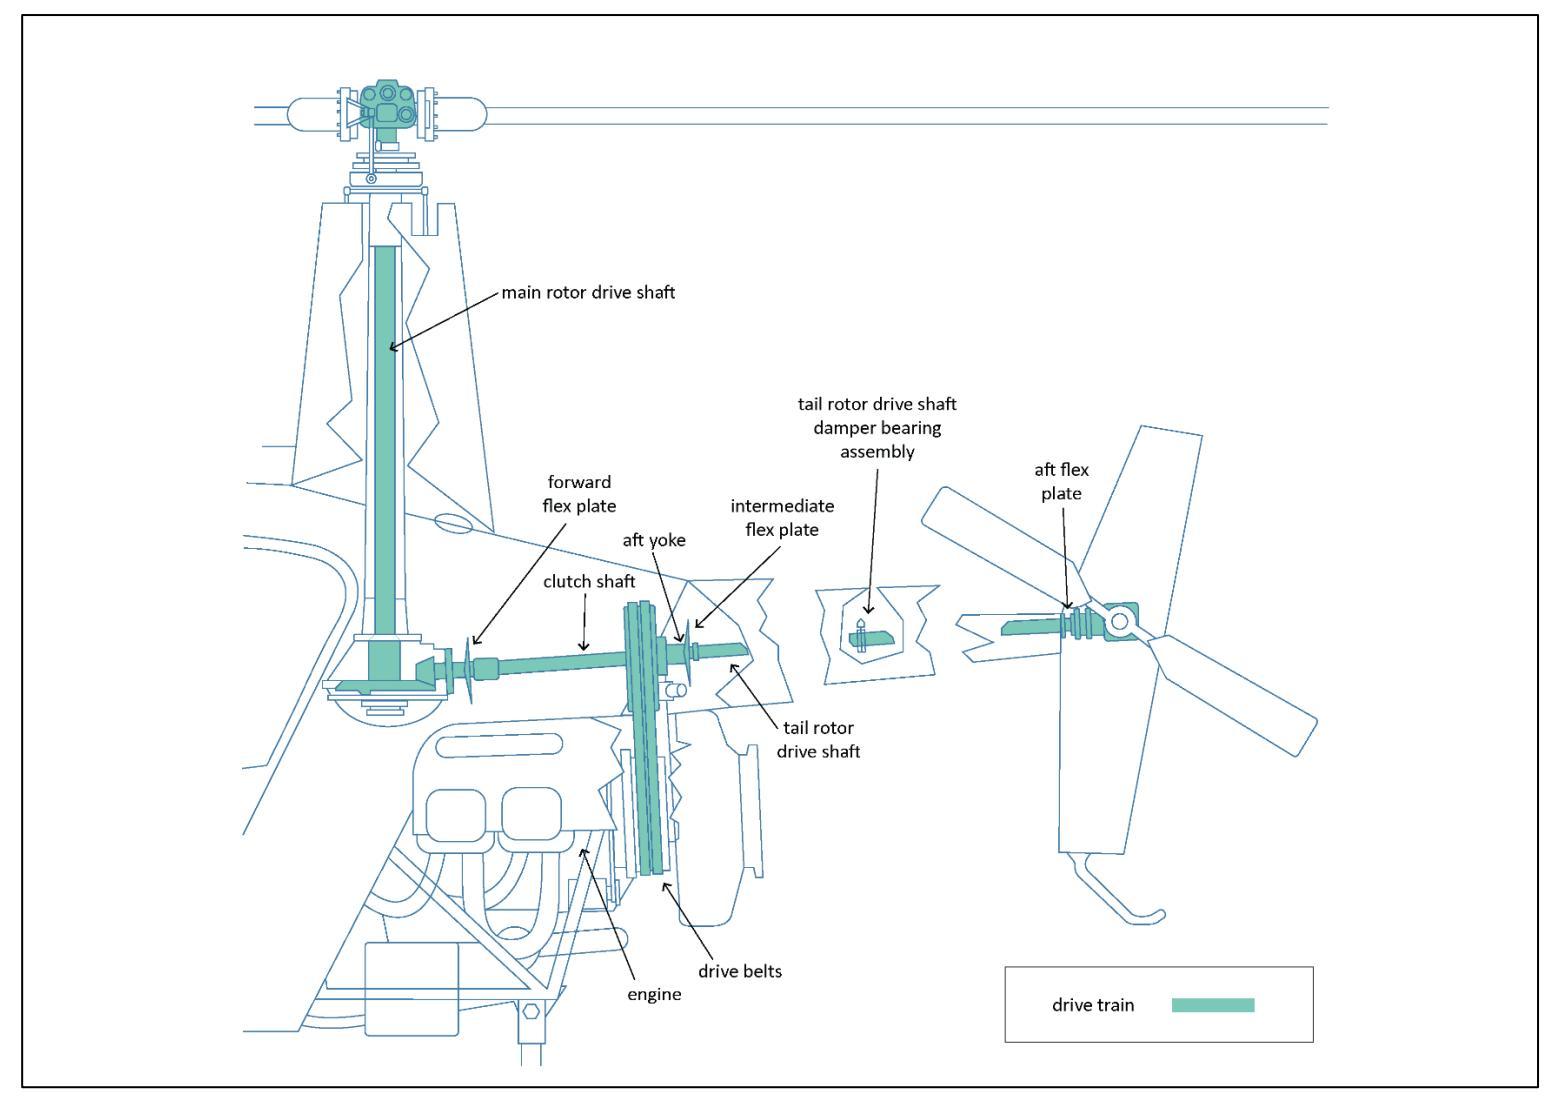
Figure 9: Robinson R22 drivetrain

- 2.51. The tailcone was damaged significantly in the accident sequence and the rotational impact from the tail rotor drive shaft caused internal damage. The tail rotor drive shaft had twisted and failed in overload forward of the damper bearing<sup>24</sup>. The clutch shaft aft yoke<sup>25</sup> exhibited torsional<sup>26</sup> failure around the yoke's flange (*see* Figure 9 and Appendix 5). The wiring loom and the tail rotor control tube had twisted around the bowed tail rotor drive shaft (*see* Figure 8). The tail rotor drive shaft exhibited scoring around the shaft's circumference at intervals where it had been contacting the tailcone formers.

- 3.10. An examination of the wreckage showed that the tailcone was almost severed at two points and the tail rotor drive shaft had twisted and entangled with the tail rotor control tube (*see* Figure 8). These were normally physically separated within the tailcone (*see* Figure 7) and would never have come into contact with each other during normal operation. During the accident sequence the tail rotor drive shaft deformed to the extent that it contacted the tail rotor control tube. The tail rotor drive shaft was not able to rotate after it had twisted with the tail rotor control tube, but the engine was still delivering power to it. This resulted in the forward end of the tail rotor drive shaft twisting, and torsional failure of the clutch shaft aft yoke (*see* Figure 9 and Appendix 5).

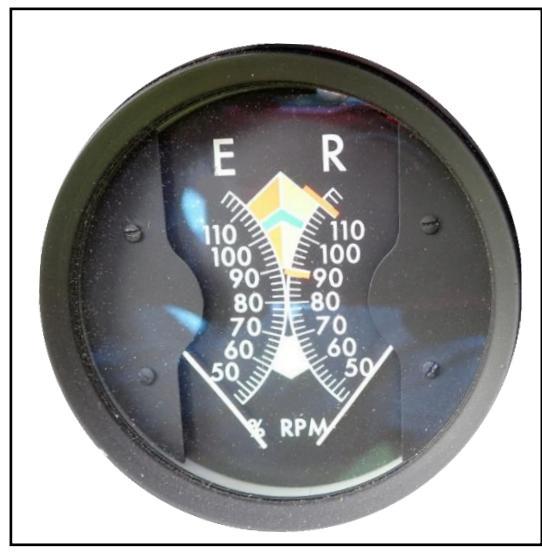
Figure 12: Engine and rotor dual tachometer indicator

3.23. The electronic governor senses engine RPM and rotates the twist grip accordingly to maintain RPM within the green arc range on the dual tachometer indicator<sup>36</sup> (*see* Figure 12). The electronic governor assists in controlling the engine RPM by making minor throttle valve adjustments through rotating the twist grip on the collective control. The governor is active only above 80 per cent engine RPM and is switched 'on' or 'off' by the pilot, with the governor toggle switch located at the end of the collective lever. The governor can be overridden by the pilot gripping the twist grip too tightly or by the pilot's manual movement of the twist grip.
