Transport Accident Investigation Commission

Final report Tuhinga whakamutunga

Aviation inquiry AO-2023-001 Airbus Helicopters AS350B2 (ZK-IDB) and EC130B4 (ZK-IUP) Reported close air proximity Queenstown Aerodrome 27 December 2022

June 2024

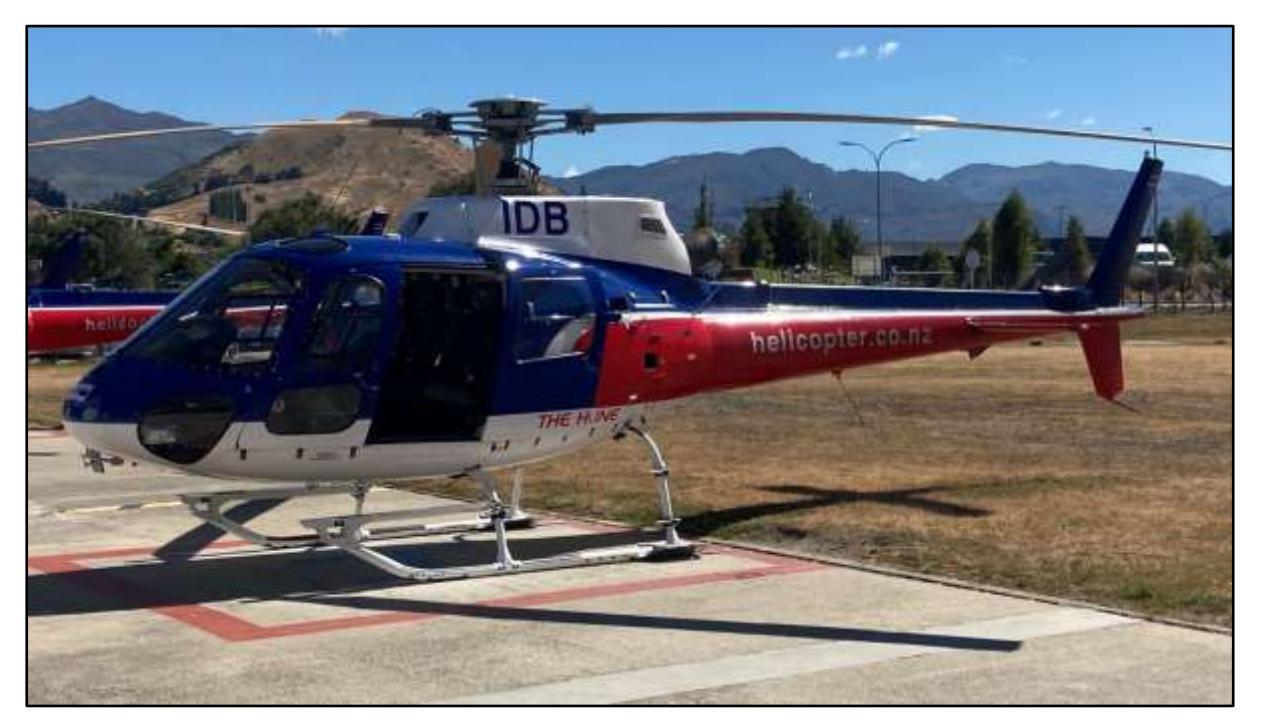
Figure 1: Airbus Helicopters AS350B2, ZK-IDB

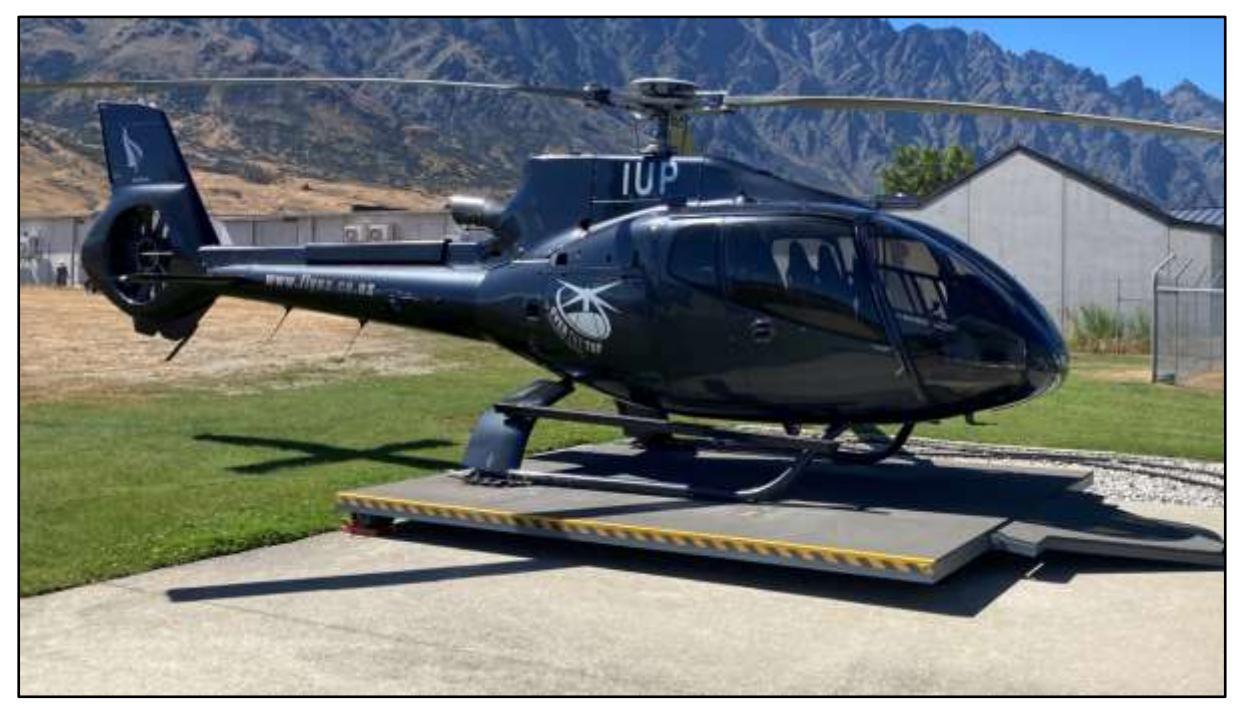
Figure 2: Airbus Helicopters EC130B4, ZK-IUP

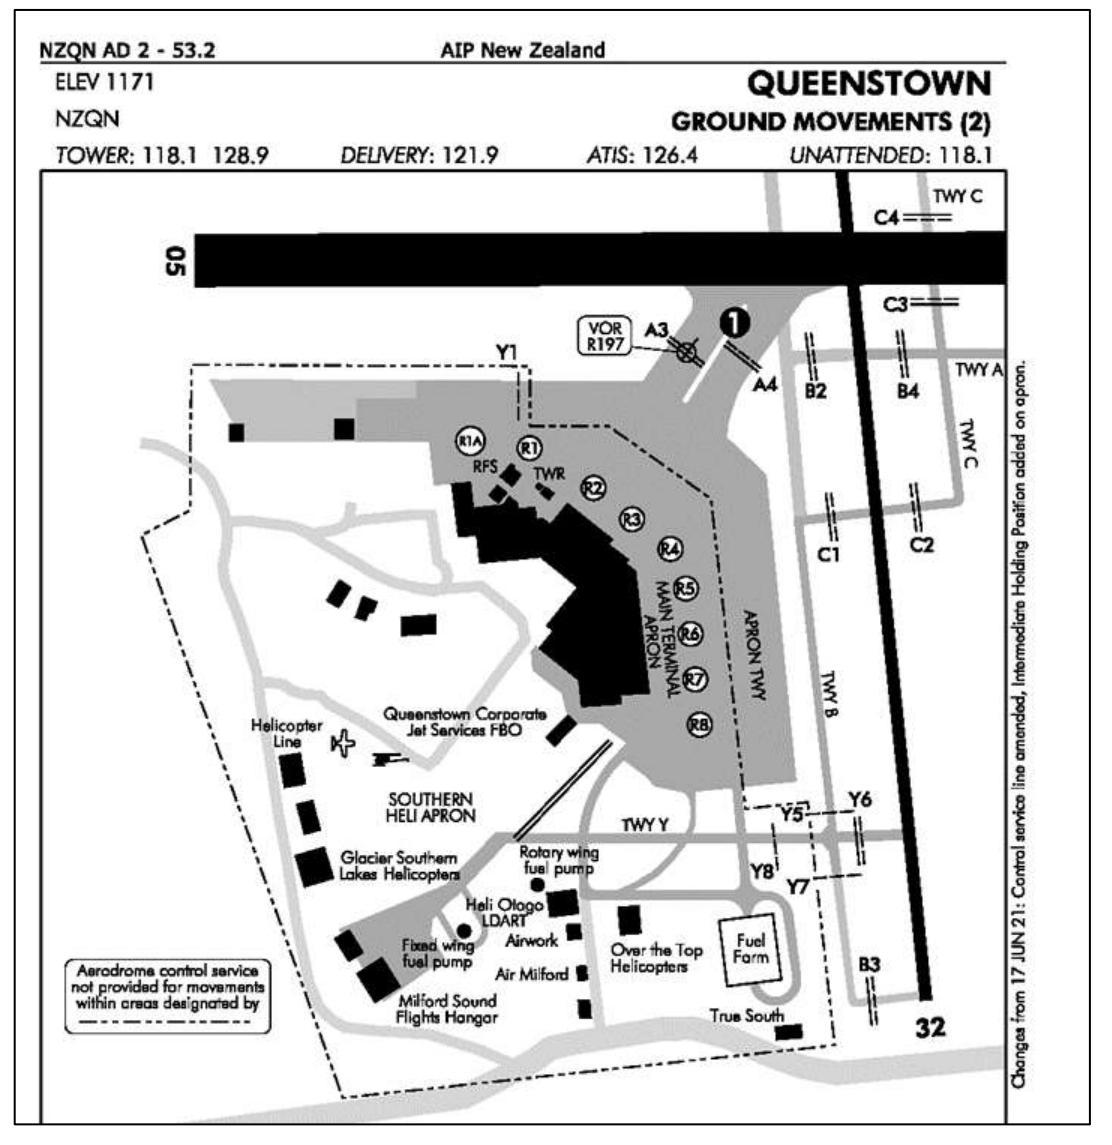
2.1 At 1316¹ on Tuesday 27 December 2022, the pilot of ZK-IUP (IUP), an Airbus Helicopters EC130B4 operated by Over the Top Helicopters, contacted Queenstown Delivery² (Delivery) in preparation for departure from their helipad on the southern apron³ (*see* Figure 4). Intending to depart to the north of the aerodrome with only the pilot on board, they were notified by Delivery of a significant delay because of inbound traffic.

Figure 4: AIP Queenstown ground movements (2), showing location of helipads (Credit: CAA/AIP New Zealand)

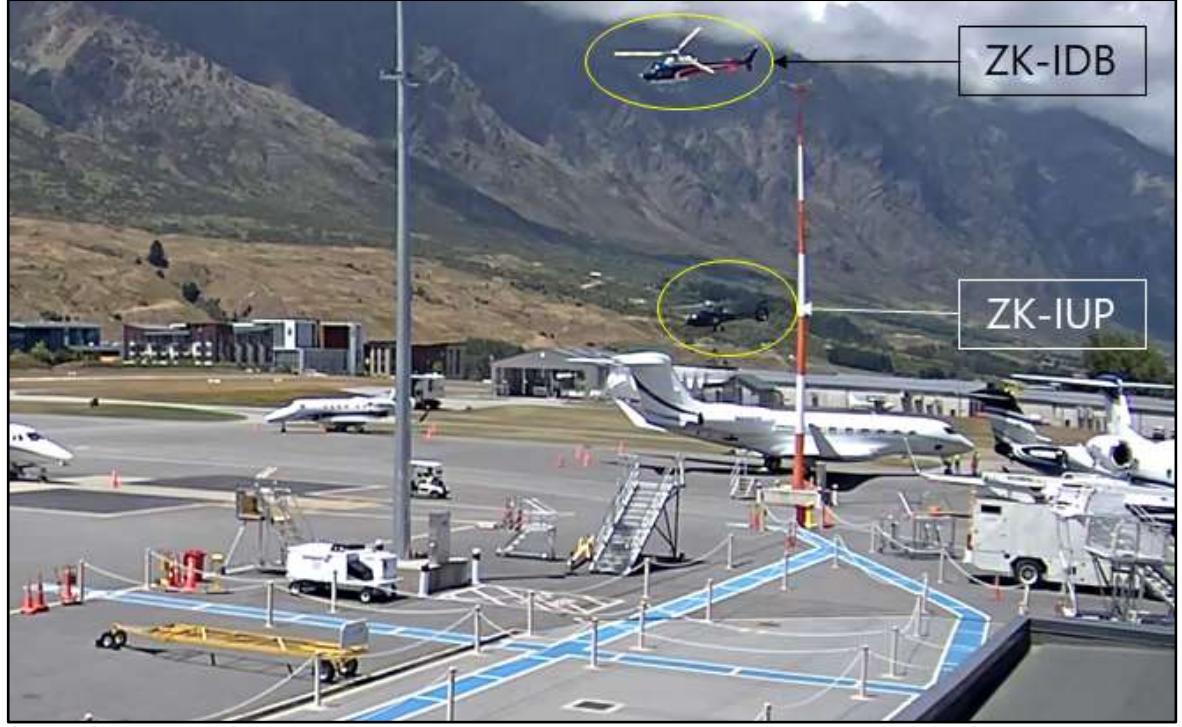
- 3.6 The pilot of IDB recalled looking along IUP's expected flight path, but they did not see IUP until they were in view of IUP's helipad. The pilot of IDB noted that IUP was on a low take-off profile and made a radio call on the Tower frequency, taking the number one position. The pilot of IUP acknowledged the radio call and followed IDB out of the southern apron area.
- 3.7 ADS-B tracking data and CCTV recordings show that, at their nearest point, the helicopters were separated laterally by about 44 m and were over parallel taxiways at their closest point (*see* Figure 3).
- 3.8 Because of altitude rounding¹³ by the ADS-B system, the exact vertical separation cannot be confirmed. However, CCTV footage shows vertical separation between the two helicopters in the southern apron area (*see* Figure 8 and Figure 9) with no excessive or obvious avoiding manoeuvre by the pilot of IDB.

Figure 9: CCTV footage of the apron towards runway 14/32 (Credit: Queenstown Airport Corporation)
