Transport Accident
Investigation
Commission

Final report

Aviation inquiry AO-2023-010
Kawasaki BK117 B-2, ZK-HHJ
Collision with terrain
Mount Pirongia
19 September 2023

April 2025

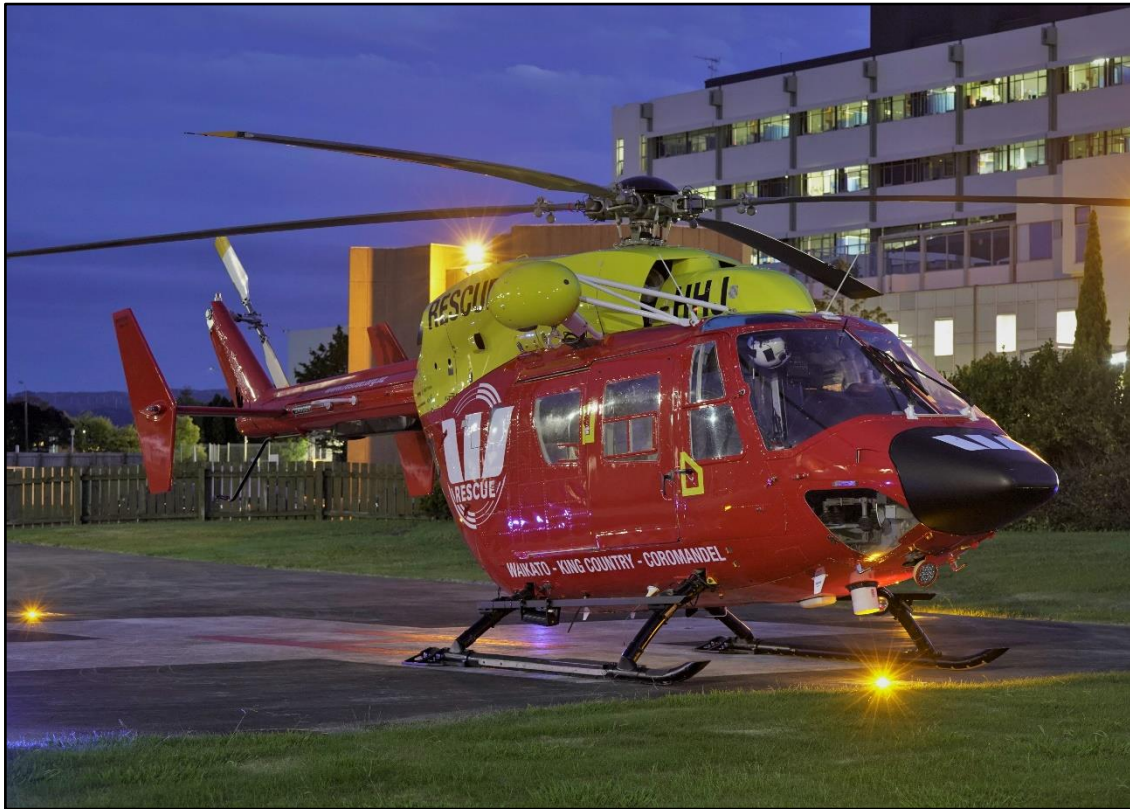
Figure 1: Kawasaki BK117 B-2, ZK-HHJ
(Credit: Search and Rescue Services Limited)

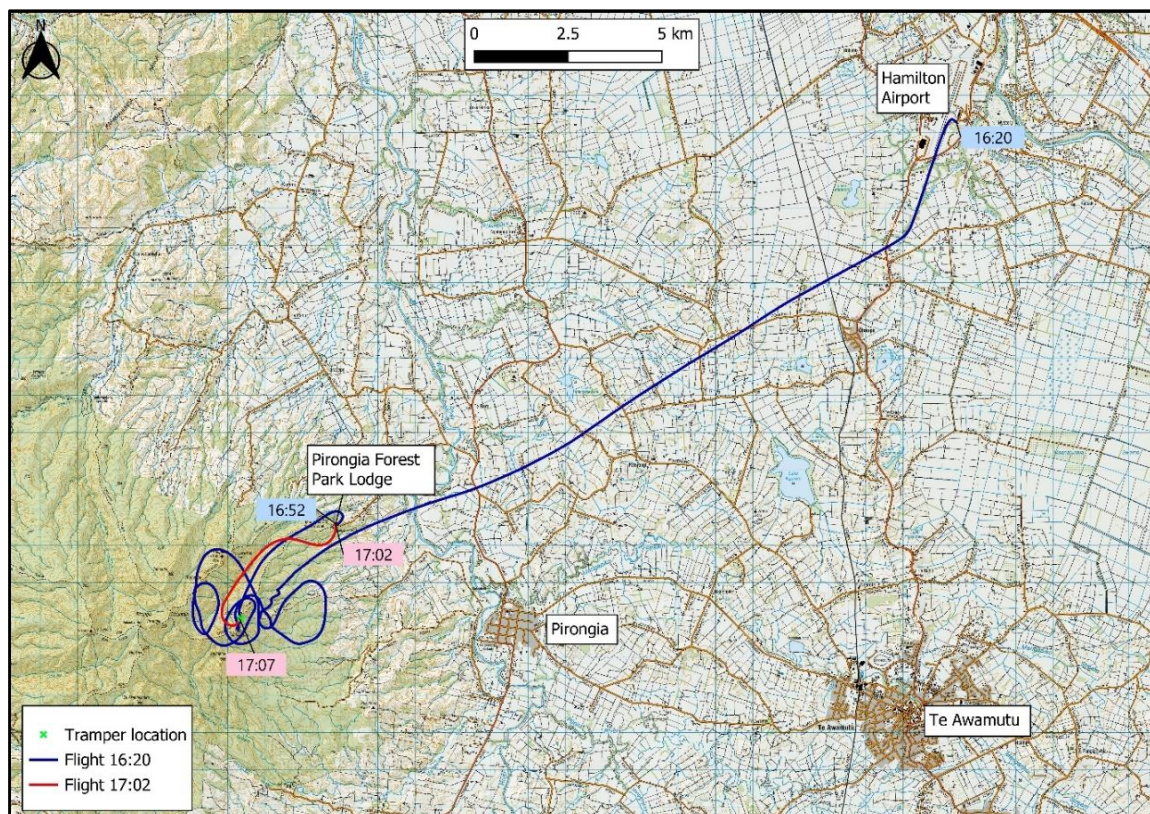
Figure 3: Helicopter flight track

- 2.3. The helicopter departed Hamilton Airport at 1620 for Te Awamutu. While enroute the pilot entered the patient's global positioning system (GPS) coordinates into the helicopter's GPS, which directed them to Mount Pirongia. While searching, the national Air Desk⁵ provided the crew with the patient's mobile-phone number and coordinates from their Personal Locator Beacon, which assisted in locating the patient.

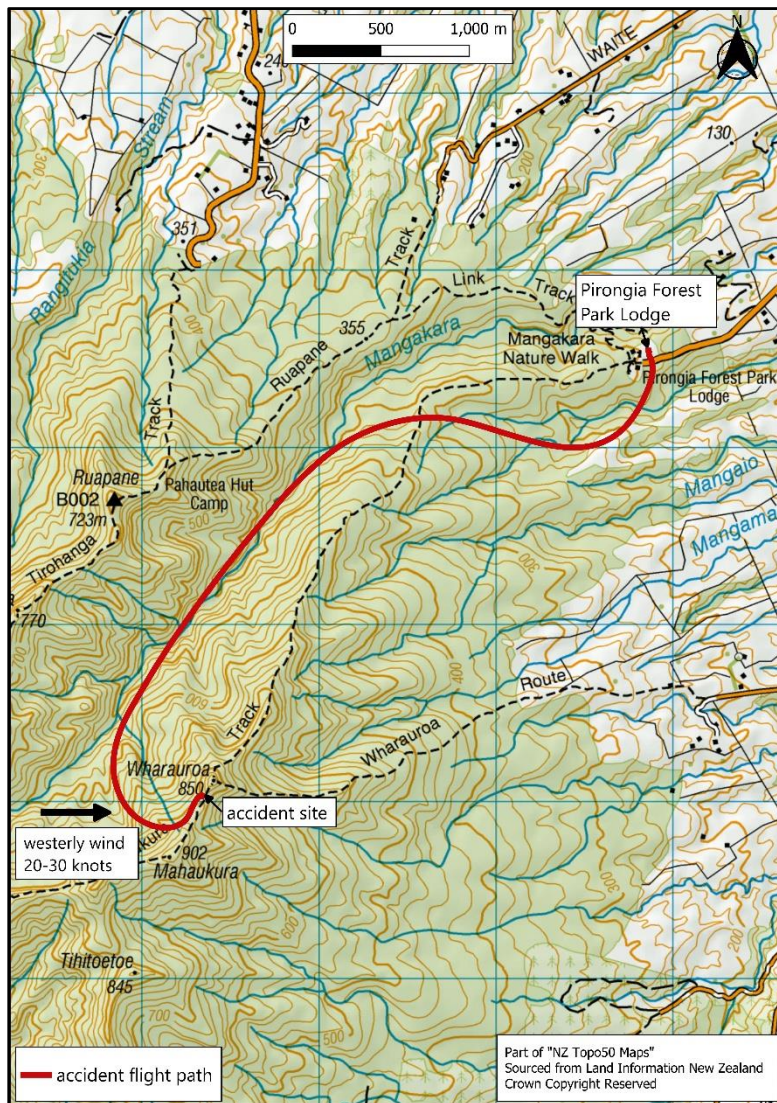
Figure 4: Accident flight

- 2.4. At about 1645 the crew located the patient and their partner on the Mahaukura Track, situated below and on the southern side of Wharauroa lookout (see Figure 4). The crew conducted a reconnaissance of the site and found that there was no suitable place for the helicopter to land near the patient and that a winch extraction would be the most suitable method of recovery.
- 2.5. The pilot then flew the helicopter to a nearby staging area at Pirongia Forest Park Lodge so that the crew could reconfigure the cabin for a winch operation. After the pilot landed and shut down the helicopter, the crew reconfigured the cabin and checked the winch was functional. They then discussed the procedures for recovering the patient by winch extraction.

- 2.6. At 1702 the helicopter departed Pirongia Forest Park Lodge and flew up the valley on the western side of Wharauroa Lookout. After passing abeam Wharauroa Lookout the helicopter entered a 180-degree climbing turn to the left and continued ascending to an altitude of 3000 feet (ft). The pilot continued the left turn before starting a descent onto final approach towards the patient on the windward side of a ridge (see Figure 4).

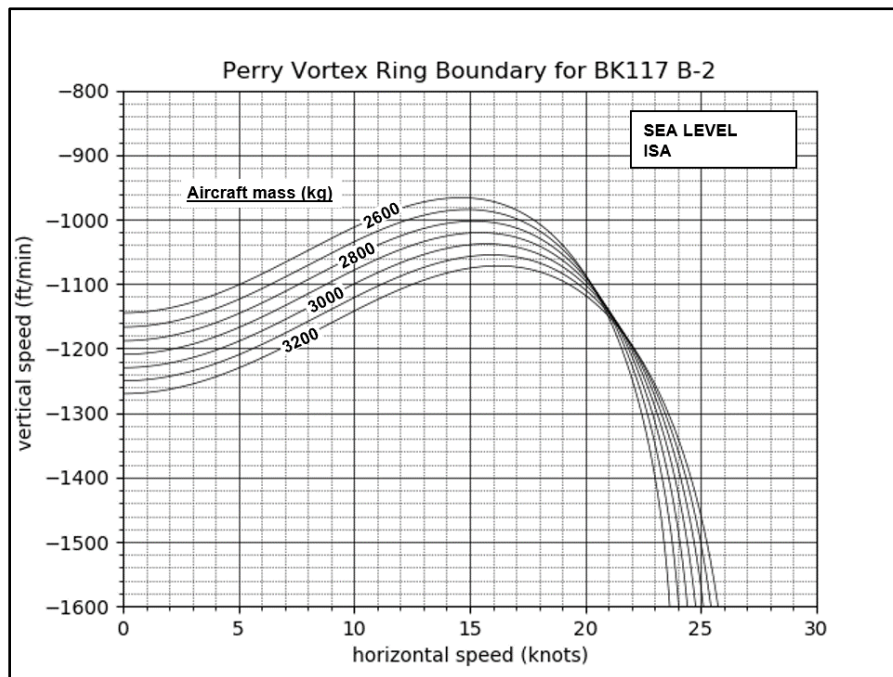
Figure 19: Predicted VRS onset boundaries, showing the effect of aircraft mass (at ISA sea level conditions).

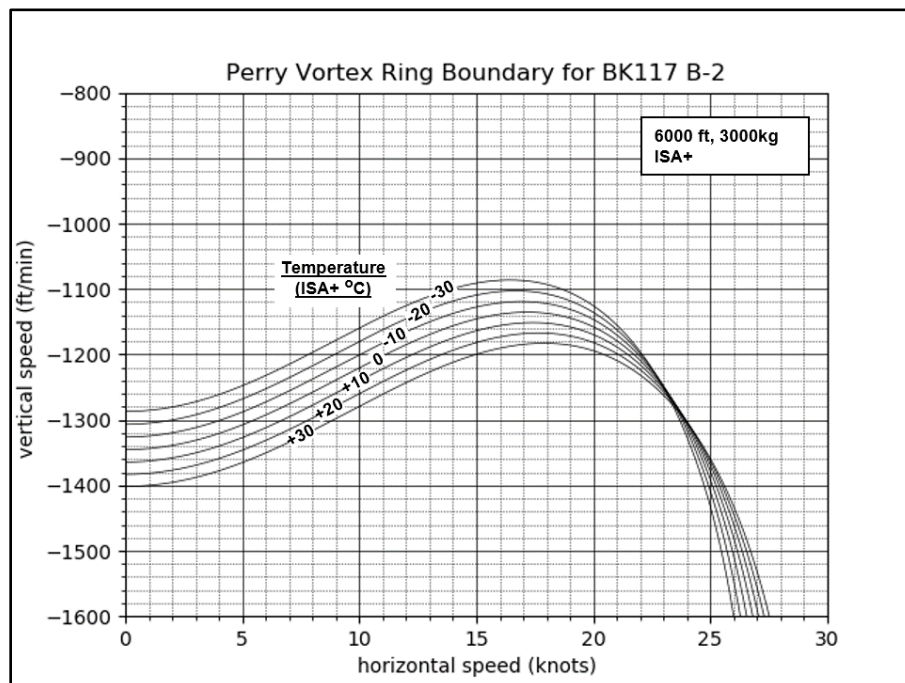
Figure 20: Predicted VRS onset boundaries, showing the effect of air temperature (at 6,000 ft with aircraft mass 3,000 kg).
