Transport Accident Investigation Commission

Final report Tuhinga whakamutunga

Aviation inquiry AO-2023-010 Kawasaki BK117 B-2, ZK-HHJ Collision with terrain Mount Pirongia 19 September 2023

April 2025

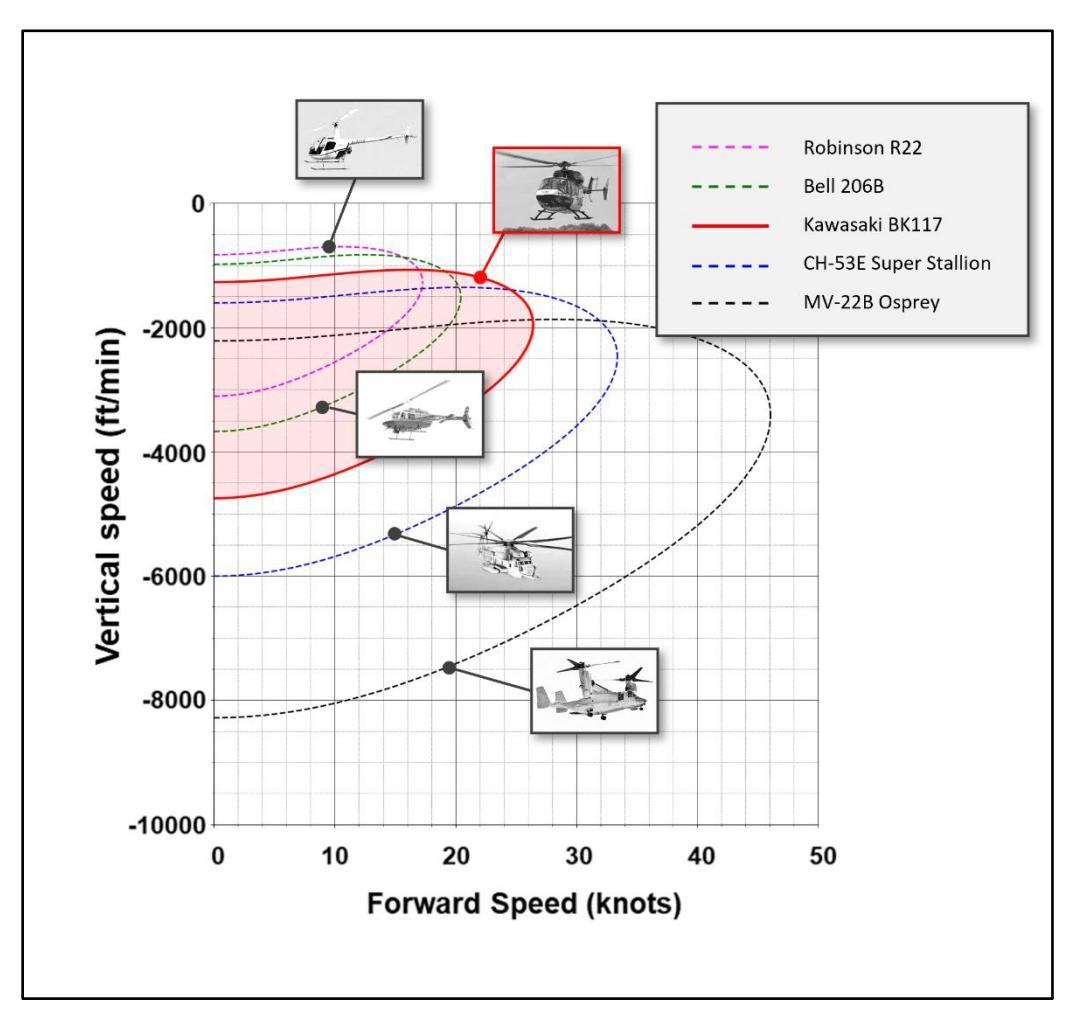
Figure 7: Predicted VRS onset boundaries for various conventional helicopters (Credit: Dr Richard E. Brown, Sophrodyne Aerospace)

2.53. The VRS domain extent for several well-known conventional helicopters is compared in Figure 7. The coloured line indicates the VRS onset boundary for each specific helicopter, as defined by its vertical and forward speeds. So, for instance, the BK117 helicopter will encounter VRS if its trajectory takes it into the region of the diagram that is shaded in red. Using similar logic, the large, heavy CH-53E military transport helicopter might experience VRS at descent rates between 1350 and 6000 ft/min, when flying at a speed less than 34 kt; a small helicopter, such as the Robinson R22, would only encounter VRS at descent rates between 700 and 3100 ft/min, when flying at speeds less than 17 kt.

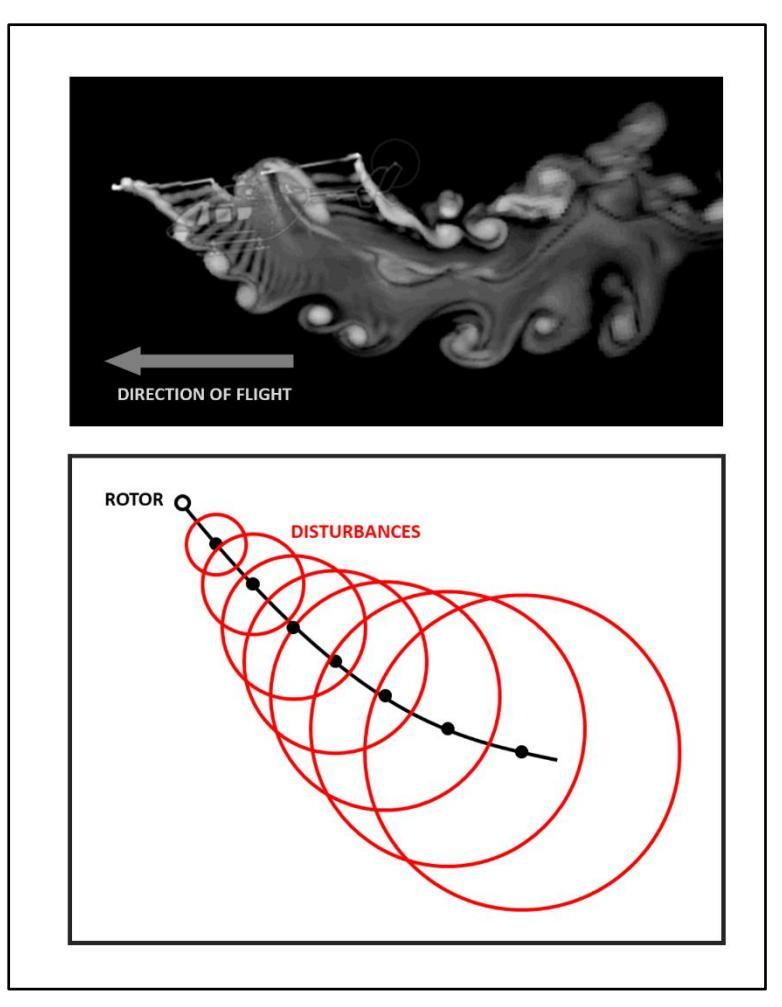
Figure 8: Representation of the main rotor wake in forward flight

2.54. In normal flight, a helicopter's main rotor creates a long, cylindrical wake that streams down into the flow below and behind the main rotor (*see* Figure 8). The wake from a helicopter's main rotor is inherently unstable. This instability causes the orderly structure of the wake eventually to break down into a highly turbulent, chaotic flow. In normal flight this breakdown occurs below and behind the helicopter and has very little influence on the aerodynamics of the main rotor itself.

- 2.55. A physical representation of the main rotor wake with the helicopter in forward flight is demonstrated in Figure 8. The image shows how the wake near the main rotor initially has an ordered cylindrical shape and how, further away from the helicopter, the wake becomes increasingly more disordered as its inherent instability starts to take hold. The figure at the bottom shows an idealisation of this process.

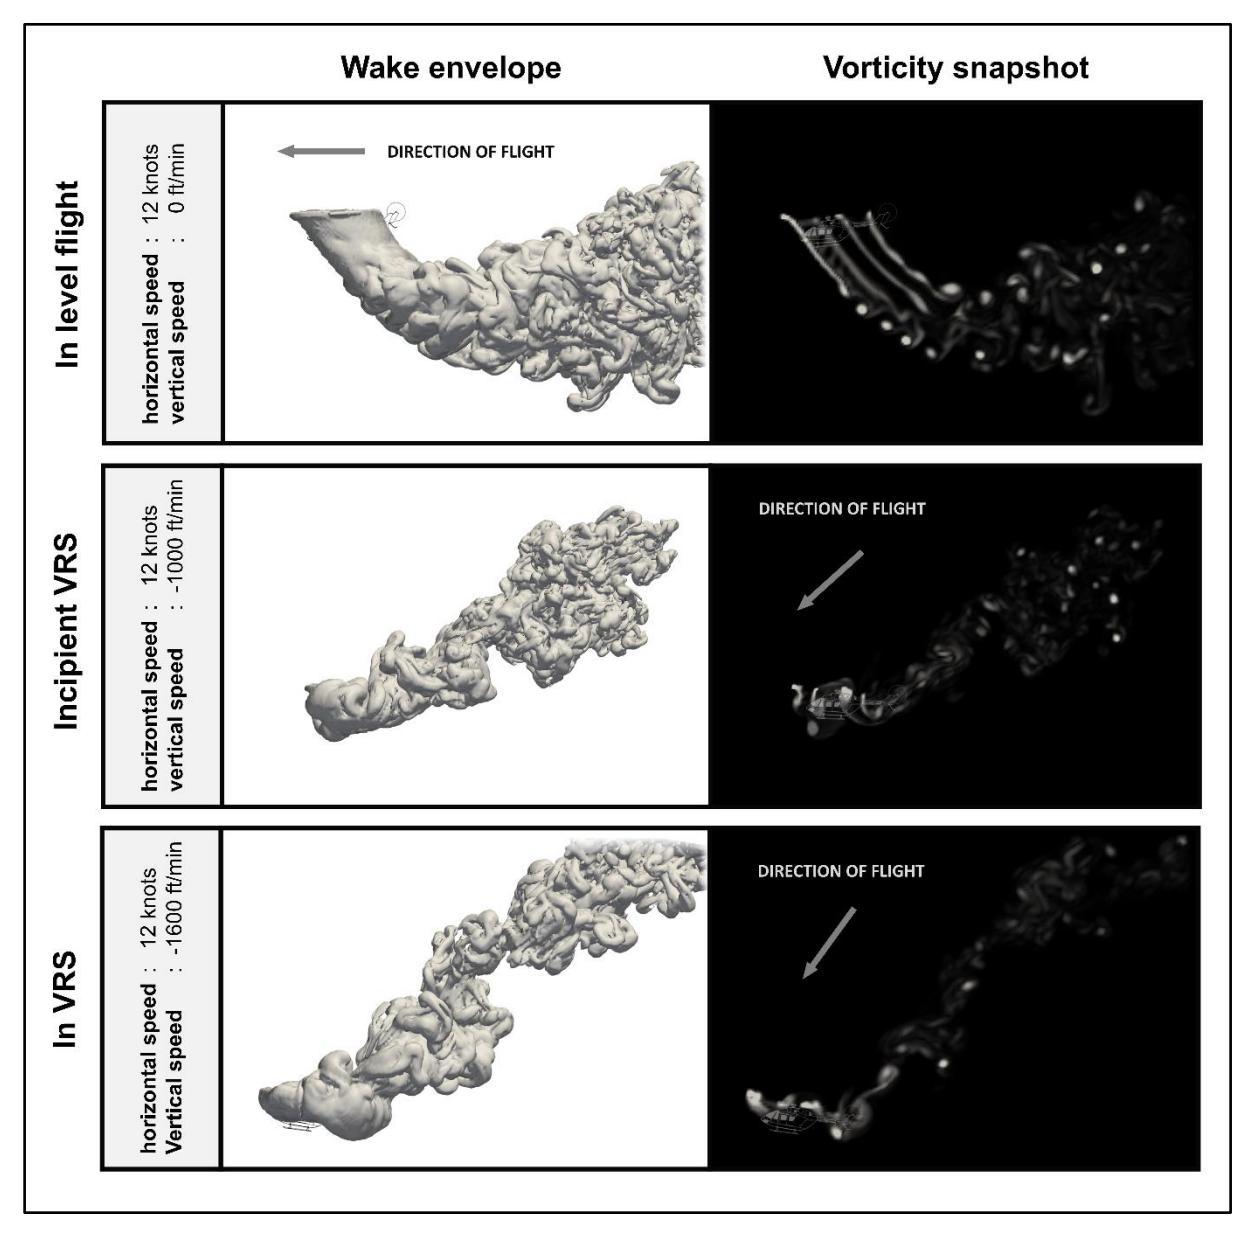
Figure 9: Structure of the rotor wake in level flight compared with the structure in fully developed VRS

- 2.57. A comparison of a helicopter's main rotor wake structure in level flight at a speed of 12 kt is demonstrated in Figure 9. The middle image shows the structure of the wake

just before VRS onset. The disturbances in the main rotor wake have practically caught up with the main rotor. The bottom image shows the helicopter relatively deep within VRS. The wake has transitioned into the toroidal recirculatory form that is associated with VRS.

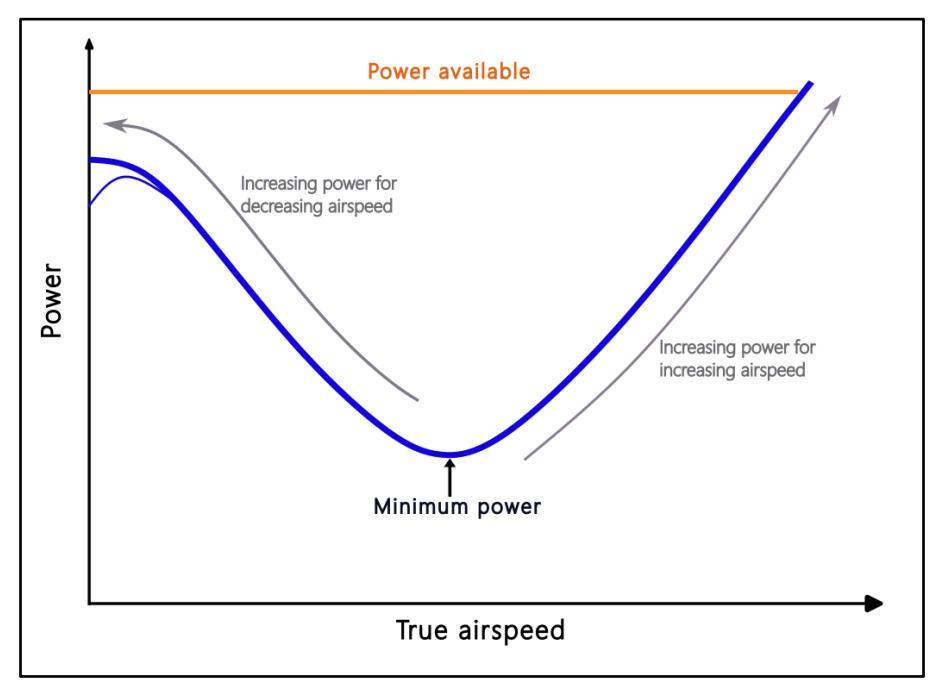
Figure 10: Power versus airspeed for level flight

- 2.62. The power required to sustain level flight increases as the forward speed of the helicopter is reduced below the minimum power setting for level flight (*see* Figure 10). If the engine(s) cannot provide the necessary power, then the helicopter will begin to descend or settle. This is not VRS but rather a condition where the engine(s) have reached their maximum available power limit. The power required exceeds the power available.
