Transport Accident
Investigation
Commission

Final report

Aviation inquiry AO-2023-010
Kawasaki BK117 B-2, ZK-HHJ
Collision with terrain
Mount Pirongia
19 September 2023

April 2025

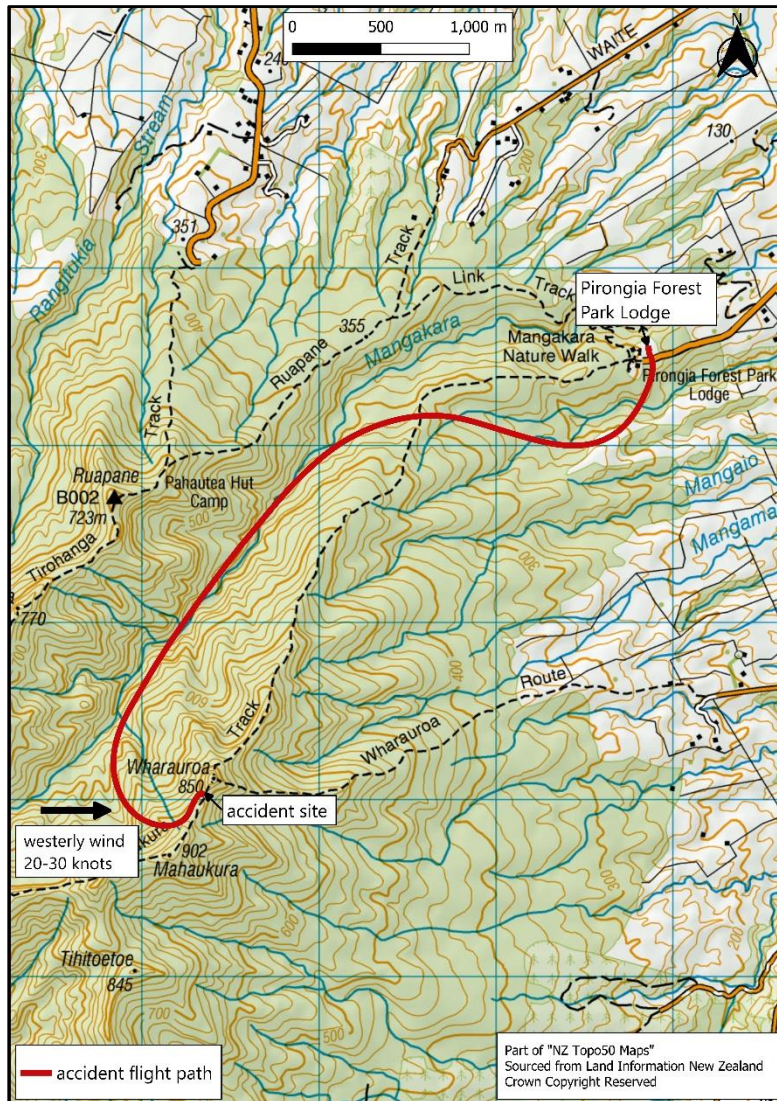
Figure 4: Accident flight

- 2.6. At 1702 the helicopter departed Pirongia Forest Park Lodge and flew up the valley on the western side of Wharauroa Lookout. After passing abeam Wharauroa Lookout the helicopter entered a 180-degree climbing turn to the left and continued ascending to an altitude of 3000 feet (ft). The pilot continued the left turn before starting a descent onto final approach towards the patient on the windward side of a ridge (see Figure 4).

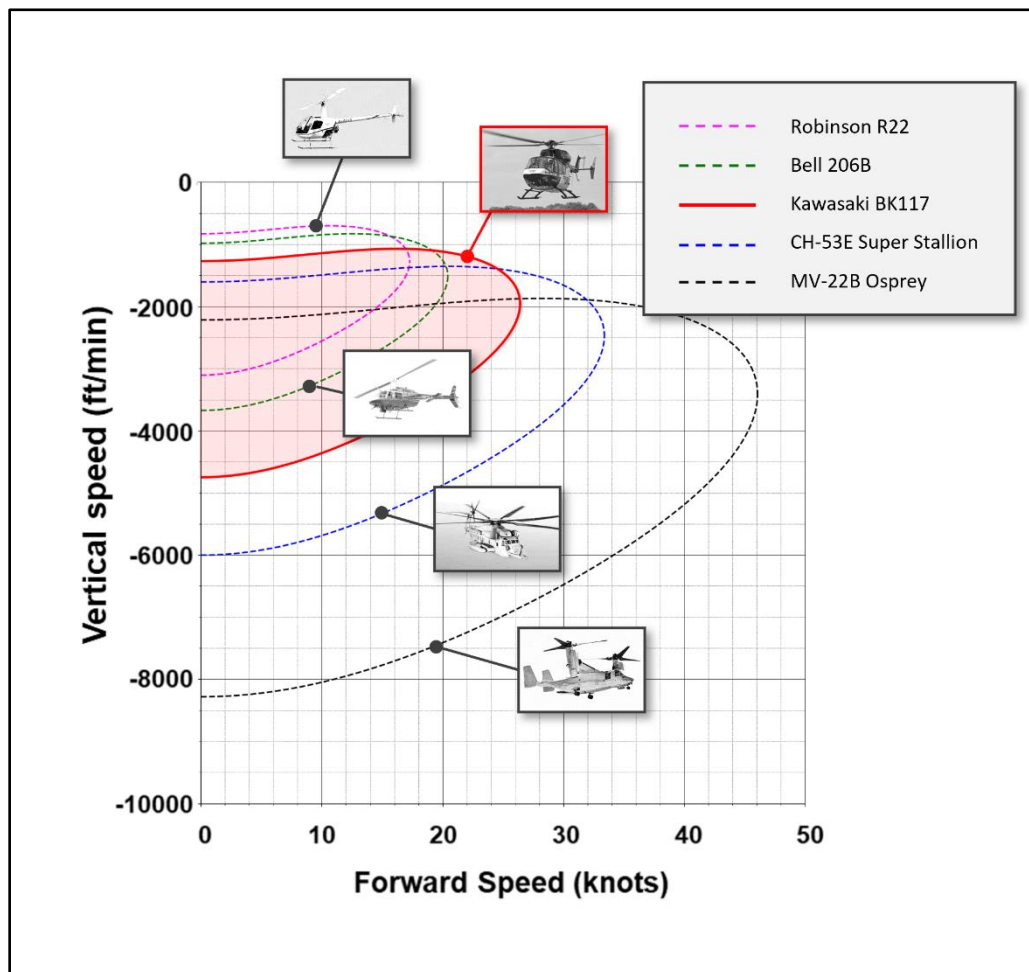
Figure 7: Predicted VRS onset boundaries for various conventional helicopters
(Credit: Dr Richard E. Brown, Sophrodyne Aerospace)

- 2.53. The VRS domain extent for several well-known conventional helicopters is compared in Figure 7. The coloured line indicates the VRS onset boundary for each specific helicopter, as defined by its vertical and forward speeds. So, for instance, the BK117 helicopter will encounter VRS if its trajectory takes it into the region of the diagram that is shaded in red. Using similar logic, the large, heavy CH-53E military transport helicopter might experience VRS at descent rates between 1350 and 6000 ft/min, when flying at a speed less than 34 kt; a small helicopter, such as the Robinson R22, would only encounter VRS at descent rates between 700 and 3100 ft/min, when flying at speeds less than 17 kt.

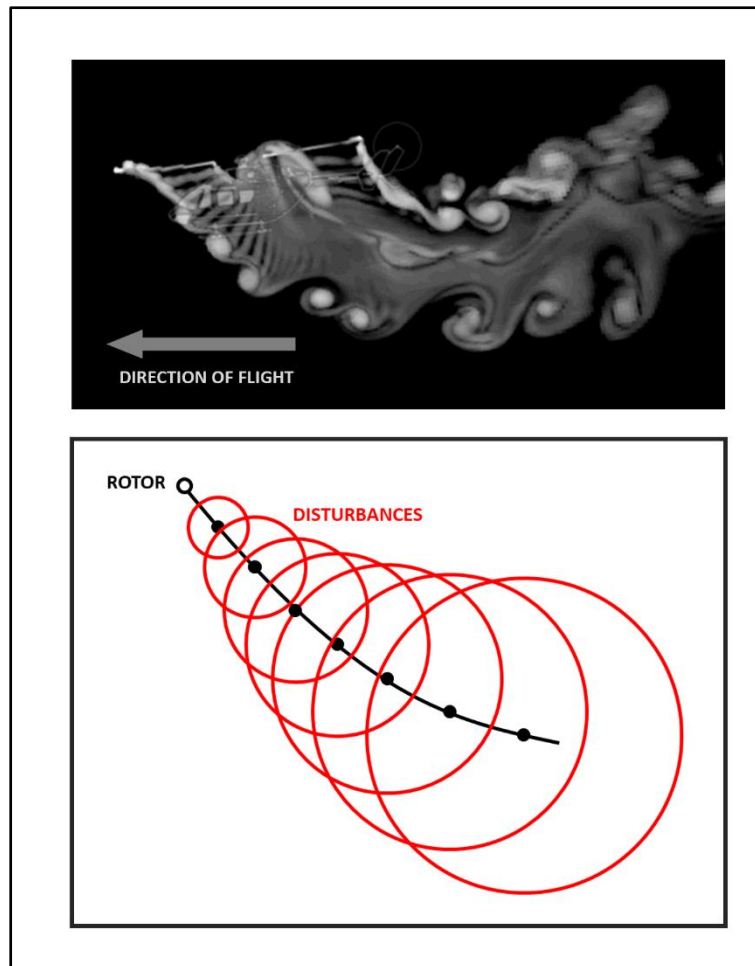
Figure 8: Representation of the main rotor wake in forward flight

- 2.54. In normal flight, a helicopter's main rotor creates a long, cylindrical wake that streams down into the flow below and behind the main rotor (see Figure 8). The wake from a helicopter's main rotor is inherently unstable. This instability causes the orderly structure of the wake eventually to break down into a highly turbulent, chaotic flow. In normal flight this breakdown occurs below and behind the helicopter and has very little influence on the aerodynamics of the main rotor itself.

- 2.55. A physical representation of the main rotor wake with the helicopter in forward flight is demonstrated in Figure 8. The image shows how the wake near the main rotor initially has an ordered cylindrical shape and how, further away from the helicopter, the wake becomes increasingly more disordered as its inherent instability starts to take hold. The figure at the bottom shows an idealisation of this process.

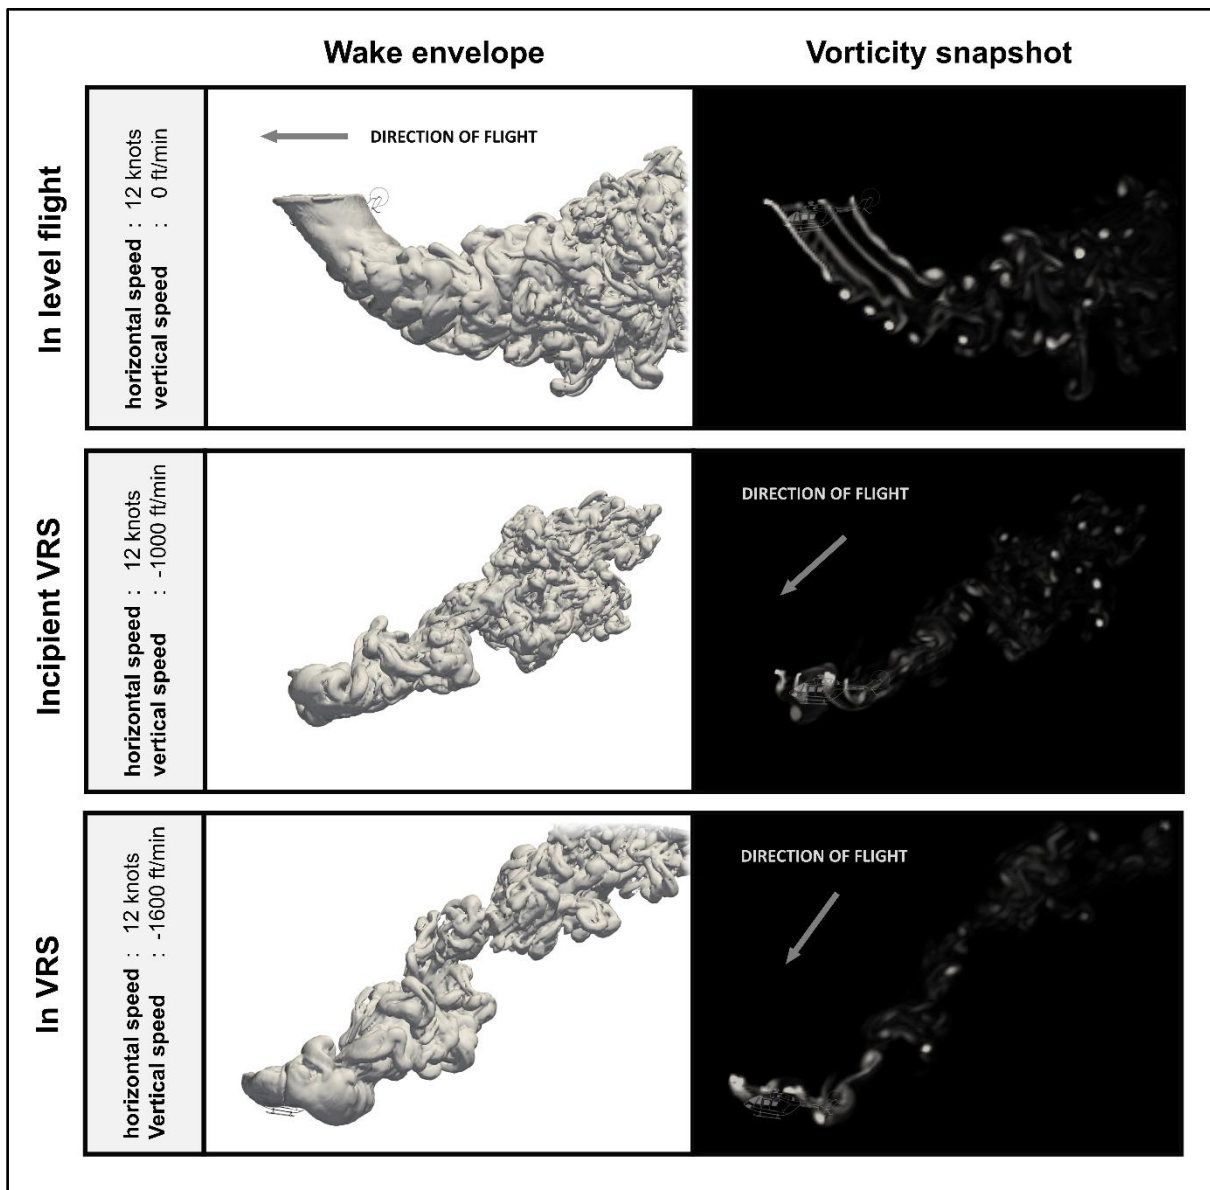
Figure 9: Structure of the rotor wake in level flight compared with the structure in fully developed VRS

- 2.57. A comparison of a helicopter's main rotor wake structure in level flight at a speed of 12 kt is demonstrated in Figure 9. The middle image shows the structure of the wake

just before VRS onset. The disturbances in the main rotor wake have practically caught up with the main rotor. The bottom image shows the helicopter relatively deep within VRS. The wake has transitioned into the toroidal recirculatory form that is associated with VRS.

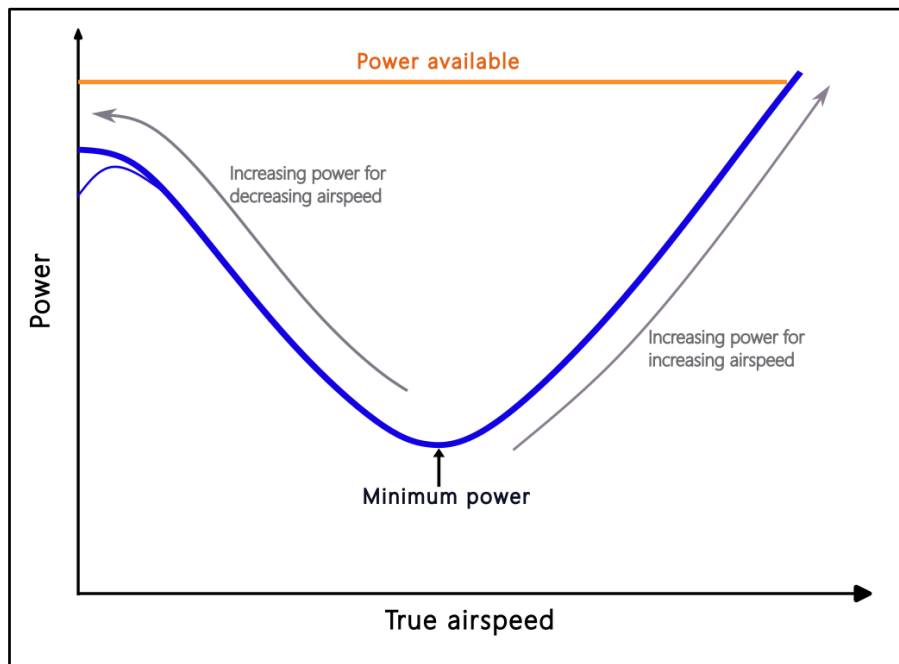
Figure 10: Power versus airspeed for level flight

- 2.62. The power required to sustain level flight increases as the forward speed of the helicopter is reduced below the minimum power setting for level flight (see Figure 10). If the engine(s) cannot provide the necessary power, then the helicopter will begin to descend or settle. This is not VRS but rather a condition where the engine(s) have reached their maximum available power limit. The power required exceeds the power available.

- 2.63. In certain circumstances, if the airspeed is slow enough, the descent rate can build up to the point at which VRS is eventually encountered in its aerodynamic form (see paragraphs 2.55 to 2.57).
