Transport Accident
Investigation
Commission

Aviation inquiry A0-2023-011

ZK-JED Beech 76 / ZK-WFS Cessna 172

Near mid-air collision

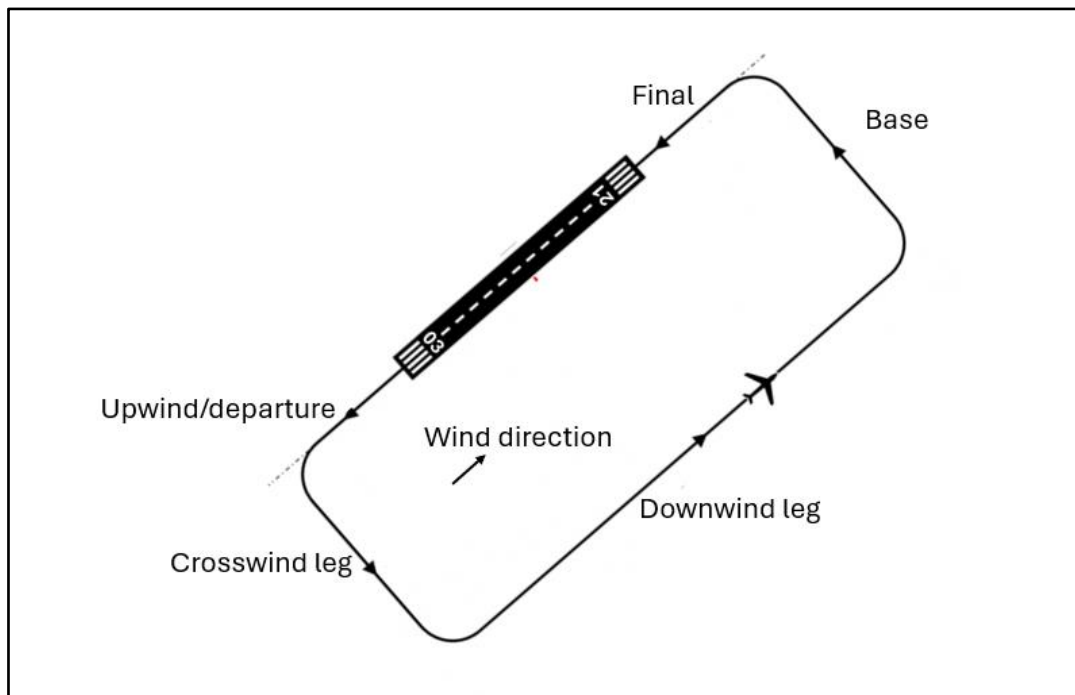
Figure 4: Ardmore circuit diagram

- 2.4. The crew changed over, with the rear seat passenger swapping positions with the pilot and taking over as the pilot flying under instruction.
- 2.5. The circuit layout is shown in Figure 4 and is explained further in Appendix 1. The prevailing wind was south-westerly, and pilots were using runway 21⁷ at Ardmore.

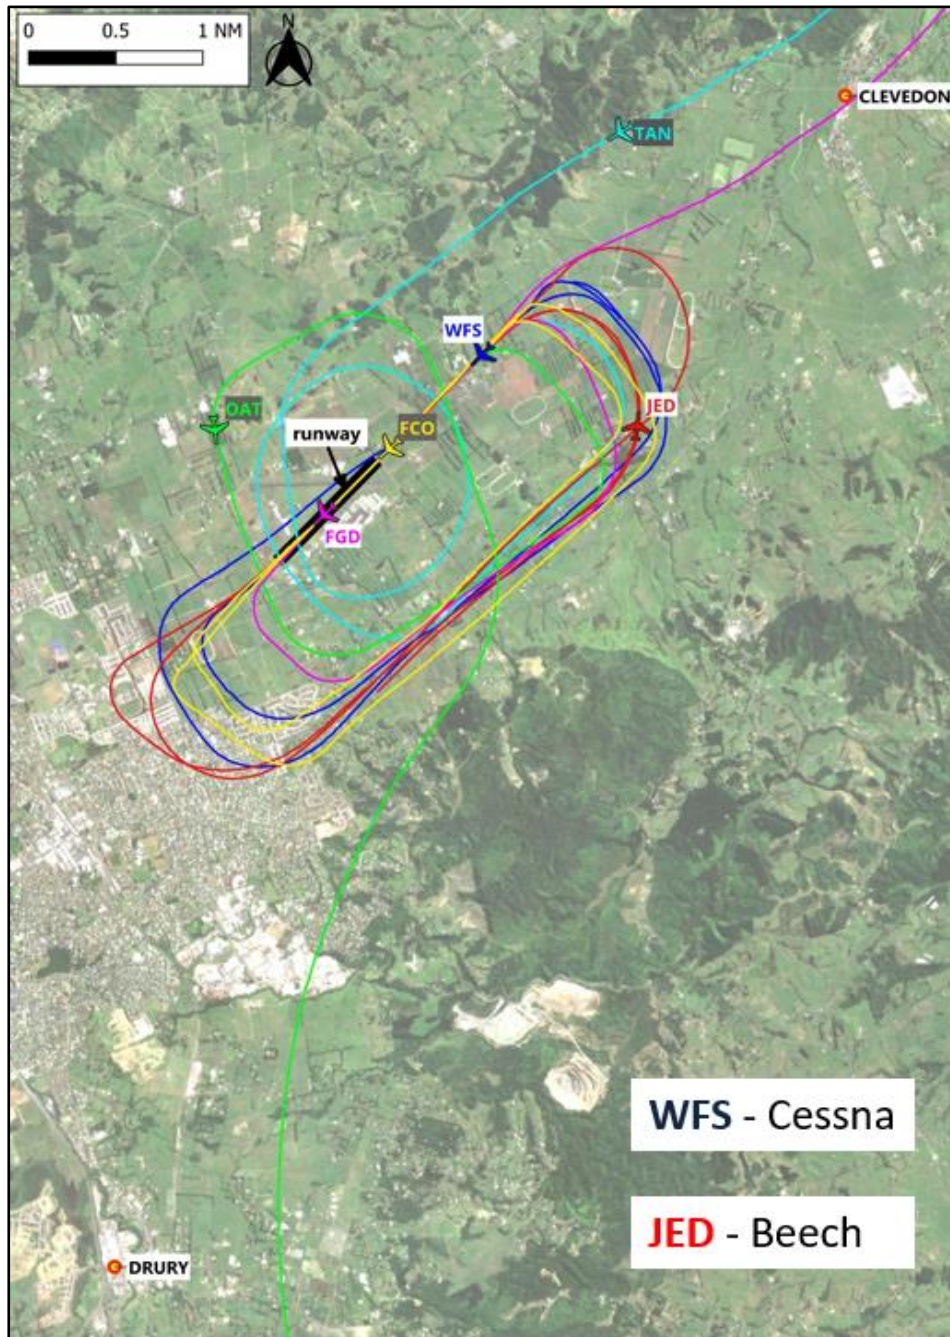
Figure 5: Aircraft sequence at 2118

- 2.9. At 2113 OAT called that they were inbound from Drury to join the circuit from the overhead position.¹²
- 2.10. At 2117 TAN called that they were inbound from Clevedon to join overhead for the circuit. They would eventually be positioned behind FCO, the Cessna and the Beech as the fourth aircraft. Figure 5 shows a snapshot of the six aircraft in the circuit area at 2118. This was the second circuit flown by the Cessna and the Beech. The Beech made their downwind call late, calling "late downwind turning base".

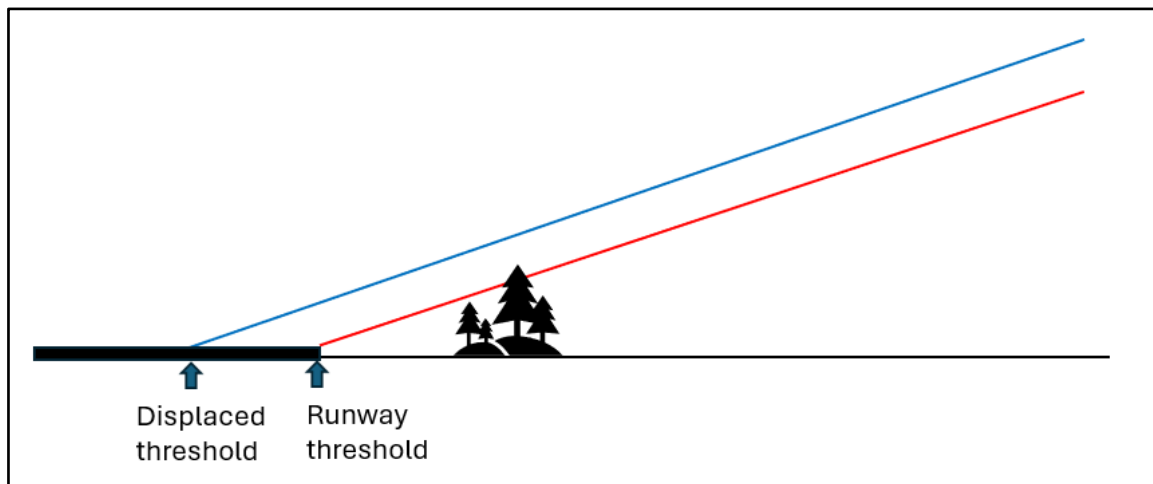
Figure 14: Displaced runway threshold

Figure 14 shows the approach path to the runway in red infringed by trees. By displacing the threshold the approach path in blue is above the obstacle on approach by the approved margin.
