Transport Accident
Investigation
Commission

Final report

Aviation Inquiry AO-2019-007
Air Traffic Services Outage
30 September 2019

April 2023

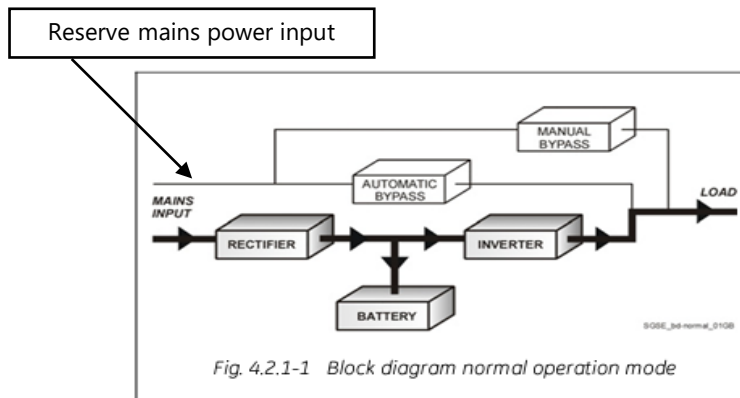
Figure 2: UPS internal schematic

- 2.15. The external manual bypass switch is provided so that the entire UPS can be bypassed to facilitate maintenance or replacement while the load is still connected to mains power.
