Transport Accident  
Investigation  
Commission

# **Final report**

***Rail inquiry RO-2021-103***  
***Te Huia passenger service***  
***Train parting***  
***North Island Main Trunk line, Paerata***  
***19 July 2021***

**December 2022**

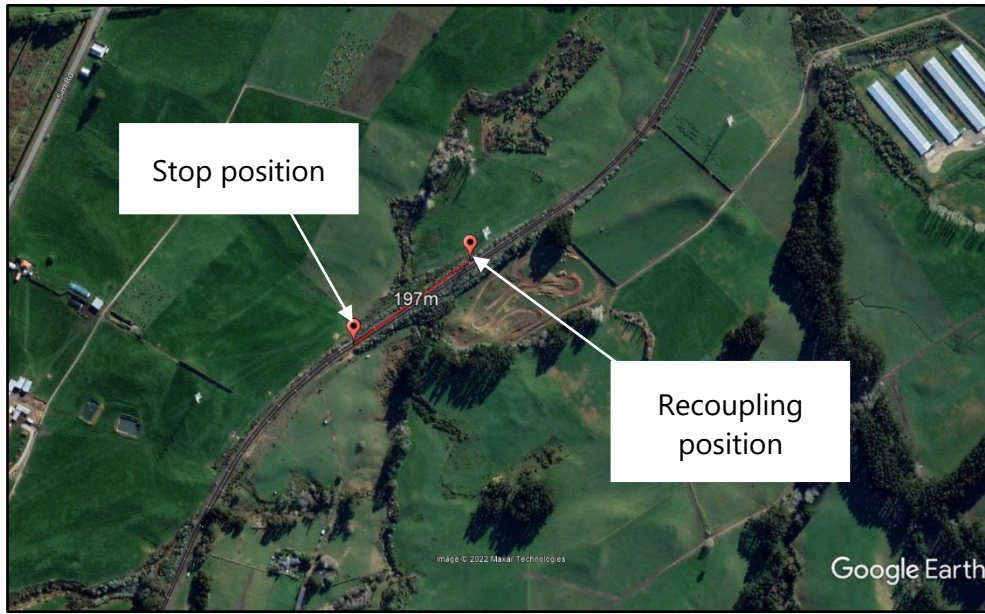
**Figure 3: Locomotive GPS positions – first parting**

- 2.10 The third and fourth carriages (the rear portion) came to rest at 1651:58, 27 seconds after the brakes began to apply.
- 2.11 The front portion of the train came to rest at 1652:08, 37 seconds after initial braking, and during this time it covered a distance of about 565 metres.
- 2.12 GPS data from the locomotive's Tranzlog<sup>6</sup> indicated the separation distance between the front and rear portions was around 200 metres by the time both had come to rest. Figure 3 shows the recorded position of the locomotive when it came to a stop and then when the two train portions were later recoupled.

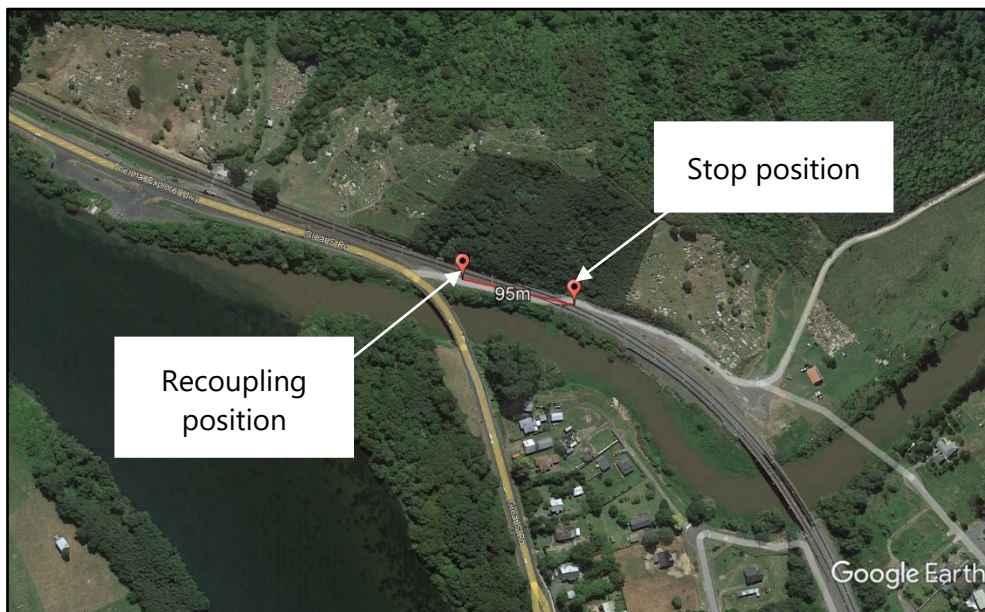
**Figure 7: Locomotive positions – second parting**

- 2.35 At 2050:38, as it entered Taupiri in power notch two and travelling at 45 kilometres per hour, the train again parted between the second and third carriages.

- 2.36 The train driver released the locomotive's independent brake again, with the front portion travelling about 180 metres before coming to rest. The two train portions were separated by about 95 metres once both had come to rest. Figure 7 shows the position of the locomotive when it initially came to a stop and then when the two train portions were later recoupled.

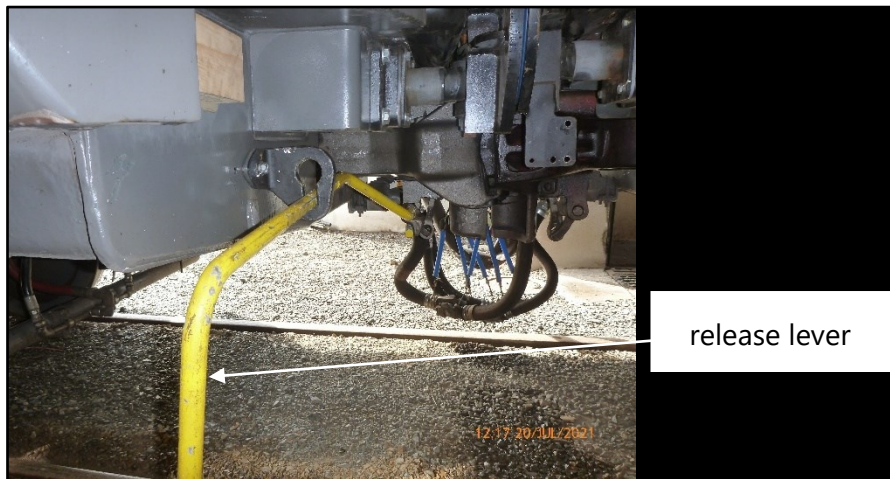
**Figure 12: A-P coupler with release lever -- SR5801 No. 1 end**

- 2.56 KiwiRail procured four A-P couplers for trial before wider fitment to the SRx fleet. Three were fitted to the incident train and the fourth was retained as a spare. Fitting of the trial couplers was completed a week before the parting incidents.
- 2.57 This comprised of fitting both ends of SR5801 and the No. 2 end<sup>13</sup> of SR3285 with A-P couplers and the No. 1 end of SR3285 with a Buckeye drophead coupler, so that both 'A-P to A-P' and 'A-P to Buckeye drophead' coupling combinations could be trialled (see figure 15).
- 2.58 A release lever was fitted for the A-P coupler at the No. 1 end of SR5801, as shown in figure 12.

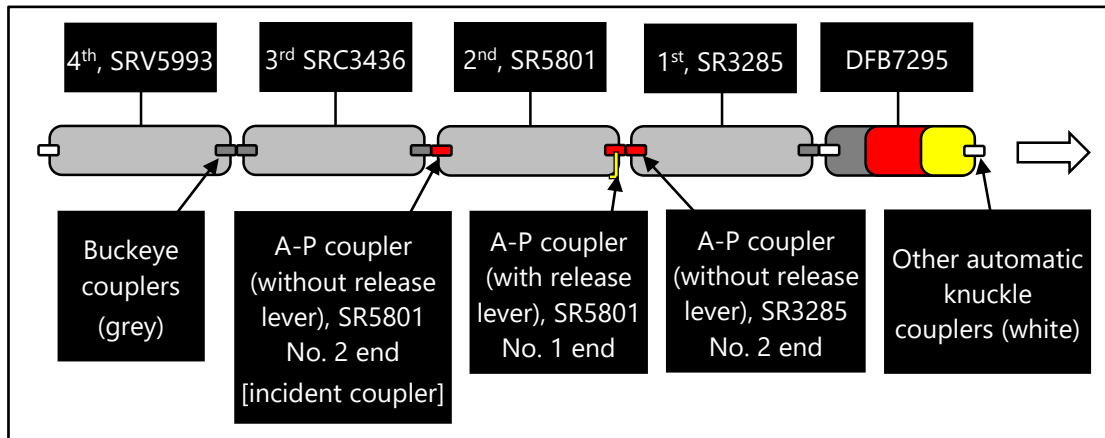
**Figure 14: Configuration of couplers for incident train**

- 2.60 Figure 14 summarises the coupler configurations of interest to this inquiry, and their positions throughout the incident train.

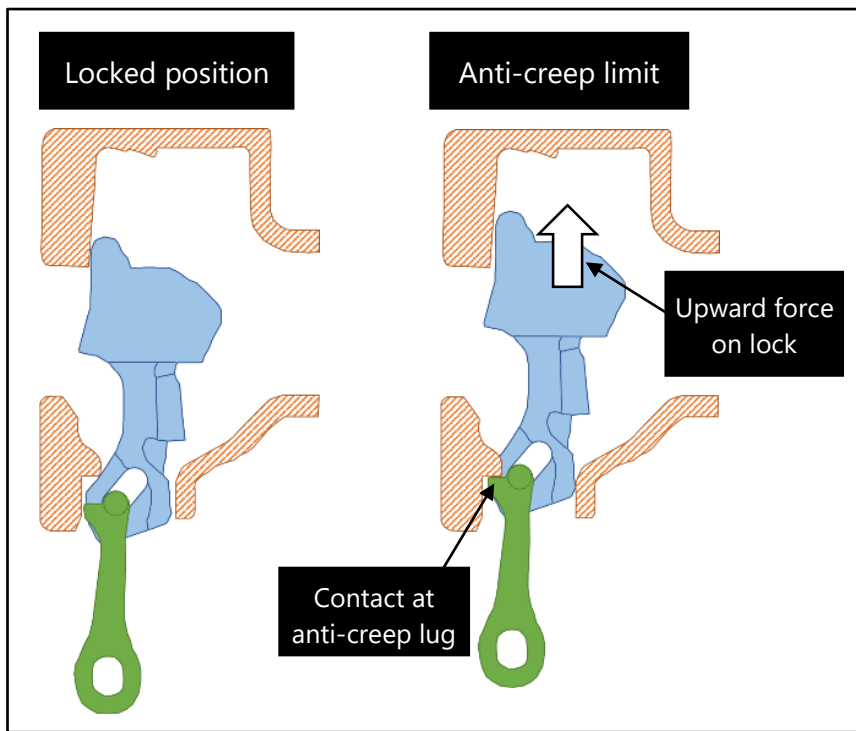
**Figure 16: A-P coupler – anti-creep protection**

- 2.64 If an upward force acts only upon the lock, or the lock and the locklift toggle simultaneously, the toggle will remain at the lower end of the lock's slotted hole. In this position, the locklift toggle's upper edge cannot clear the anti-creep lug in the coupler body, so both the toggle and the lock are prevented from moving upwards beyond this limit. Figure 16 shows this mechanism and the maximum limit of upwards creep for the lock.

- 3.15 Tests conducted with a rectified lock, presented in Table 2, were able to replicate creep to the anti-creep limit (refer Figure 16), but not to the point of knuckle opening.

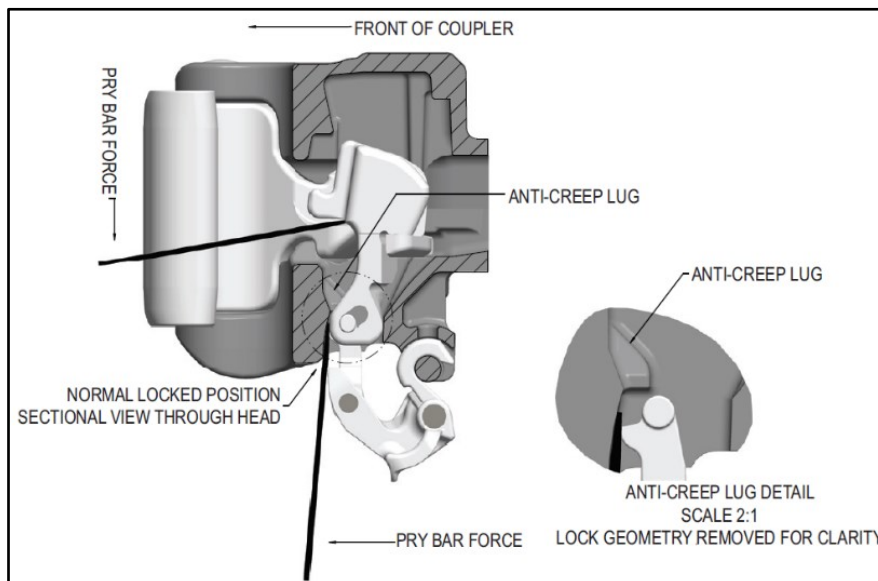
**Figure 17: Anti-creep protection functional test<sup>16</sup>**

- 2.65 Anti-creep protection can be functionally tested by applying two pry bars in the positions shown in figure 17 and confirming that the lock cannot be pried upwards into its unlocked position.

- 3.8 Post-incident inspection of the Amsted A-P coupler fitted to the No. 2 end of carriage SR5801, performed by KiwiRail engineering staff, found it to fail a functional check for anti-creep (as it is described in paragraph 2.65 and shown in figure 17). Commission investigators later repeated this testing and confirmed the result.

- 3.13 Commission investigators confirmed this finding by performing a functional anti-creep check on the incident coupler, as shown in figure 17. The incident coupler with the incident lock (figure 24, left) fitted was found to consistently fail the test. The incident coupler with a rectified lock (figure 24, right) fitted was found to consistently pass the test. All other coupler components in both test configurations were from the incident coupler, with only the lock being changed.
- 3.14 Vertical shake-table testing, as described in paragraphs 2.82 to 2.84, using an out-of-tolerance lock similar to the incident coupler's lock, was able to replicate creep to the point of knuckle opening in four of 12 tests as shown in the Table 1.

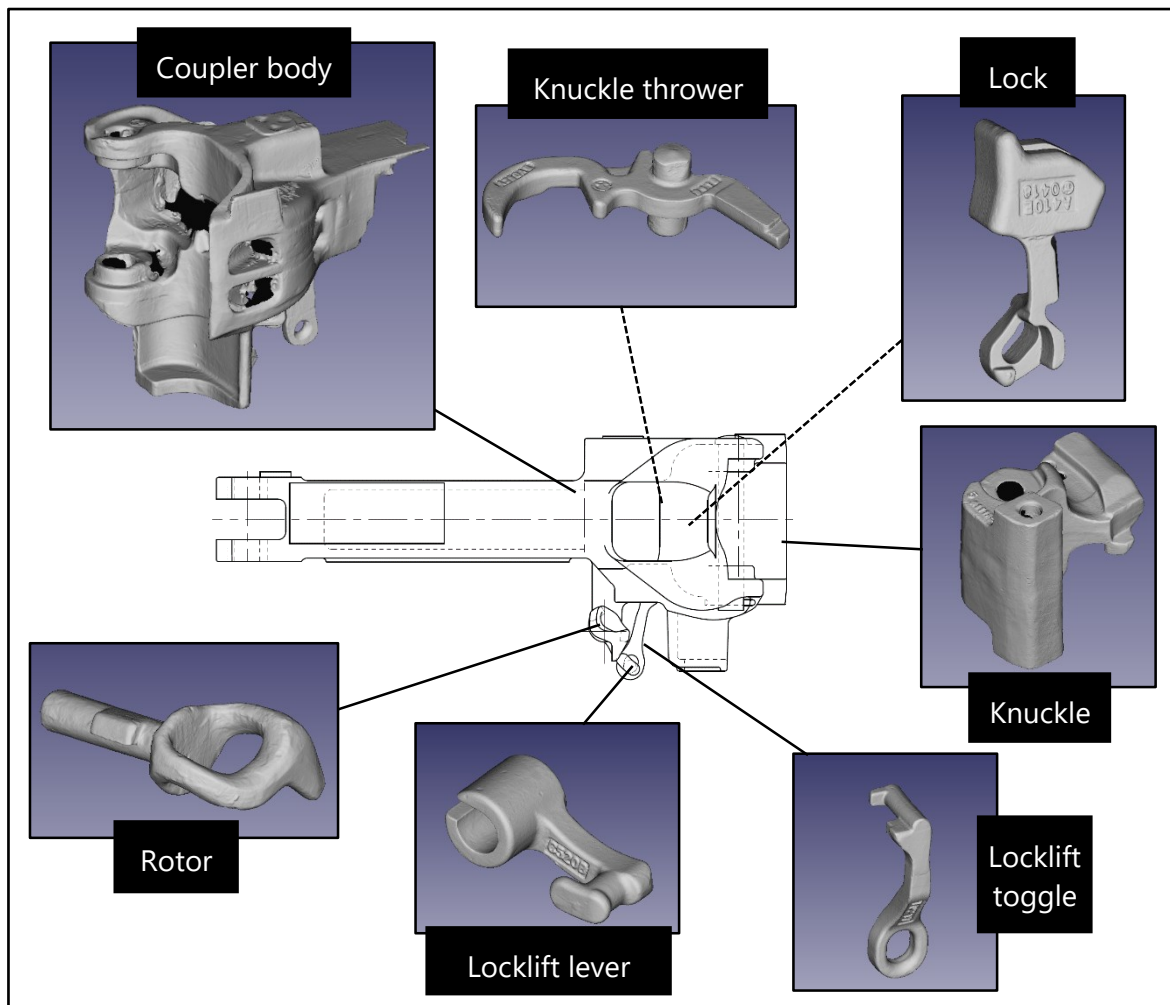
**Figure 21: Laser scan of coupler components**

2.81 The incident coupler's components were laser-scanned and the images were obtained by the Commission (see figure 21).

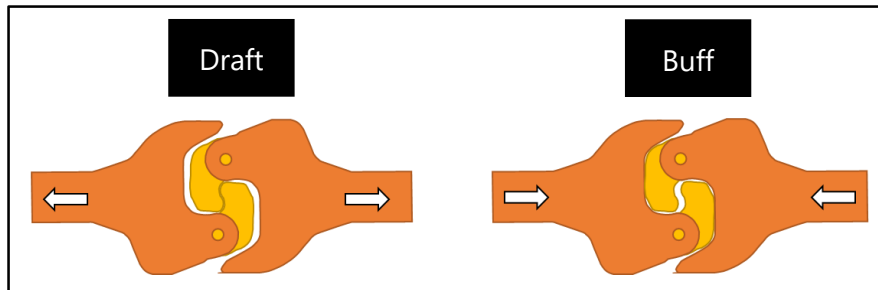
Figure 26: Coupler loading states

- 3.21 The squeezing force the knuckle applies to the lock under draft loading (ie, in tension, see figure 26) is required for creep to occur. Under buff loading this squeezing force is released, and the lock drops back to its fully locked position with gravity. Creep effectively accrues during periods of draft loading and is 'reset' during buff loading.

- 3.23 From these observations it is **very likely** the sustained draft loading conditions necessary for unchecked creep to cause knuckle opening existed in the lead-up to both partings.

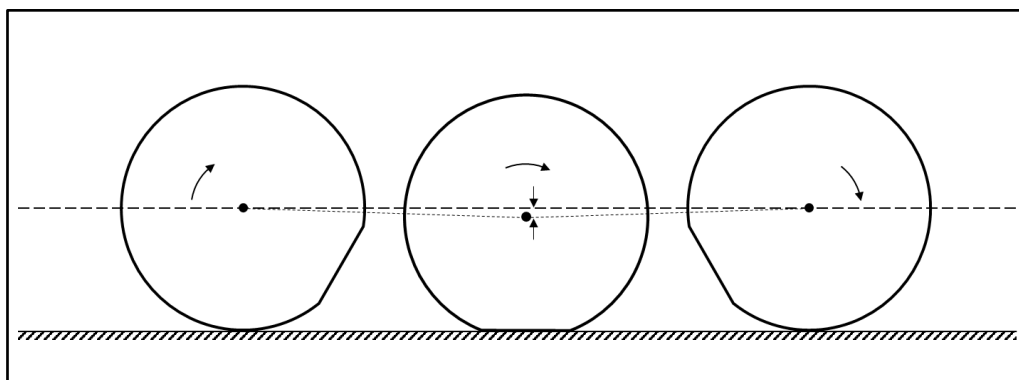
**Figure 27: Effect of wheel flat on axle centreline path**

- 3.27 Wheel flats result from wheel-slide occurring under braking, where material from the wheel tread surface is abraded as it slides against the rail head.

- 3.28 Both the train manager and train attendant recalled during their interviews that upon resuming travel after the first train parting, wheel flats could be clearly felt and heard from inside carriages and that this had not been noticeable before the parting. It is therefore **very likely** the resultant brake application from an initial speed of 91 kilometres per hour, triggered by the parting, caused wheels to slide and resulted in wheel flats.
- 3.29 Wheel flats create a regular bump with each rotation. Figure 27 shows the vertical displacement the axle centreline undergoes as a flat spot on the wheel tread contacts the rail.

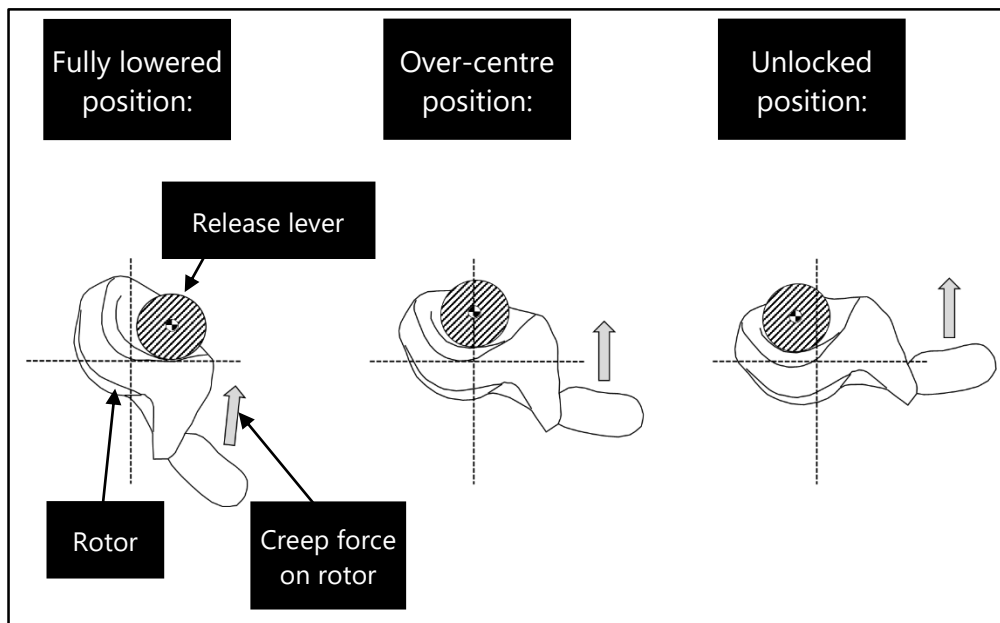
**Figure 28: Release lever and rotor interaction**

- 3.30 As described in paragraph 2.59, the incident coupler had not been fitted with a release lever, due to space constraints at the No. 2 end of SRx carriages. As part of its inquiry, the Commission has investigated the possible influence this omitted release lever had on the incident coupler's vulnerability to creep.
- 3.31 In a typical arrangement the release lever is supported at one end by the rotor. During creep the rotor is pulled around its axis of rotation and initially counteracted by the release lever's mass. At a certain point the release lever's centre of mass reaches a position directly above the rotor's centre of rotation (over-centre), and beyond this point the lever's mass acts to assist the creep force. Figure 28 shows this sequence, but it should be noted that loose clearances between mating parts provides a significant degree of freedom for all involved parts.

- 3.32 The release lever is also subject to broadly the same vehicle-borne vertical accelerations as the coupler. So, while the release lever's mass does interact with lock creep, the effect is relatively low.
- 3.33 The Commission **found** that the lack of a release lever had negligible influence on the coupler experiencing creep, and that there was no requirement for release levers to be fitted according to the manufacturer's specifications.

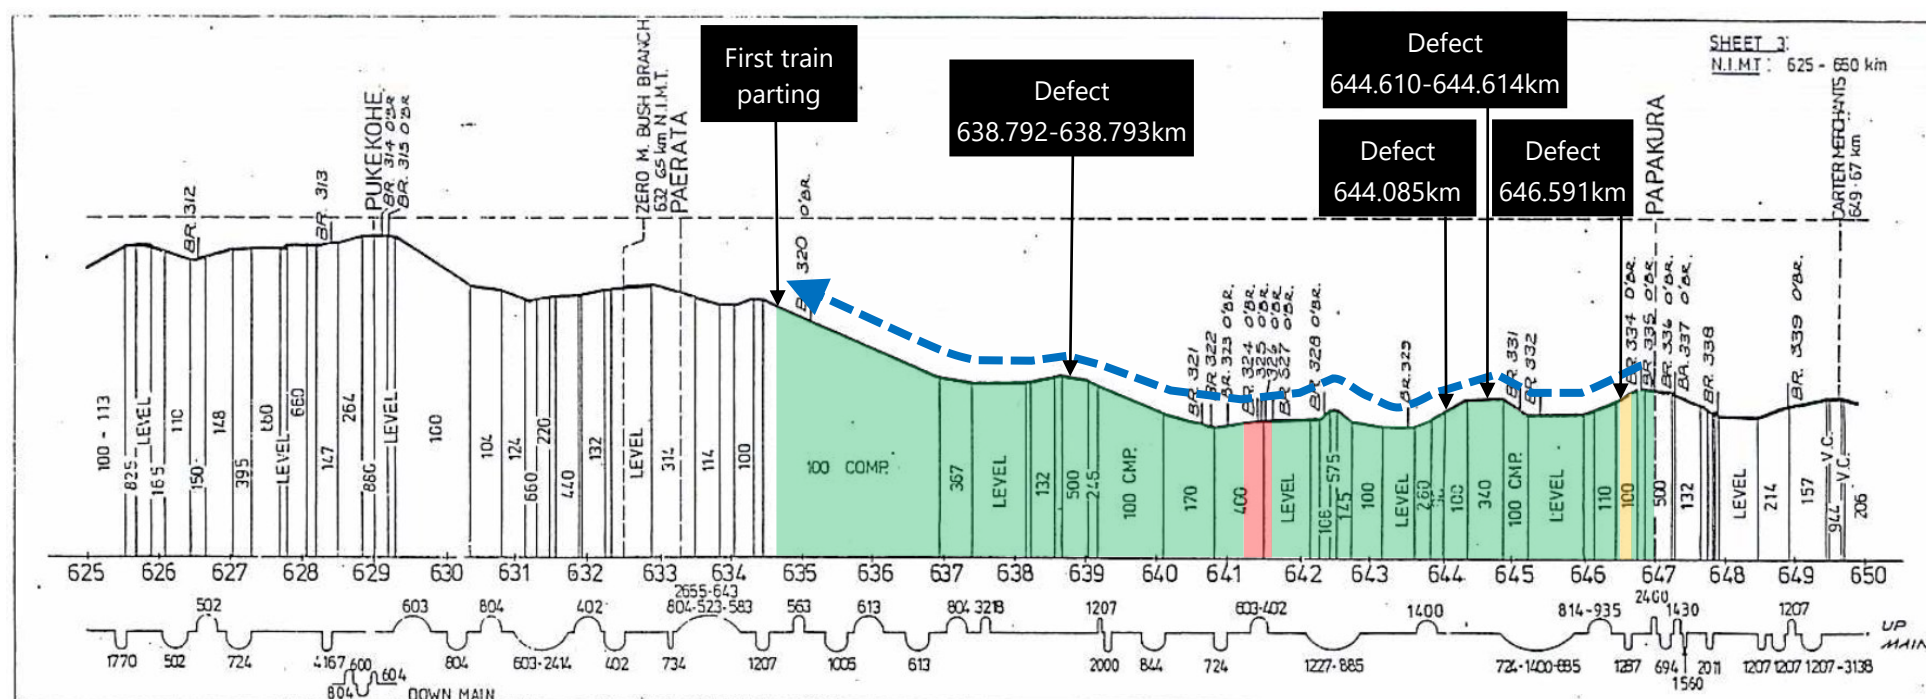
Overlaid is the train's progress from Papakura Station to the site of the first parting (blue arrow), and the train's control state as recorded by the locomotive's Tranzlog. Green denotes powering, yellow power-braking (ie, where the train brake is applied at the same time as throttle) and red when the train brake is applied.

Features of interest are identified by call-outs, including track defects, as identified by KiwiRail's track evaluation car EM80 in December 2021.

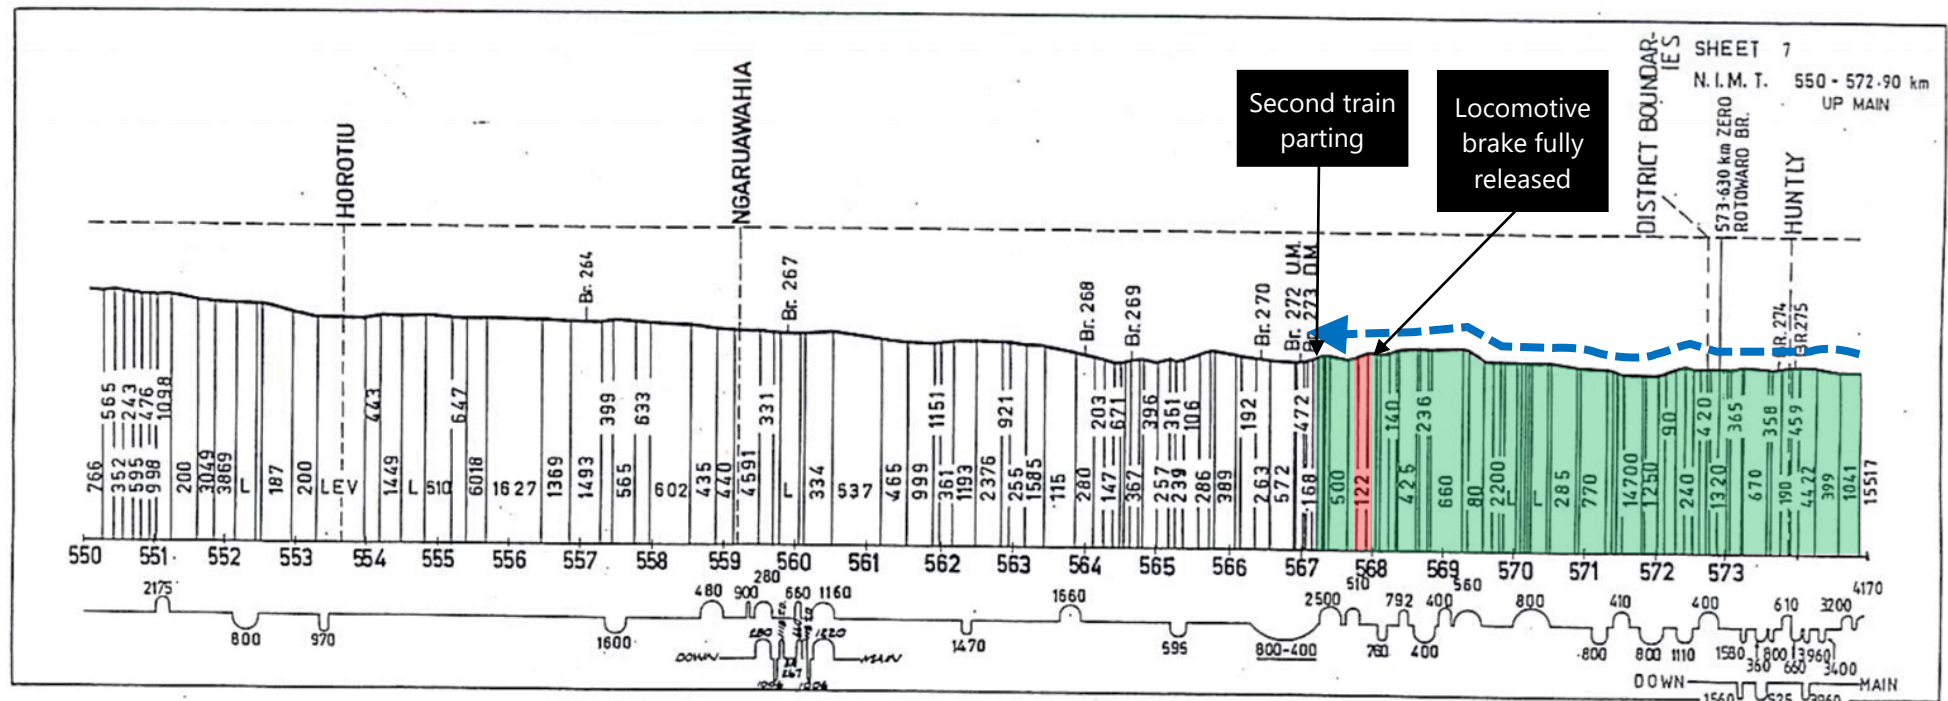
## Appendix 2 Track gradient and train handling – second parting

Below is KiwiRail's gradient and curve diagram for the section of the North Island Main Trunk where the second parting occurred. The diagram and denotations are as per Appendix 1.

Although the train brake was applied shortly before the parting, the locomotive brake was fully released during this application (as denoted by the call-out). This is a common technique to maintain stretch within a train and means the incident coupler **very likely** remained in draft loading.
