Transport Accident
Investigation
Commission

Final report

Rail inquiry RO-2021-105
Unintended movement resulting in locomotive
and wagon entering Picton Harbour
Picton
1 September 2021

June 2023

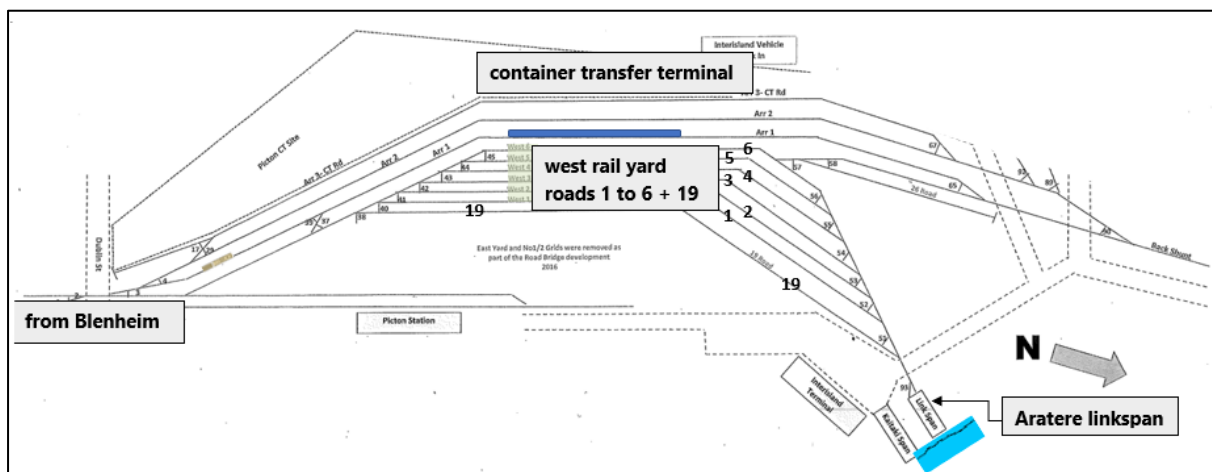
Figure 3: West rail yard, Picton

- 2.1 The Picton freight yard facility and rail linkspan¹ structure are strategic assets in connecting State Highway 1 and the North Island Main Trunk to the South Island. It is a vital part of New Zealand's transport and tourism infrastructure.
- 2.2 The west rail yard at Picton consists of seven designated railway tracks (see Figure 3), also referred to as 'roads' in rail terminology.
- 2.3 Roads 1 to 6 are used for general shunting² and road 19 is used for storing surplus rail wagons³.
- 2.4 Freight trains enter the yard on the main north line from the south. The port and rail linkspan are situated at the north end of the yard.

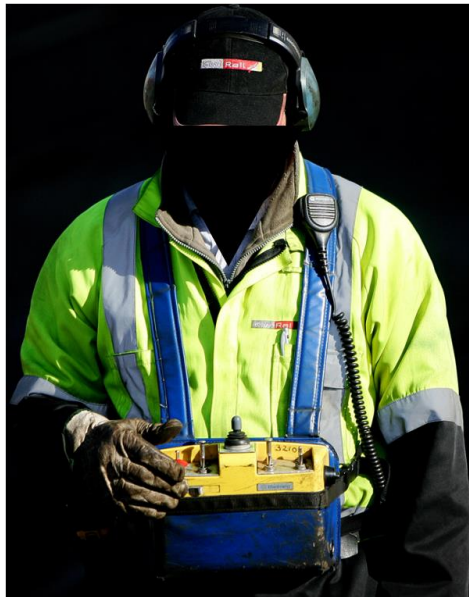
Figure 4: RCO with Arataki 1 remote-control pack in harness

- 2.5 At 0600⁴ on 1 September 2021, a two-person shunt team consisting of a remote-control operator (RCO) and a rail operator (RO) commenced duty at the Waitohi Picton KiwiRail freight depot.
- 2.6 The RCO was issued with an Arataki 1 remote-control pack⁵ (see Figures 4 and 8) and configured shunt locomotive⁶ DSJ4004 (the shunt locomotive) for remote operations.
- 2.7 Due to rail ferry scheduling disruptions, the shunt team was informed by the acting team leader that the day's tasks would likely differ from those normally expected.

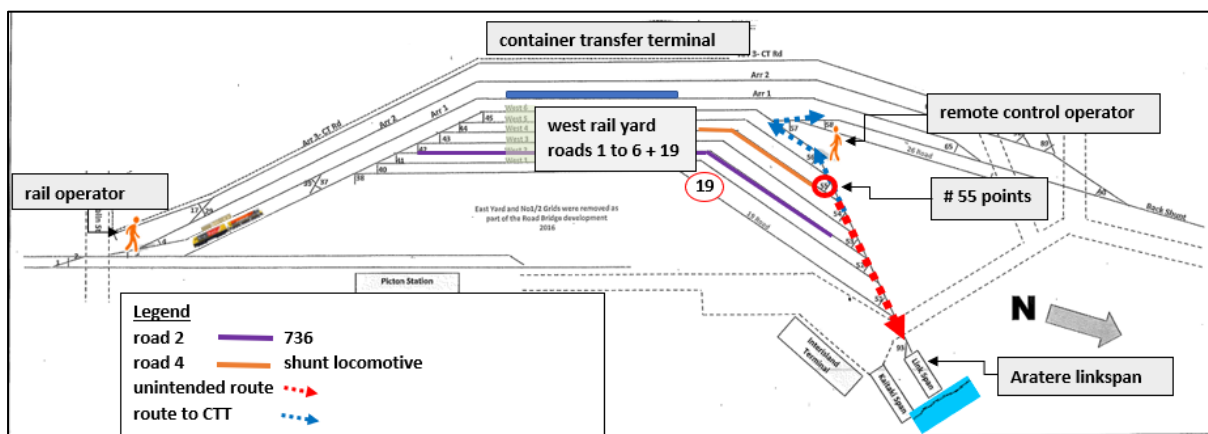
Figure 6: West yard layout at time of incident

- 2.24 After the brakes were released and the throttle activated, the shunt locomotive travelled a distance of 112.5 metres, traversing an unprotected road vehicle crossing and entering the rail linkspan.
- 2.25 During this time the RCO continued walking south away from the shunt locomotive's northerly direction of travel. By the time the RCO turned around, the shunt locomotive and wagon were on the rail linkspan (see Figure 7, picture 6).
- 2.26 The shunt locomotive was travelling at 3 kilometres per hour when it entered the raised portion of the rail linkspan, at 1530:19.
- 2.27 As the shunt locomotive travelled up and along the unsupported rail linkspan, its weight caused the rail linkspan to drop towards the harbour.
- 2.28 The acute angle between the shunt locomotive and the attached head wagon caused the shunt locomotive and wagon to separate. The brake hoses uncoupled

- 3.8 The RO was at the south end of the yard, out of visual range of the RCO completing unrelated tasks (see Figure 6). The plan was for the RO to assist the RCO with the shunt movement from west 6 road to the CTT after completion of the RO's tasks.
