Transport Accident
Investigation
Commission

Final report

Rail inquiry RO-2023-103
Safe-working irregularity
3.85 km mark Johnsonville line – tunnel 5
04 May 2023

March 2024

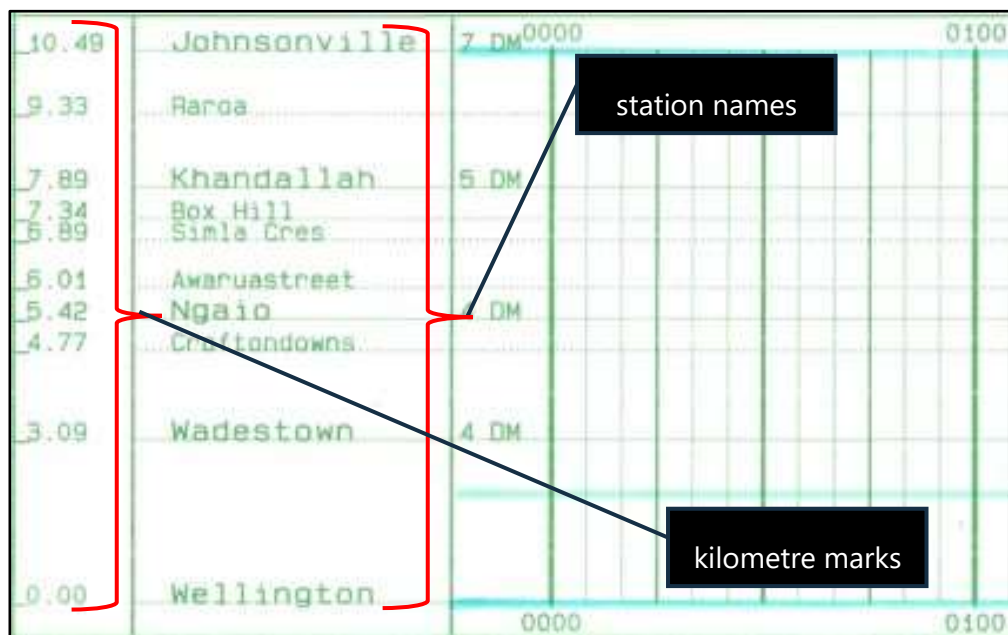
Figure 5: Section of a train control diagram showing the Johnsonville line

- 3.3. Train control diagrams (see Figure 7 and Appendix 1) have been in use by rail operators worldwide for many decades. Whilst modern electronic and digital diagram systems are available, most operators have retained the paper-based diagrams for their ease of use, ready availability to reference and simplicity of storage.

- 3.7. The train control diagram is based on a simple time/distance graph with metrages and stations annotated on both the lefthand and righthand side of the document (see Figure 7). The train controller uses the diagram to record the movements of rail traffic (trains, hi-rail vehicles, track machines), establish the boundaries of track occupation areas and record any other information such as weather conditions and faults pertinent to safe working. Train control diagrams are kept by the rail operator for 10 years in case they may be required for reference.
