Final report MO-2016-202: Passenger ship, *Azamara Quest*, contact with Wheki Rock,
Tory Channel, 27 January 2016

Marine inquiry MO-2016-202
Passenger ship, *Azamara Quest*, contact with
Wheki Rock, Tory Channel
27 January 2016

Approved for publication: March 2018

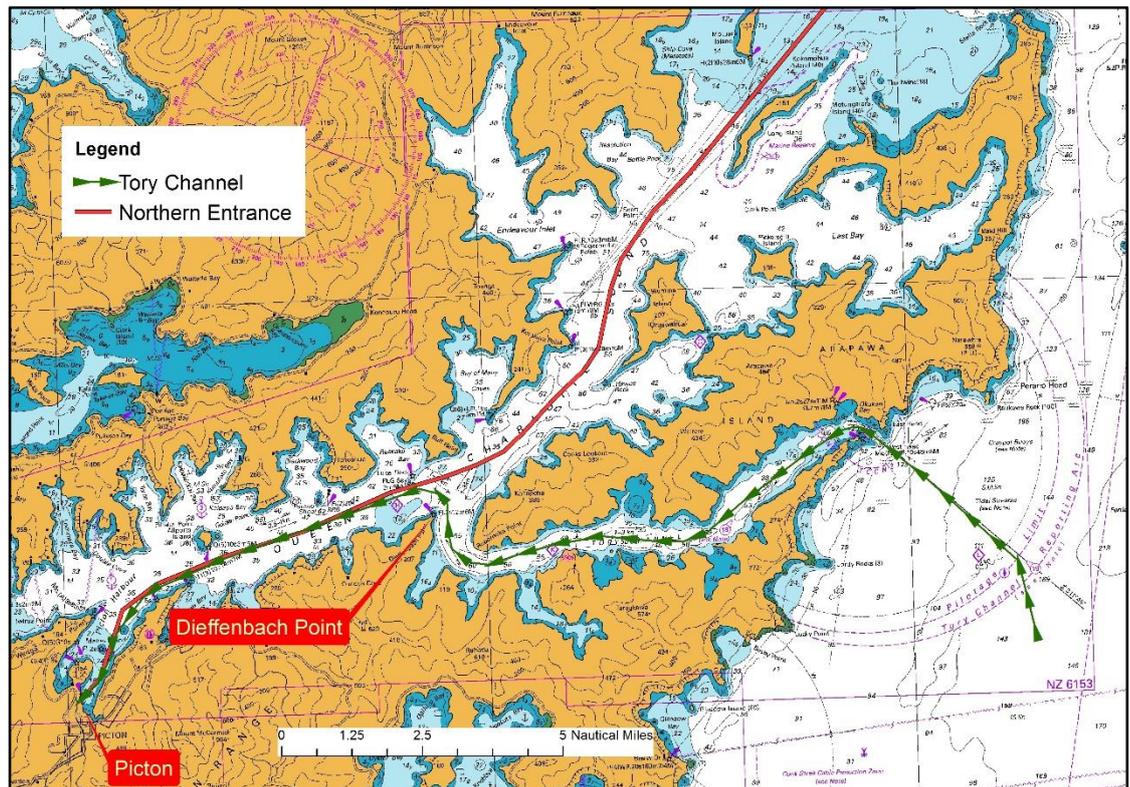
Figure 1
Chart detailing the two routes to Picton

- 3.1.1. On 26 January 2016 the Maltese-flagged passenger ship, the *Azamara Quest*, was on passage from Akaroa to Picton on the north-eastern coast of New Zealand's South Island. The ship was on its maiden voyage to Picton and was due to arrive the following morning, on 27 January 2016. There were 652 passengers and 394 crew on board.
- 3.1.2. The port of Picton was accessible via two routes: a more direct northern entrance through Queen Charlotte Sound (shown in red, Figure 1); and a more difficult eastern entrance through Tory Channel (shown in green, Figure 1).

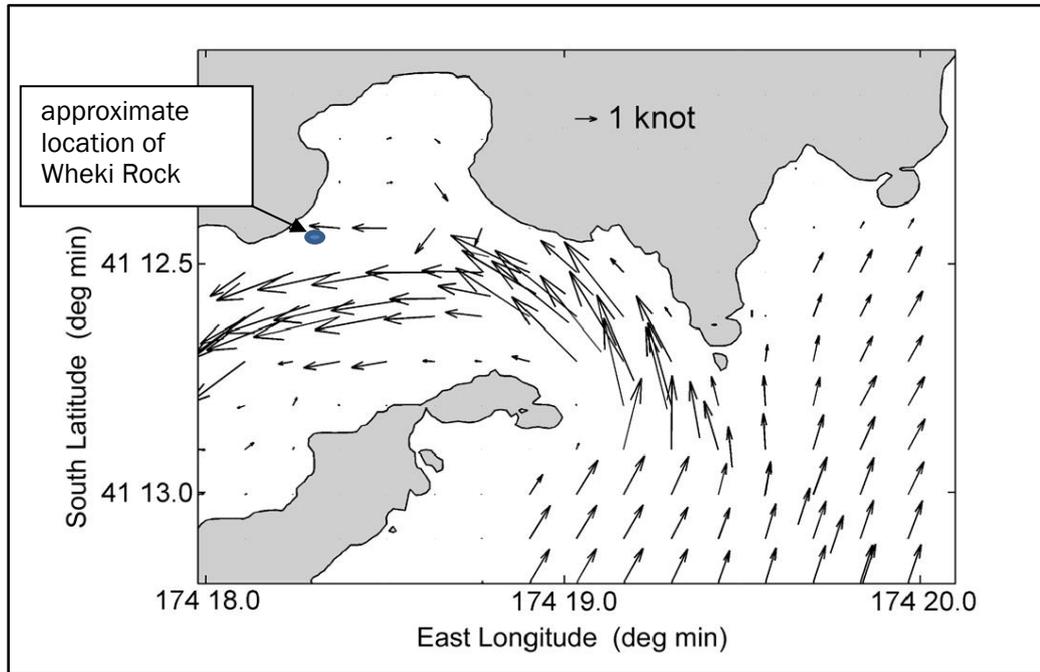
Figure 5
Tory Channel entrance, tidal stream at spring tide, three hours before high water
(the length of the arrows is representative of the strength of the tidal stream)

- 3.3.2. The tidal stream was about 6 knots¹² through the eastern entrance to Tory Channel. Land Information New Zealand described the tidal conditions as:

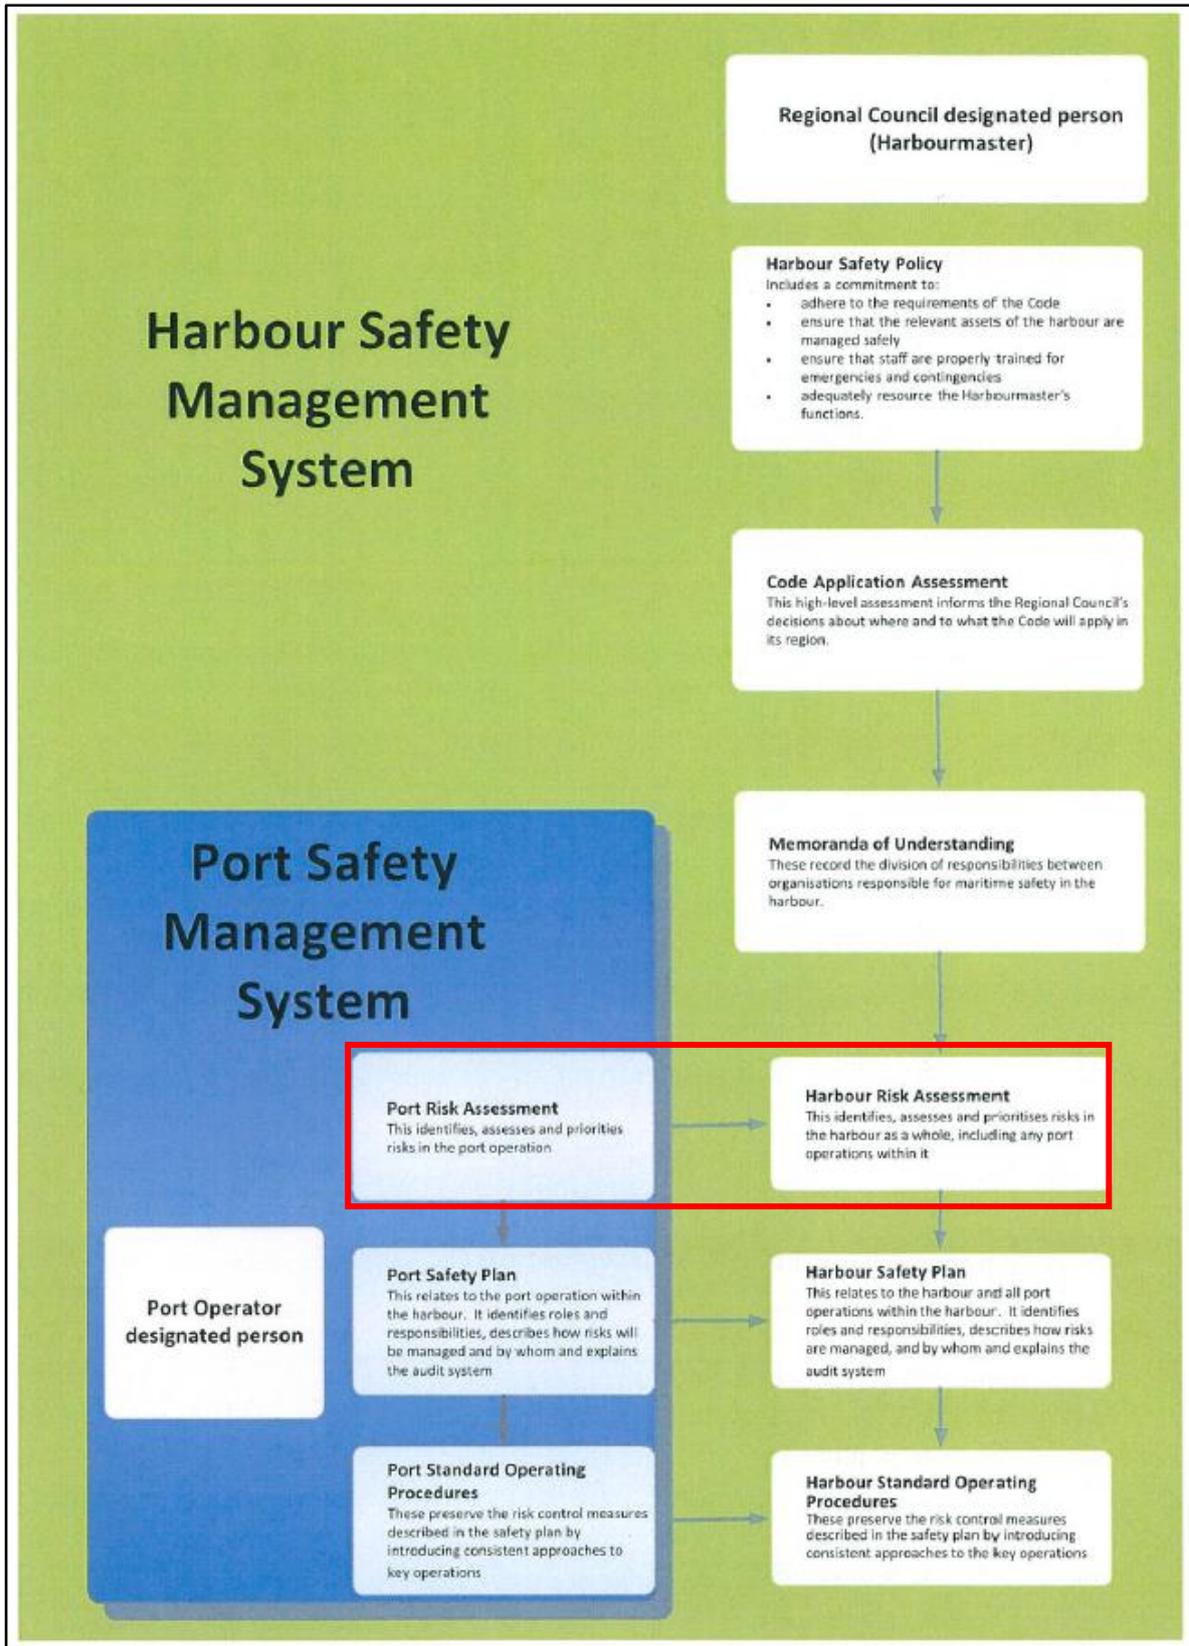
Figure 6
Port and harbour safety management system

- 3.4.3. A step in implementing the code is for regional councils and port operators to each develop and document its own safety management system. The harbour safety management system is built around a harbour risk assessment undertaken by the regional council. It incorporates a port risk assessment carried out by any port operator for areas and activities covered by its port marine operations (see Figure 6).

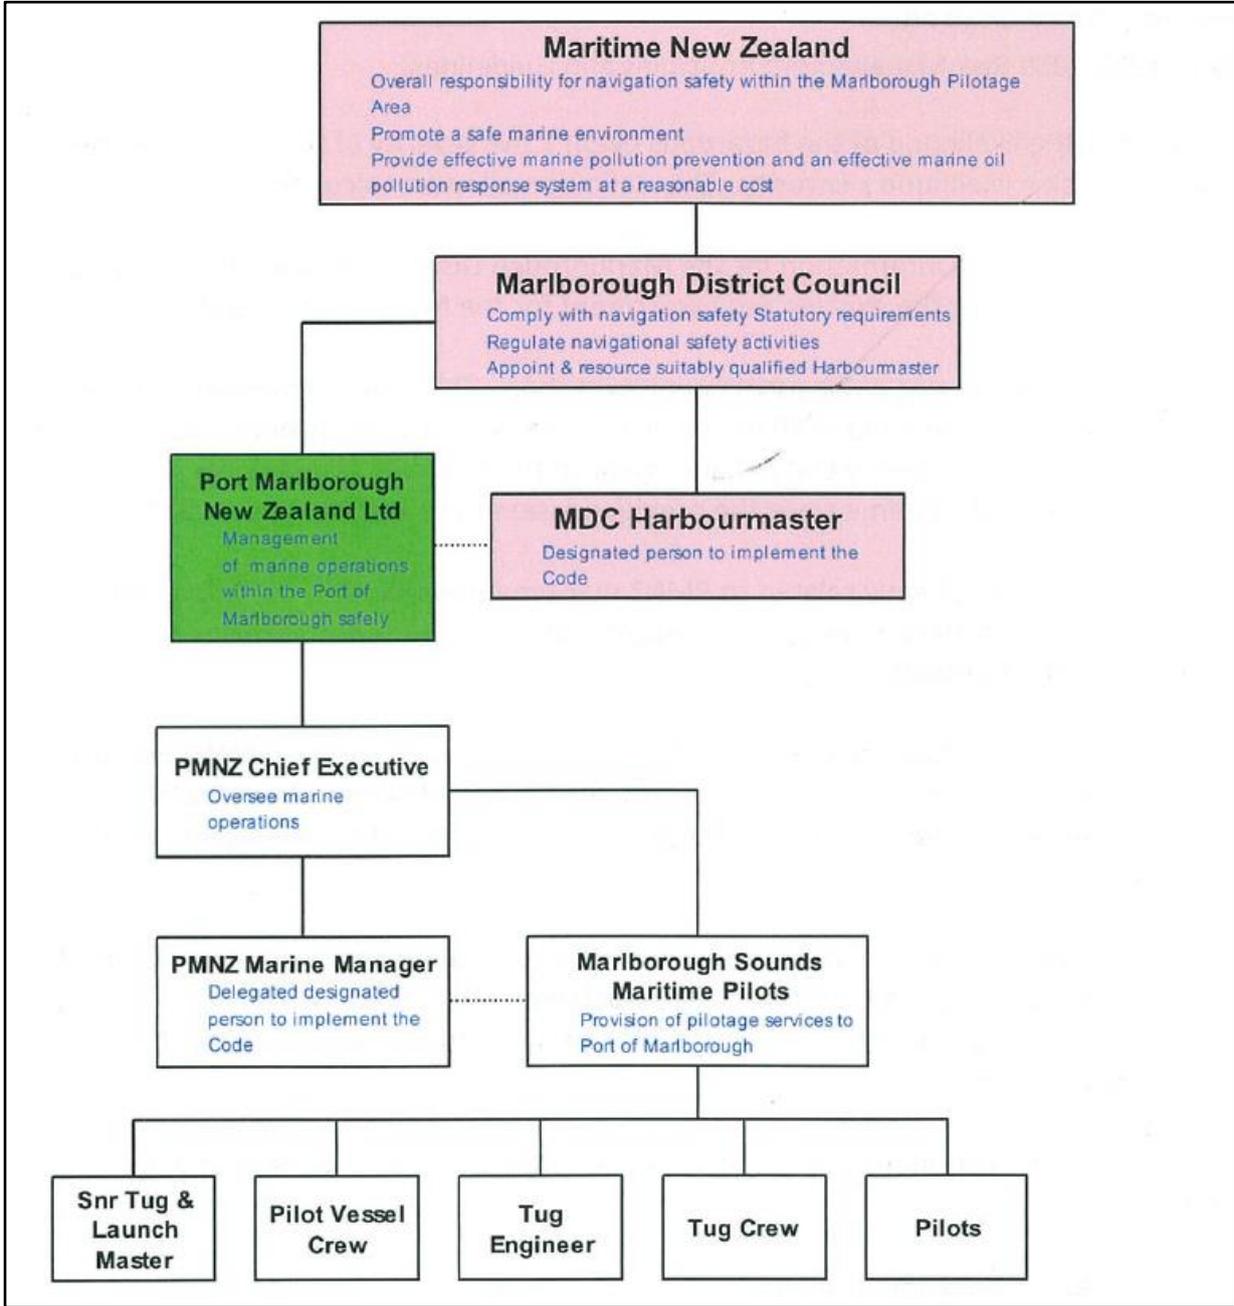
Figure 7
Flow chart showing relationship between Maritime New Zealand, Marlborough District Council and Port Marlborough

3.4.4. Commercial activities at the port of Picton were undertaken by Port Marlborough, a company wholly owned by Marlborough District Council. Marlborough District Council was also the harbour authority responsible for the navigation and safety of all maritime activities within the harbour. Marlborough District Council discharged this responsibility through a council-appointed harbourmaster. Pilot and harbour towage services for shipping in Marlborough were provided by Port Marlborough New Zealand Limited Marine Services. Figure 7 shows how the different organisations at the port of Picton interfaced.
