Final report MO-2017-203: Burst nitrogen cylinder causing fatality,  
passenger cruise ship *Emerald Princess*, 9 February 2017

Marine inquiry MO-2017-203  
Burst nitrogen cylinder causing fatality,  
passenger cruise ship *Emerald Princess*,  
9 February 2017

Approved for publication: November 2018

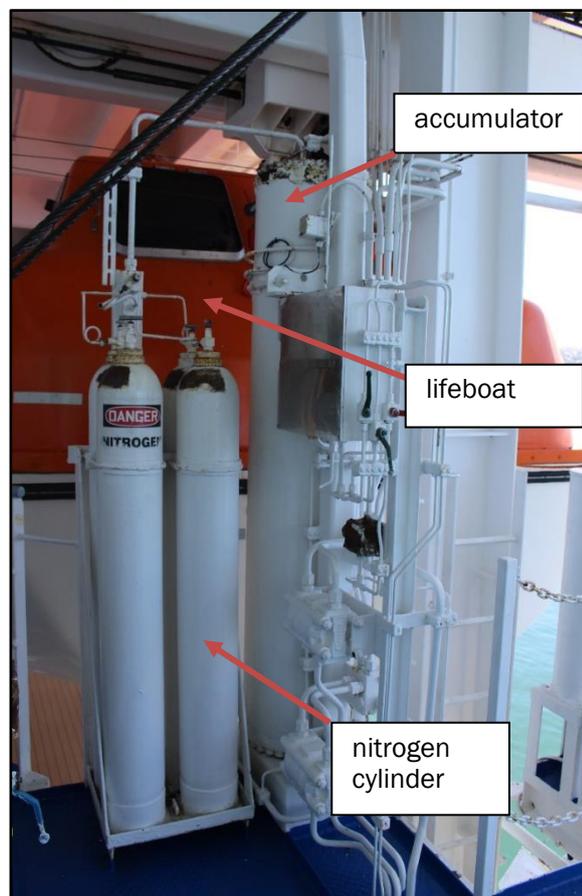
**Figure 2**  
Typical arrangement of the stored energy system

- 3.1.2. The davits were hydraulically powered by six hydraulic power packs, three power packs for each side of the vessel. The International Convention for the Safety of Life at Sea (SOLAS) regulations required that an emergency launching and recovery system be provided so that the lifeboats could be launched even if the ship suffered a total power failure. To comply with this regulation, a stored energy system<sup>4</sup> comprising an accumulator<sup>5</sup> and a set of high-pressure nitrogen cylinders was fitted to each launching davit.

- 3.1.3. The nitrogen system had a nominal working pressure range of 180-200 bar<sup>6</sup>. Prior to the vessel's arrival at Dunedin, the crew had observed that the pressure of the nitrogen system for lifeboat station No. 24 had dropped to about 165 bar.

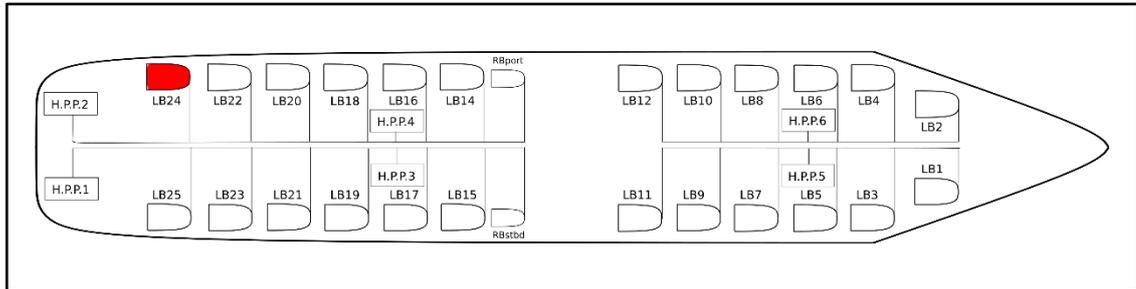
Figure 3  
Location of lifeboat station No. 24

- 3.2.1. On arrival at Dunedin on 9 February 2017, the staff engineer tasked the deck and safety engineer with tracing the source of the nitrogen leak with the assistance of two fitters, Fitter-A and Fitter-B.

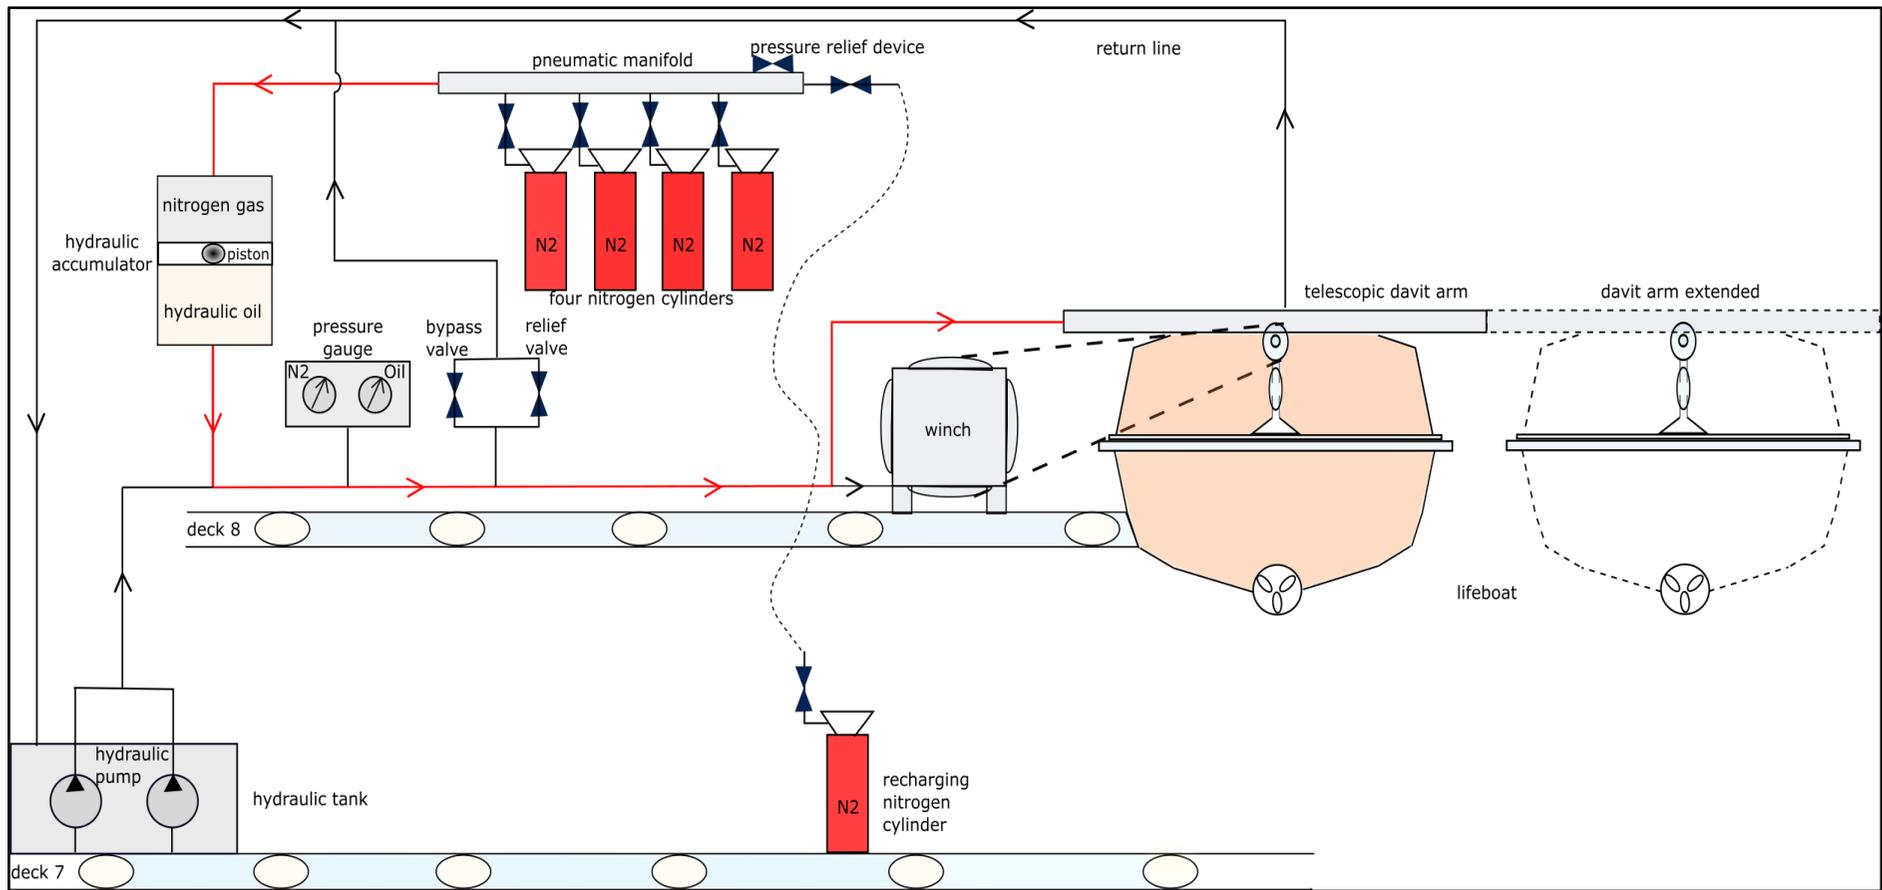
**Figure 6**  
Simplified diagram of the stored energy system

- 3.3.3. The upper chamber of the accumulator was filled with nitrogen gas at a maximum working pressure of about 200 bar at 20 degrees. The nitrogen pressure was maintained by a set of pressurised nitrogen cylinders connected to the upper chamber via a pneumatic manifold. The manifold was fitted with an overpressure relief device set at 250 bar. The lower chamber of the accumulator was filled with hydraulic oil at a maximum working pressure of about 230 bar. In between the lower and upper chambers was a piston. In the event of a power failure this piston was pressurised by the nitrogen gas in the upper chamber and pushed downwards, pressurising the hydraulic oil in the lower chamber of the accumulator, which in turn operated the hydraulic piston that moved the telescopic davit arms (Figure 6 is a schematic diagram of the lifeboat launching appliance; the red line shows the operation of the stored energy system).

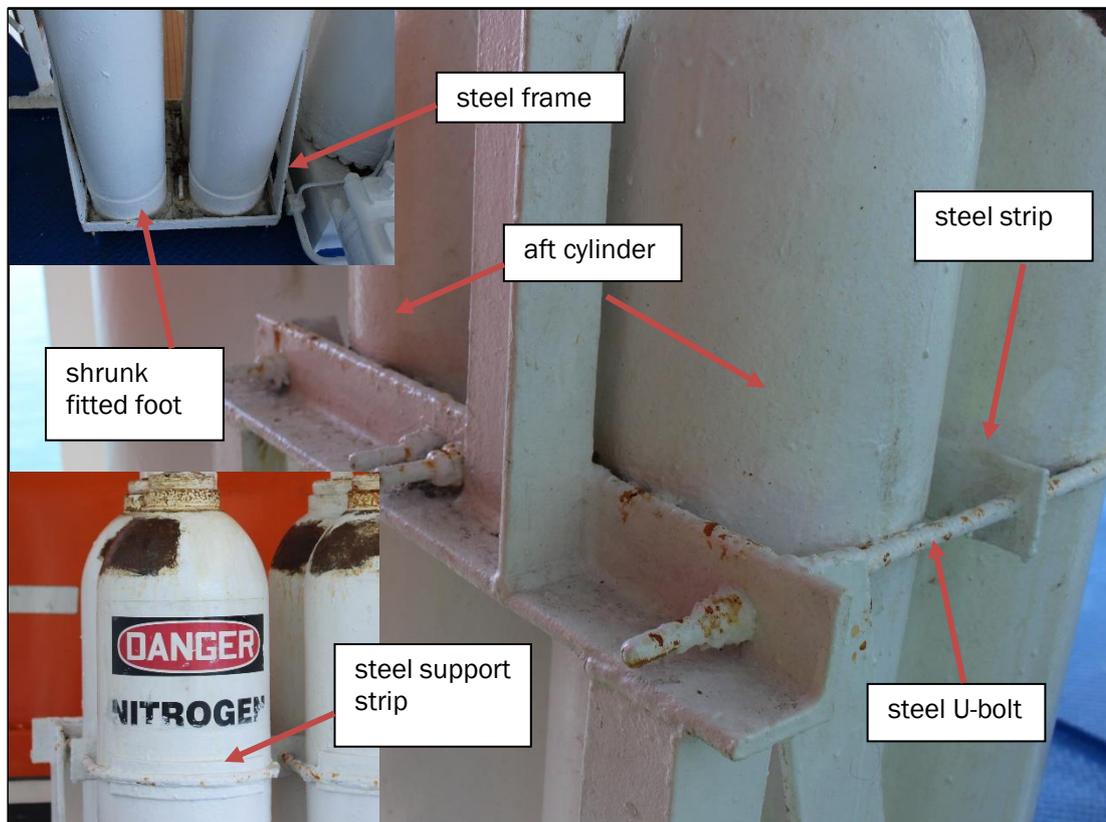
Figure 7  
Nitrogen cylinder securing arrangement

- 3.4.1. Each lifeboat station had four nitrogen cylinders. Each cylinder had a capacity of 40 litres and was filled with nitrogen to its normal working pressure of about 200 bar. The cylinders were held in a steel frame that raised and restrained the base of each cylinder above the deck.
- 3.4.2. The cylinders were held in place near the top by two round bar steel U-bolt straps. One U-bolt went around a forward cylinders and an aft cylinder and was fastened to the rear portion of the frame (see Figure 7). The front two cylinders of the four in the frame had a steel support strip under the restraining U-bolt to prevent the cylinders being mechanically damaged. A steel strip separated the forward cylinders from the aft cylinders

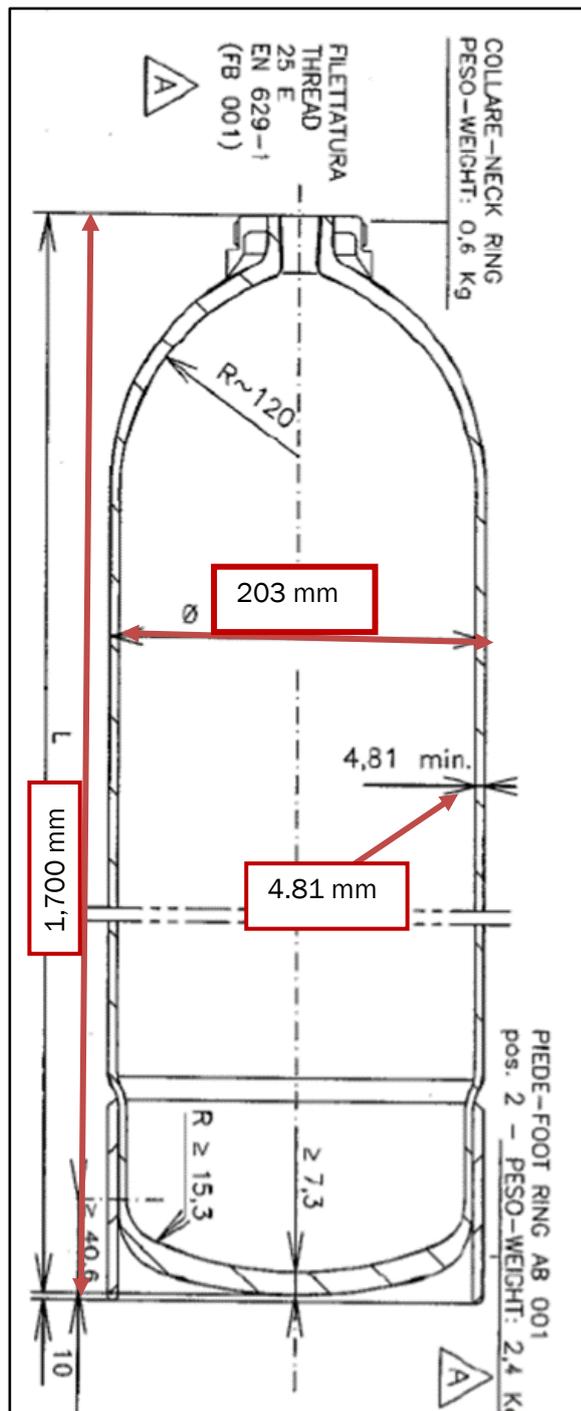
Figure 8  
Cylinder dimensions

- 3.4.3. The nitrogen cylinders had been manufactured by Tenaris in Dalmine Italy, and designed to EN1964 3-2001<sup>9</sup> standards. Each cylinder was fabricated from a one-piece forging, with a shrink-fitted foot ring<sup>10</sup> and a threaded neck ring attached.

- 3.4.4. The cylinders were made in batches of no more than 202. Two cylinders from each batch were tested for quality through a burst pressure test<sup>11</sup> on one cylinder and a mechanical test on the other. These tests were witnessed by a surveyor from Lloyds Register. The Lloyds Register certificate stated that the fabrication of cylinders was completed as per Lloyd Register's procedures and specifications. In addition, the surveyor visually inspected each cylinder and hydraulically tested it at 300 bar. Figure 8 shows the cylinder dimensions.
