Final report MO-2017-205: Multipurpose container vessel *Kokopo Chief*,  
cargo hold fire, 23 September 2017

Marine inquiry MO-2017-205  
Multipurpose container vessel *Kokopo Chief*

Cargo hold fire

23 September 2017

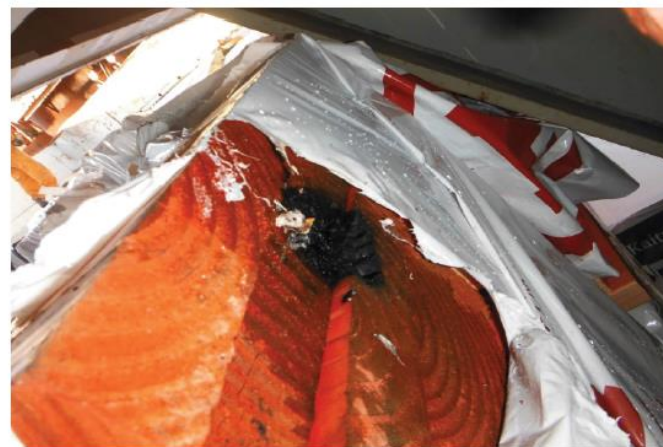
While lashing some timber packs on #4(S)Tween Deck, stevedore noticed one timber pack, being close to halogen lamp emitting some smoke, and a smell of burnt timber was felt. A plastic cover of a timber pack shrunk & burnt due to its proximity to the cargo hold lamp. Two sawn timber planks sustained about 35 cm burn spot on their sides. Affected area was immediately flushed with water and observed for several minutes. Burn spot was removed. All lights were switched off in cargo holds and tween decks which contained timber.

- 1) Take a note of proximity of fixed lighting in cargo holds to stowed timber.
- 2) All deck officers to keep cargo lights off in holds contained timber when cargo operations are seized.
- 3) Circulate 4 box to share the near miss with other fleet.
