Transport Accident
Investigation
Commission

Final Report

Marine Inquiry MO-2018-202
Accommodation fire on board
Fishing trawler Dong Won 701
Timaru
9 April 2018

December 2019

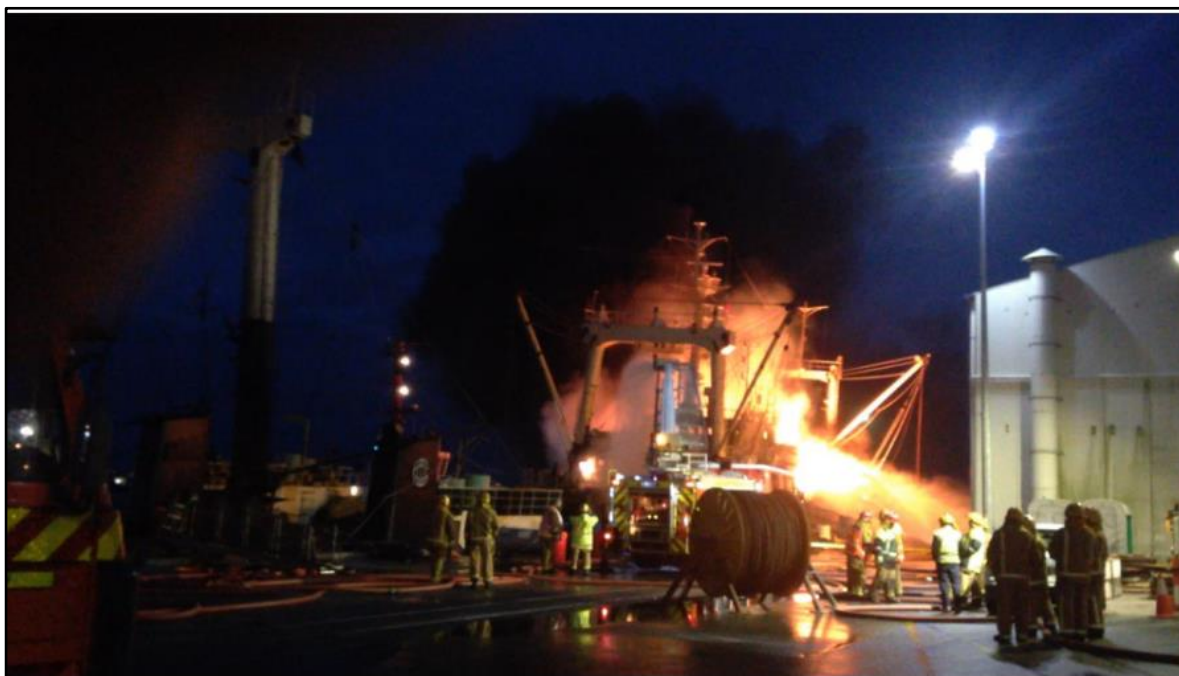
Figure 4: FENZ firefighters on the scene at 2132

- 2.14. At about 2125 a member of the public notified FENZ of the fire. FENZ arrived on the scene at about 2132. By this time the fire was well established and the vessel's accommodation superstructure was engulfed in flames.

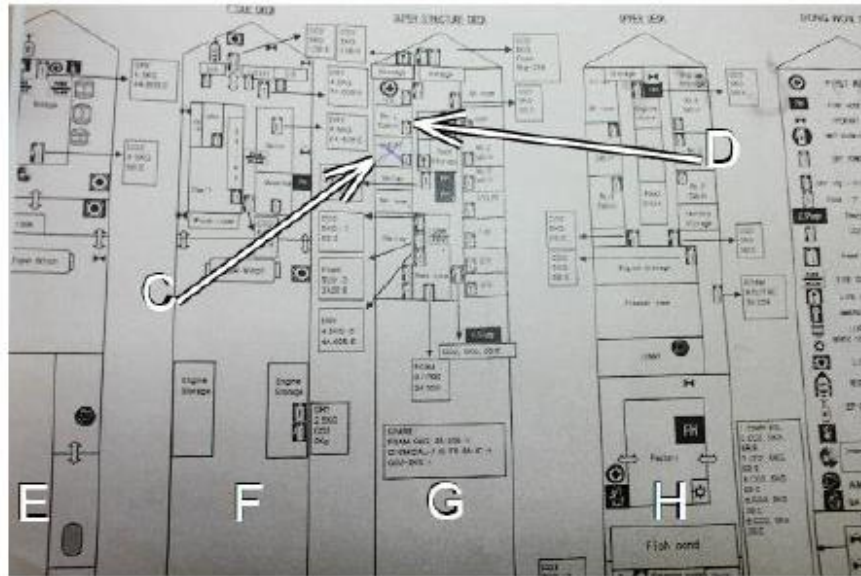
Photo 3: 'C' shows the location of the First Engineer's cabin and 'D' shows the cabin forward where a crewman was on the phone and noticed some smoke. 'E' is the Bridge level. 'F' is the Captain's Living Quarters. 'G' is the Officers' Living Quarters. 'H' is the Seamen's Living Quarters.

To the left of the cylinders (port side) there was an open space that was obviously living quarters. I knew this due to the debris that remained. I was able to identify the remains of fridges, oil column heaters and electrical equipment. By examining the ventilation ducting and aligning that with the steel droppers that were part of the structure that the hardboard walls would have been fixed to, I was able to determine where each cabin was. After referring to the vessel's map that was supplied to me by Maritime NZ, I was then able to confirm the area to the port side of the cylinders that lay in the passageway was the cabin of the first engineer. (Refer to photo 3).

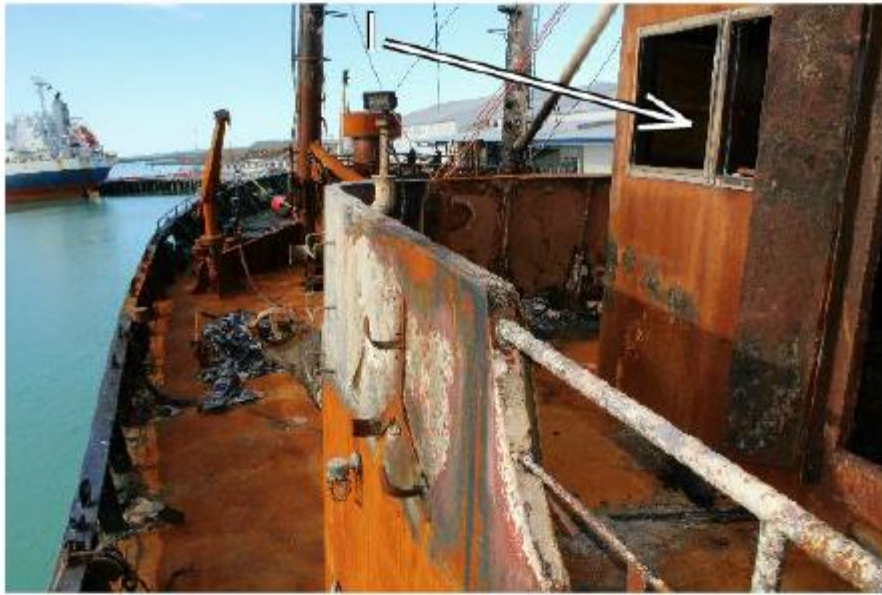
The Superstructure and the deck area in front of it showed extreme effects of heat. The buckling and oxidization of the steel on both were evidence of this. There was also extensive warping to the gunnel in front of the bridge windows. (Refer to photo 5 and 6). The rear of the Superstructure was less effected as identified by the remaining paint and no warping of the deck or gunnel.

Photo 5: Photo taken looking toward the front of the vessel while standing beside the bridge port entrance. "I" indicates the bridge.

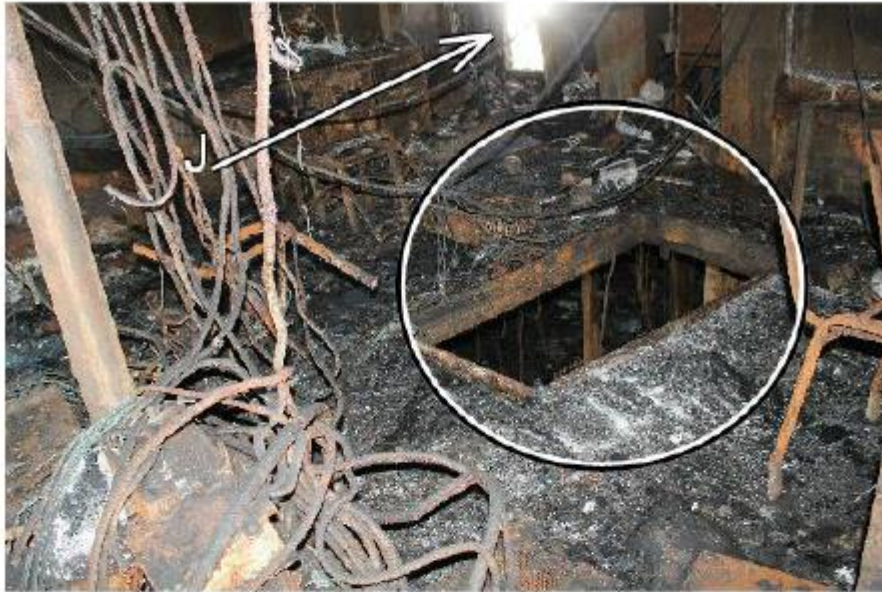
Photo 7: Looking across the bridge from the port side entrance the circle identifies where the ladder was that gave access to lower levels. 'J' shows the rear entrance on the starboard side.
