Transport Accident
Investigation
Commission

Final report

Marine inquiry MO-2018-205

***Fatality on board the factory trawler San Granit
14 November 2018***

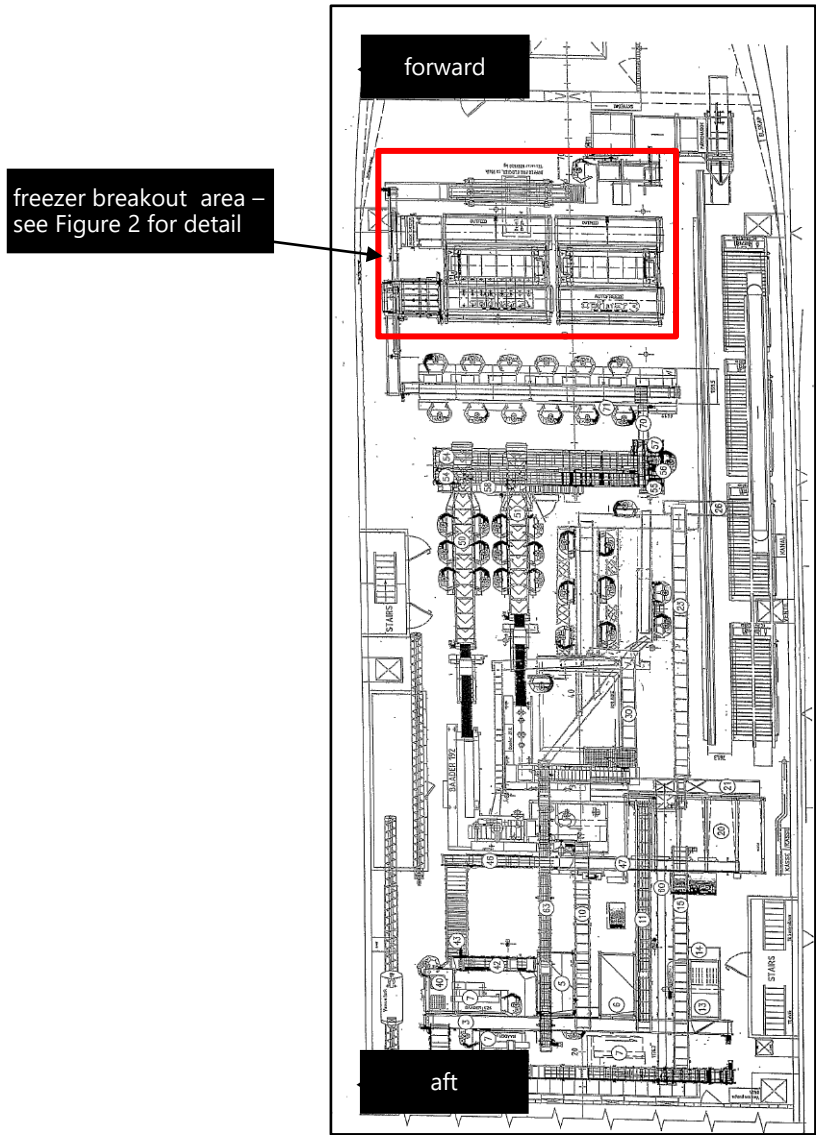
Figure 3: Factory plan for the *San Granit*

- 2.4. At approximately 0350 a deckhand who had been working on the factory deck went to the freezer area (see Figure 3) to talk to the freezerman. When the working area forward of the freezers came into view, the deckhand saw that the freezerman was trapped in a piece of the machinery called the accumulator. The deckhand believed that the freezerman was deceased and immediately left to inform the factory supervisor. In turn, the factory supervisor sent for the factory manager and the medic and told the remaining factory hands to leave the factory. The first officer, who was the officer of the watch, was informed of the situation and promptly called the master.

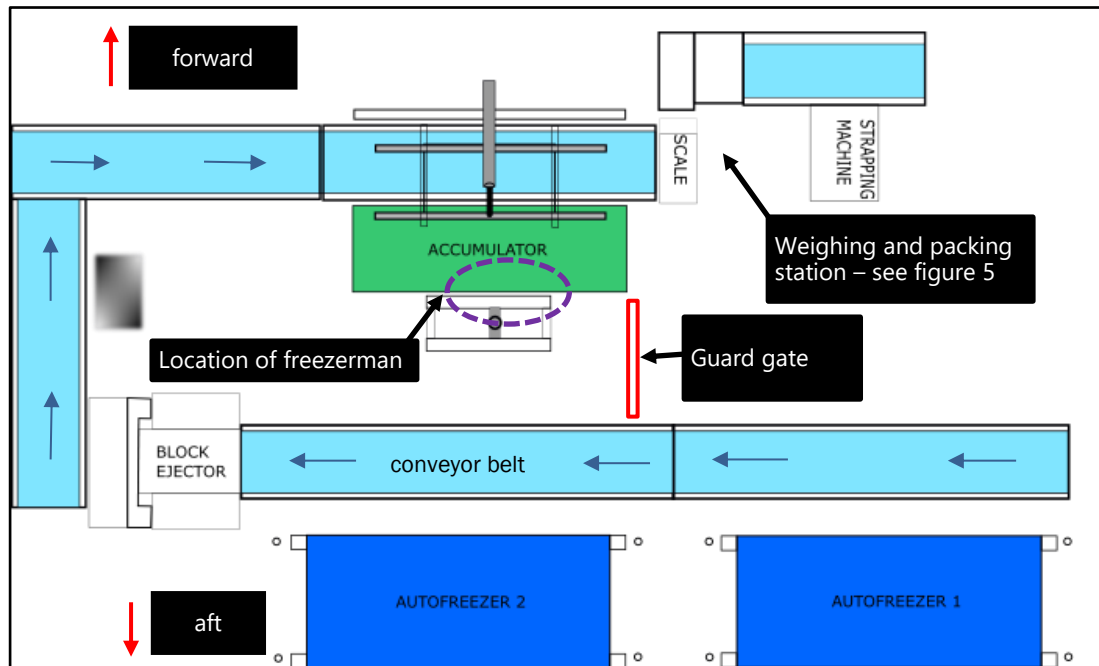
Figure 4: Layout of the freezers and freezer breakout area on board the *San Granit*

- 2.7. The *San Granit* was one of 12 freezer factory vessels operated by Sanford from its Timaru-based deep-sea fishing fleet. Originally built as the *Juvel* and later named the *Granit IV*, the vessel had been purchased from a Norwegian fishing company in 2015. Following a survey in 2016, the vessel had been transferred to the New Zealand flag and renamed the *San Granit*.
- 2.8. The *San Granit* had arrived in Timaru in the middle of November 2016. An extensive refurbishment of the factory had been undertaken, which included the installation of fish-processing machinery more suited to the species of fish being targeted by the Sanford fleet. The conveying, packing, weighing and labelling equipment forward of the automatic plate freezers, which included the accumulator, had not been significantly changed (see Figures 4 and 5).

- 2.16. The accumulator was a large tub that sat to the side of the conveyor line running from the freezers (see Figure 4). It was effectively a storage area that could be automatically loaded with up to 80 boxes when boxes were being conveyed more quickly than they could be processed.
