Transport Accident
Investigation
Commission

Final Report

***Marine inquiry MO-2019-201
Jet boat Discovery 2
contact with Skippers Canyon wall
23 February 2019***

December 2019

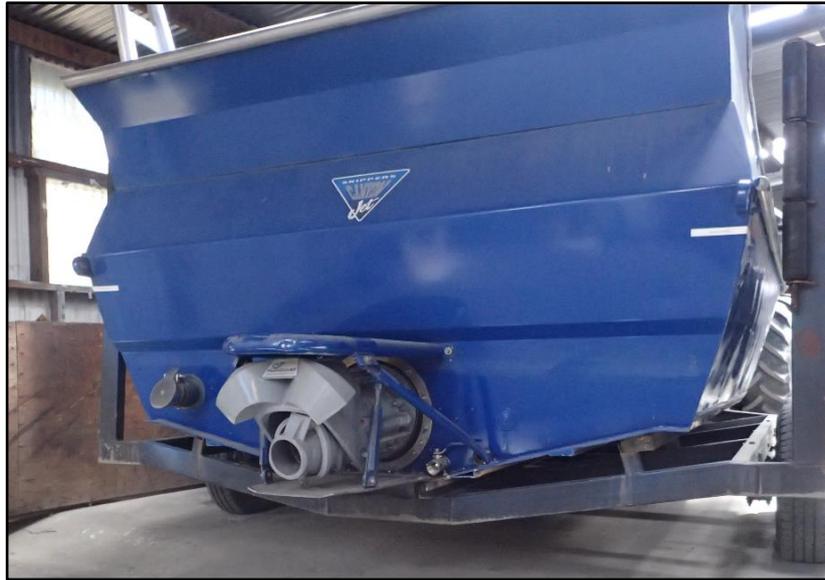
Figure 7: The jet unit installed on the *Discovery 2* prior to its removal after the accident

2.24. The tailpipe, steering nozzle and reverse bucket installed on the *Discovery 2* are shown in Figure 7.

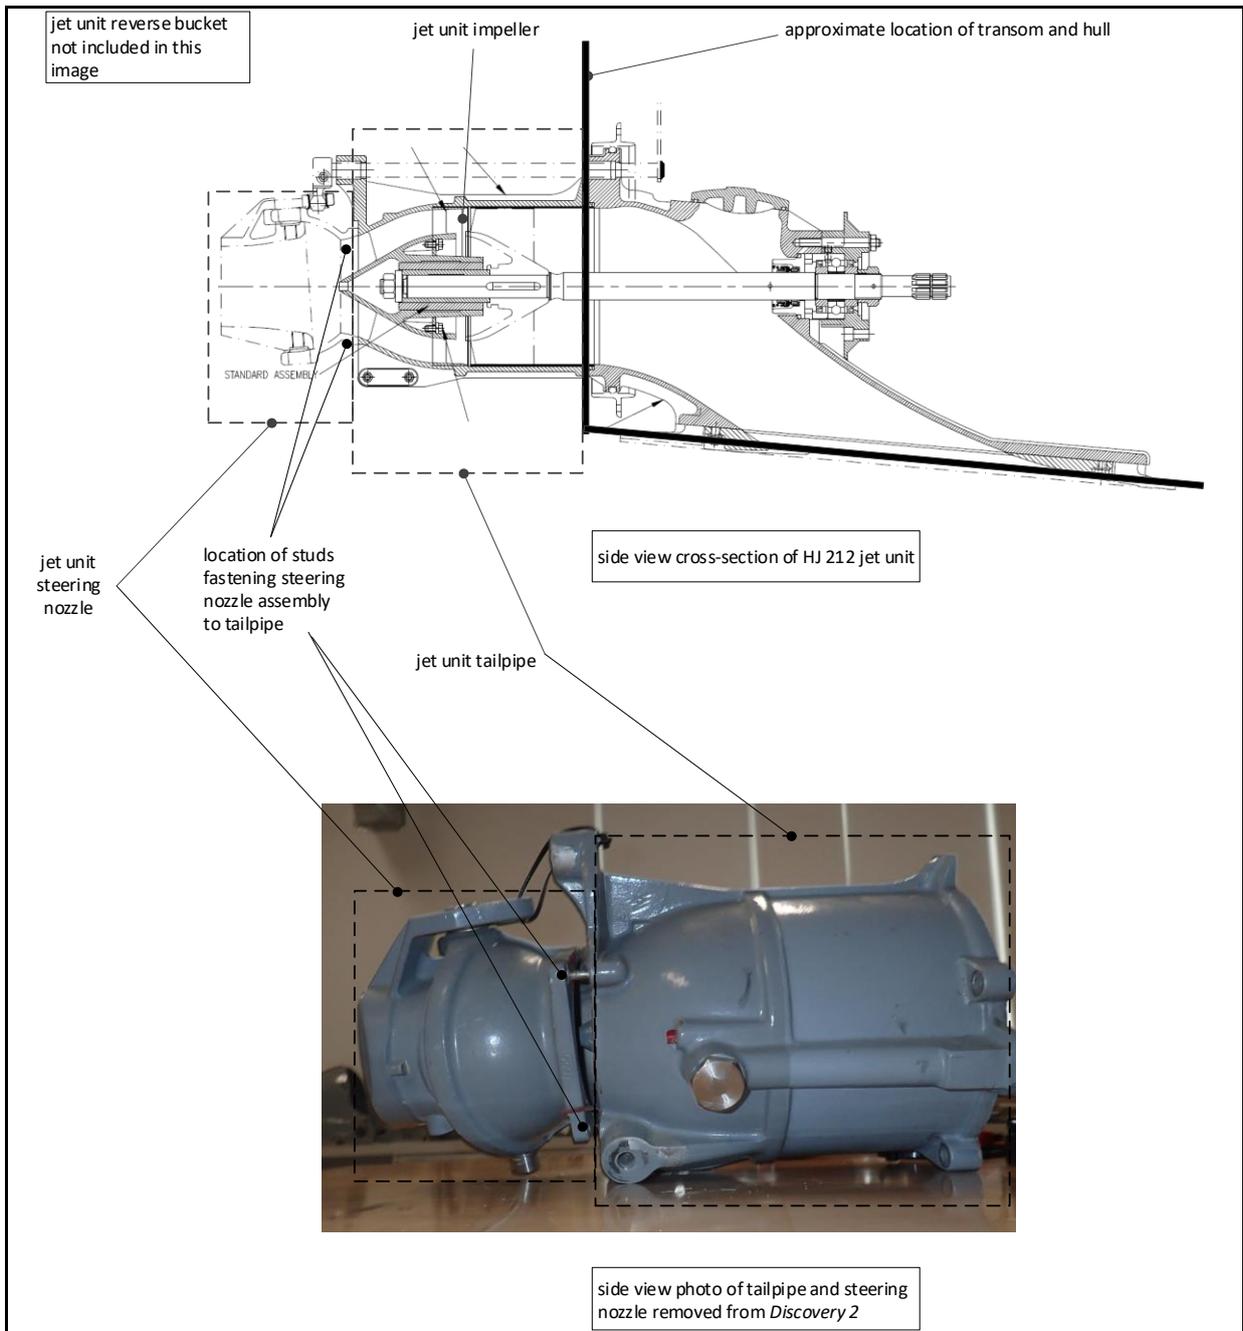
Figure 8: Cross-section and photo of the HJ212 jet unit showing the tailpipe and steering nozzle assembly

- 2.25. Hamilton Jet Limited is a jet unit manufacturing company based in Christchurch, New Zealand. The *Discovery 2* was fitted with a HamiltonJet Limited unit model HJ212. The HJ212 is designed principally for a jet boat intended to be transported by a road trailer. The model was introduced in 1992 and about 12,000 units have been produced. The HJ212 is the prevalent jet unit used by commercial jet boat operators in New Zealand.
- 2.26. Figure 8 shows a side-view cross-section design drawing of the HJ212 jet unit, together with a photograph of the HJ212 jet unit removed from the *Discovery 2* after the accident. It can be seen in the photograph that the steering nozzle had become partially detached from the tailpipe, and at least one of the stud-bolts⁴ fastening the steering nozzle assembly to the tailpipe had parted.

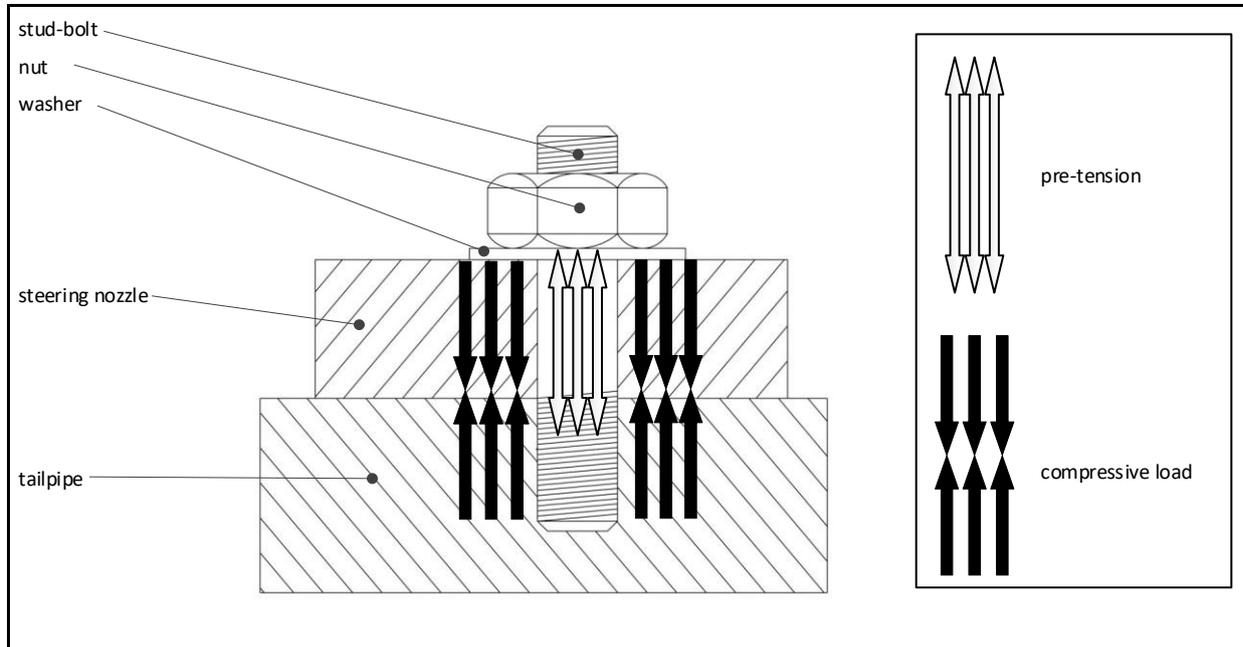
Figure 10: Schematic drawing of a stud-bolt securing the steering nozzle to the tailpipe

2.31. Figure 10 shows a schematic drawing of a stud-bolt used to clamp the jet unit steering nozzle to the tailpipe. The stud-bolt is permanently screwed into the tailpipe, and the steering nozzle is clamped on to the tailpipe with the force of the nut screwed on to the stud-bolt.

- 2.32. The integrity of the engineering joint between the steering nozzle and the tailpipe is dependent on the stud-bolts being protected from the operational loads. The job of a stud-bolt is to hold the components together tightly to transfer loads directly between the two components rather than the stud-bolt. This is achieved by applying pre-tension⁷ to the stud-bolt.

2.35. It is important to protect the stud-bolt from experiencing operational loads when the joint is subject to cyclic loading⁸, as it was on the *Discovery 2*'s stud-bolts fastening the steering nozzle to the tailpipe. Cyclic loading on a stud-bolt causes fatigue, which can lead to fatigue cracking⁹.
