Transport Accident
Investigation
Commission

Marine inquiry MO-2019-203

Bulk log carrier *Coresky OL*

**Crew fatality during cargo-securing operation,
Eastland Port, Gisborne**

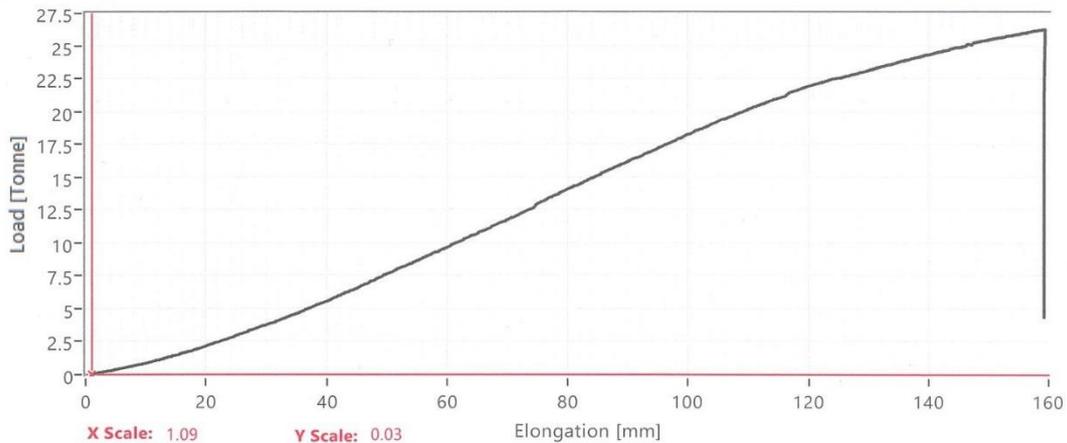
Customer: Maritime New Zealand	Test Report #: 080719005
Address: Level 11 Grey Street	Test Type: Break test
Customer PO #:	Peak Load: 26.215 Tonne
Order #:	Peak Elongation: 159.41 mm
Item Serial #: 203005	Test duration: 00:02:02
Test Date: 7/08/2019	Test Standard: EN 13411-3:2004 and class NK 4 4.1.6
Test Time: 10:14:34 AM	W.L.L.: 5
Description: 24mm sling with 500mm soft eye each end	Comments:
Customer Note:
