Transport Accident
Investigation
Commission

Marine inquiry MO-2020-201

***Collision between bulk carrier Rose Harmony and
fishing vessel Leila Jo***

Off Lyttelton

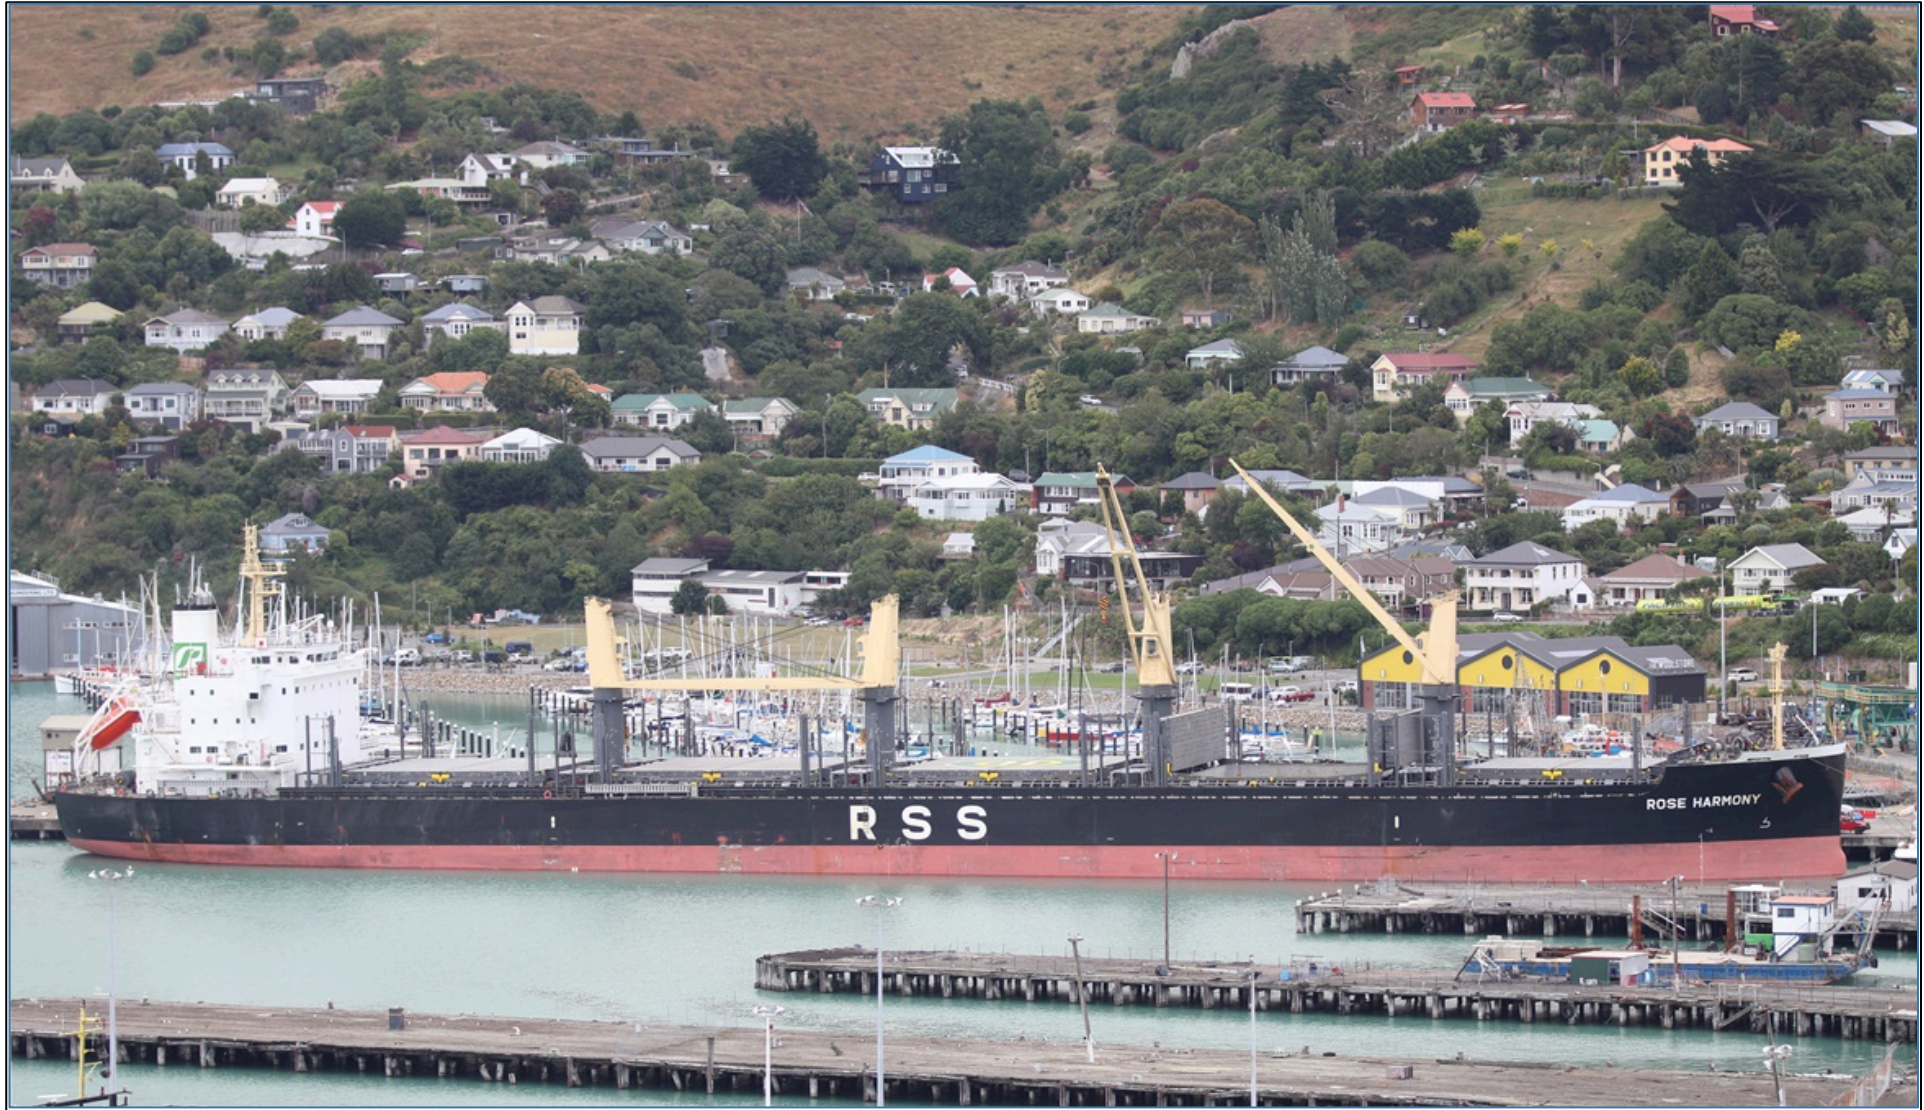
**Figure 1: The *Rose Harmony* in Lyttelton Port
(Credit: John Bell)**

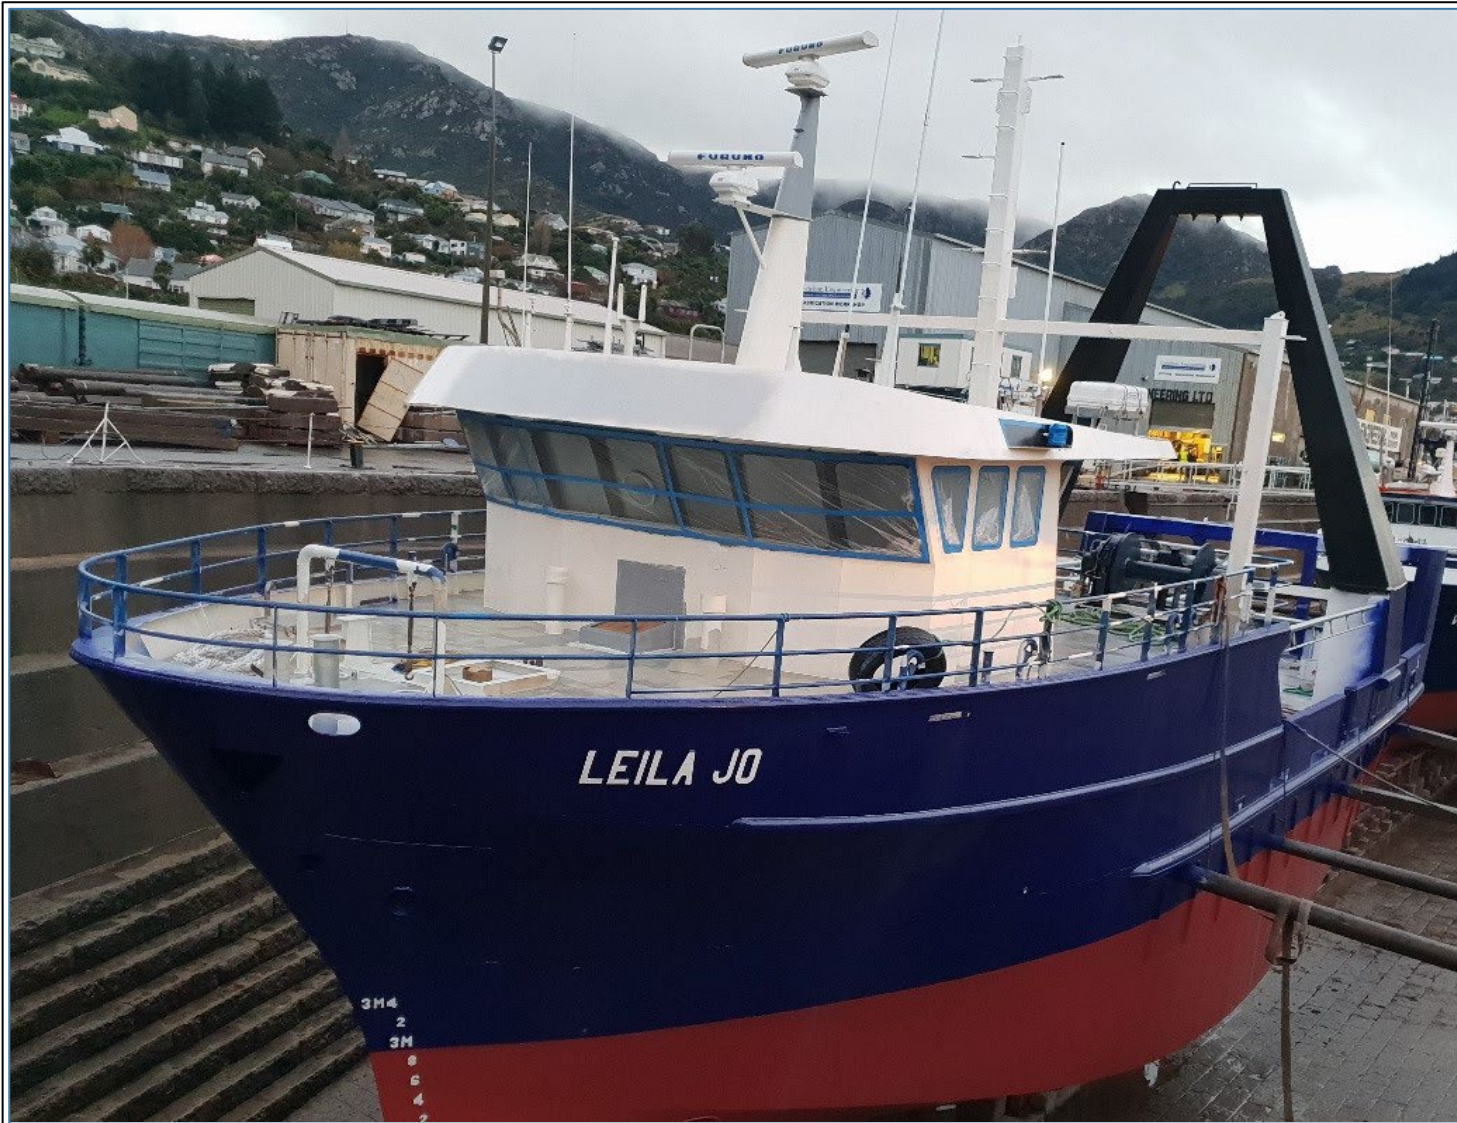
**Figure 2: The *Leila Jo* in dry-dock prior to the accident
(Photo from post-collision marine survey report)**

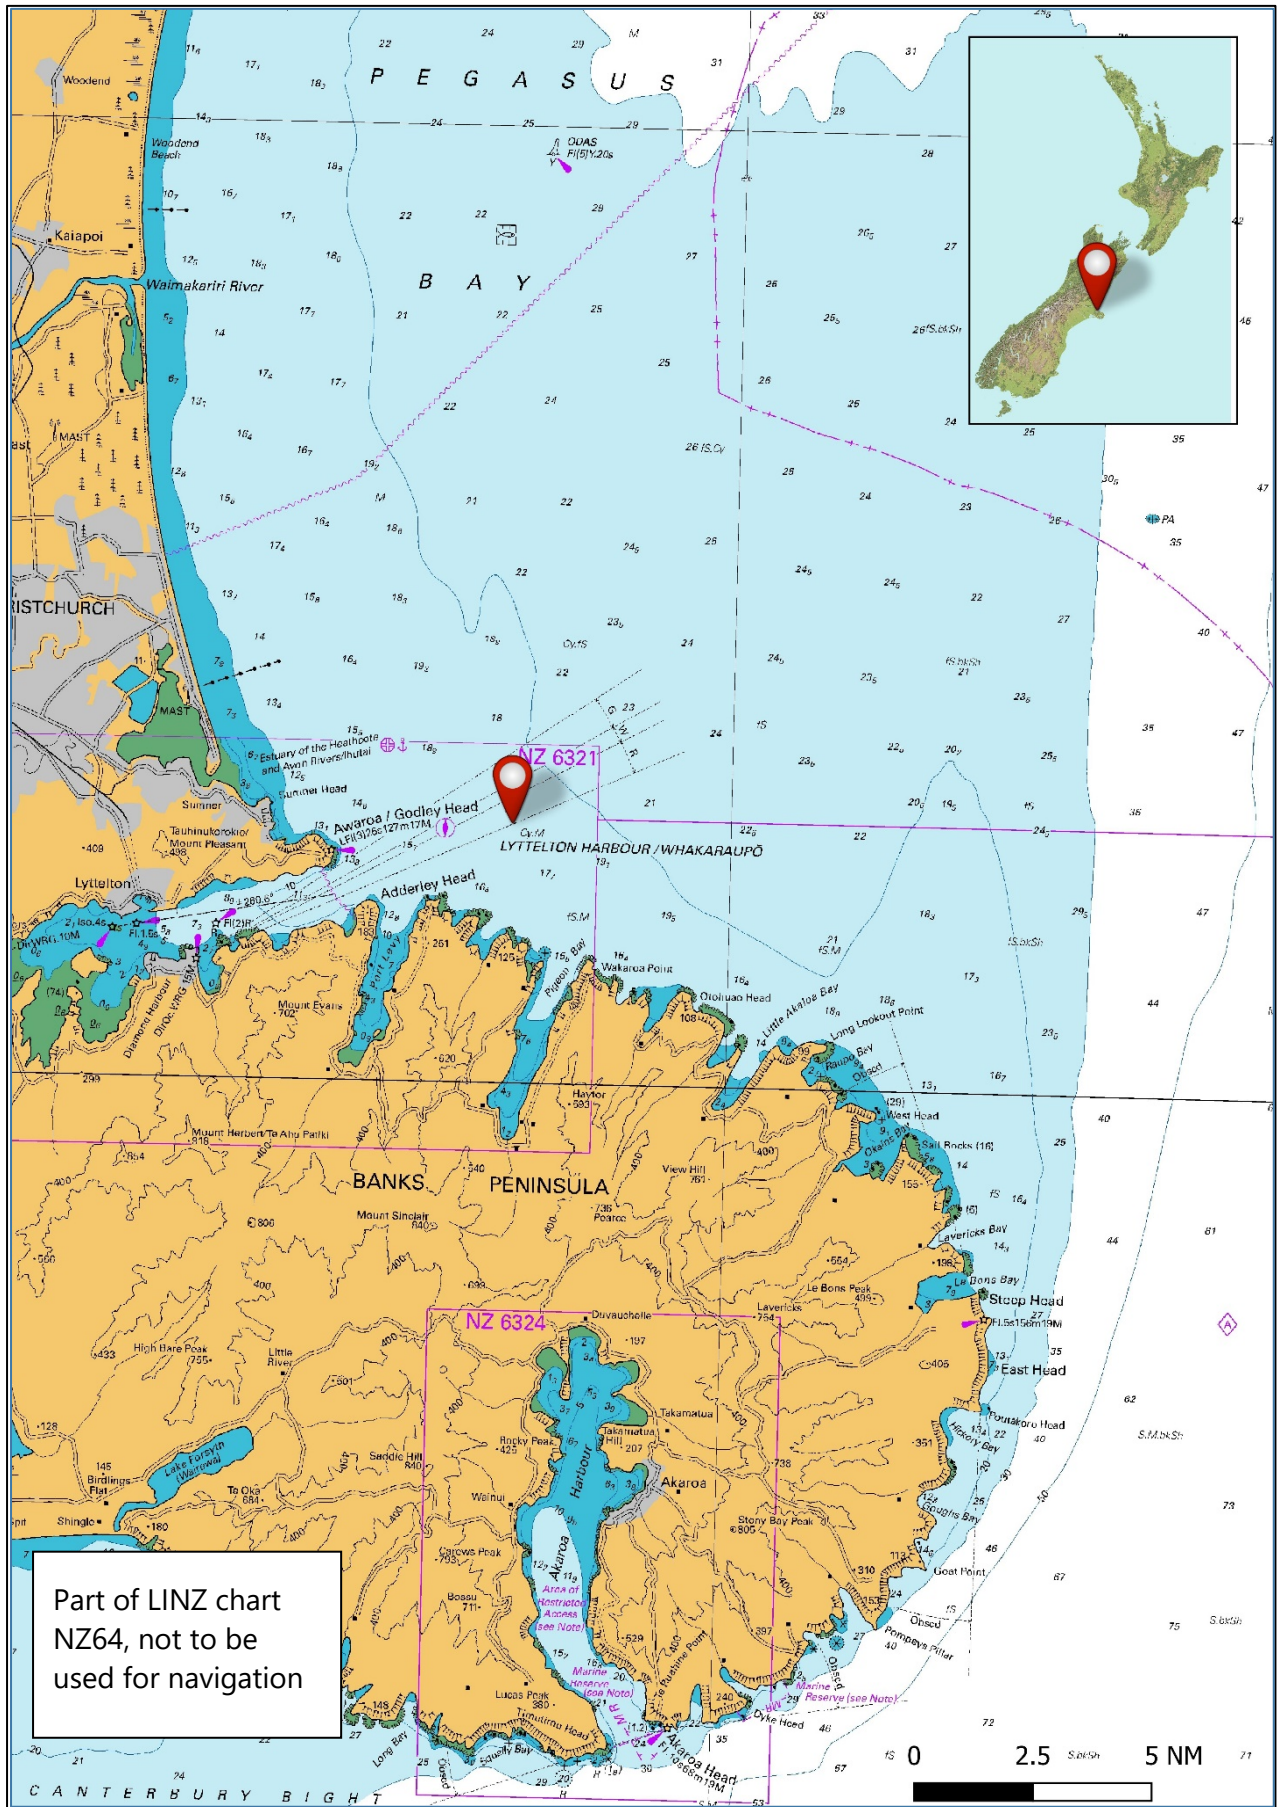
Figure 3: Location of collision

- 2.9. The deckhand remembered seeing a radar target between Awaroa/Godley Head and Adderley Head at the entrance to Whakaraupō/Lyttelton Harbour (see Figure 3) at about 2240. The deckhand had not observed the target visually and had not identified the direction in which it was heading. This radar target was almost certainly the *Rose Harmony* leaving Whakaraupō/Lyttelton Harbour and may have been visually detectable.

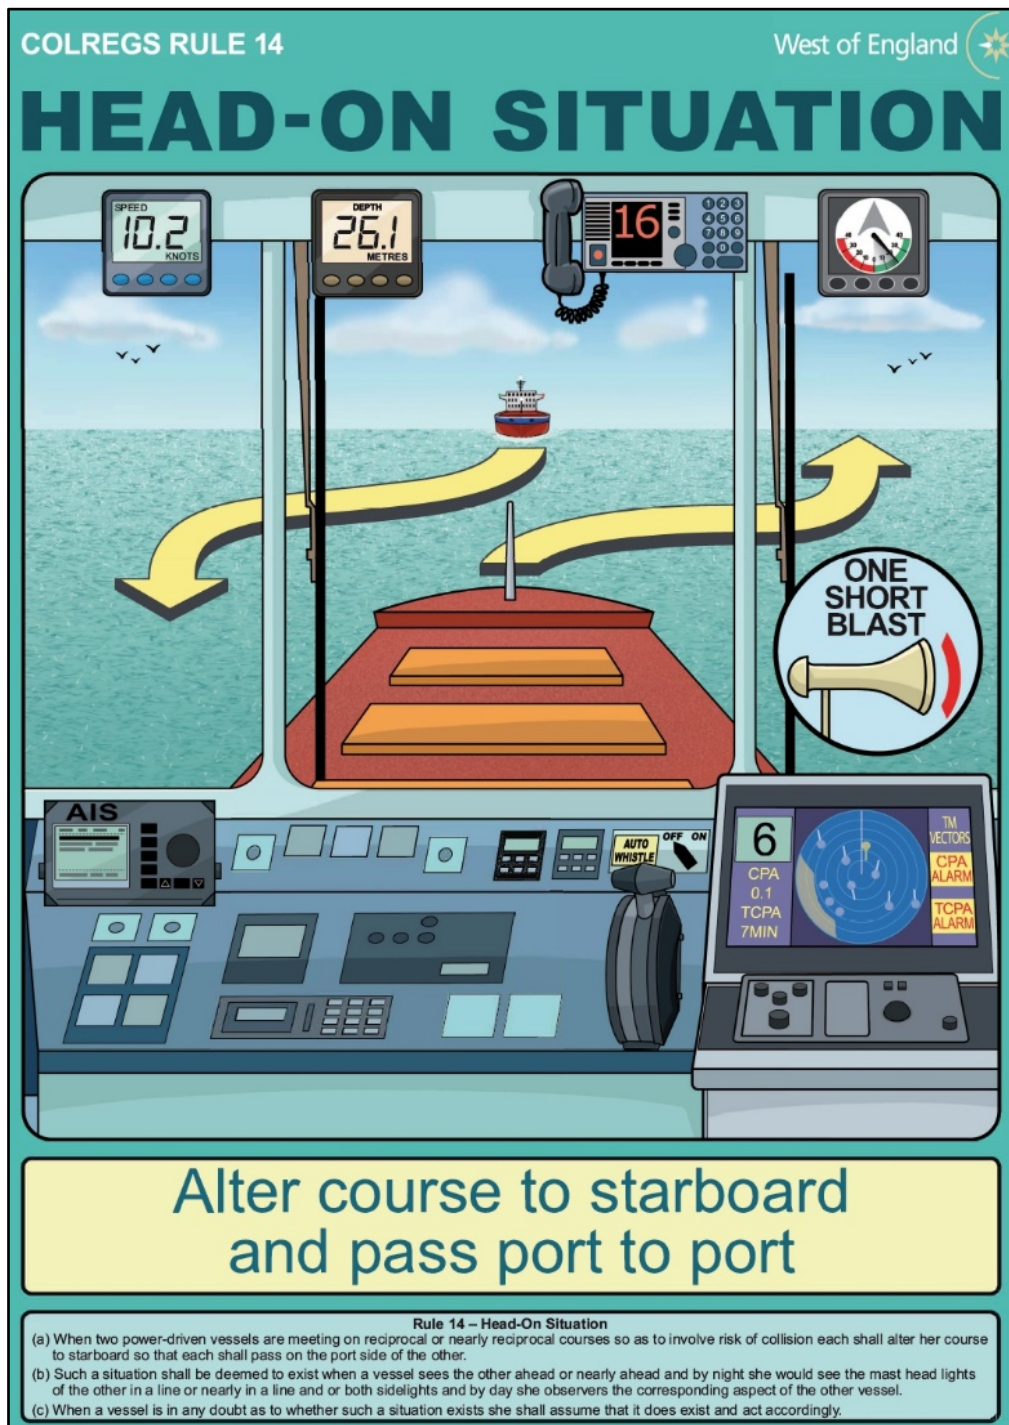
alter course to starboard so that each passed on the port side of the other¹⁸ (see Figure 9).

Figure 9: COLREGs Rule 14: Head-on situation
(Credit: West of England Protection and Indemnity provider)
