# Final Report

***Marine inquiry MO-2020-202***

***Bulk log carrier Funing***

***Loss of manoeuvrability while leaving port***

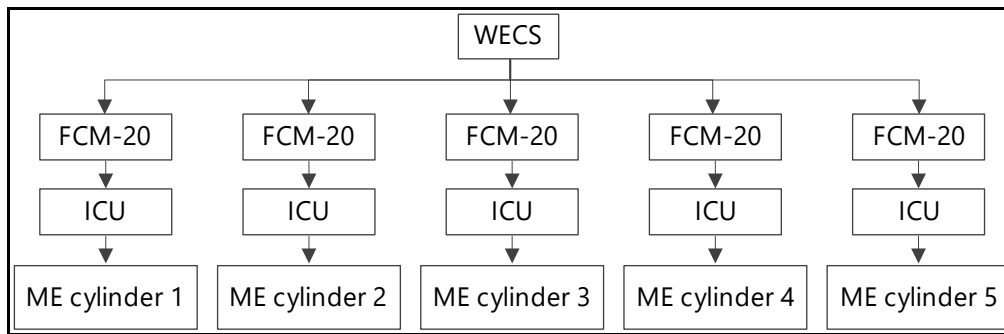
**Figure 4: Basic organisational chart of the RT-Flex fuel injection control system**

- 2.34 The *Funing's* main engine was controlled by a Wärtsilä engine control system (WECS) (Figure 5), which in turn controlled an electronic Flex Control Module (FCM-20) for each cylinder. The FCM-20 controlled electro-hydraulic valves for each ICU and is discussed in more detail later in the report.
- 2.35 The function of the ICU was to supply a predetermined quantity of fuel to the engine cylinder fuel injectors. The quantity of fuel varied depended on the load on the engine, and was apportioned by a fuel injection quantity piston within the ICU. The quantity of fuel was measured by a sensor attached to the fuel injection quantity piston.

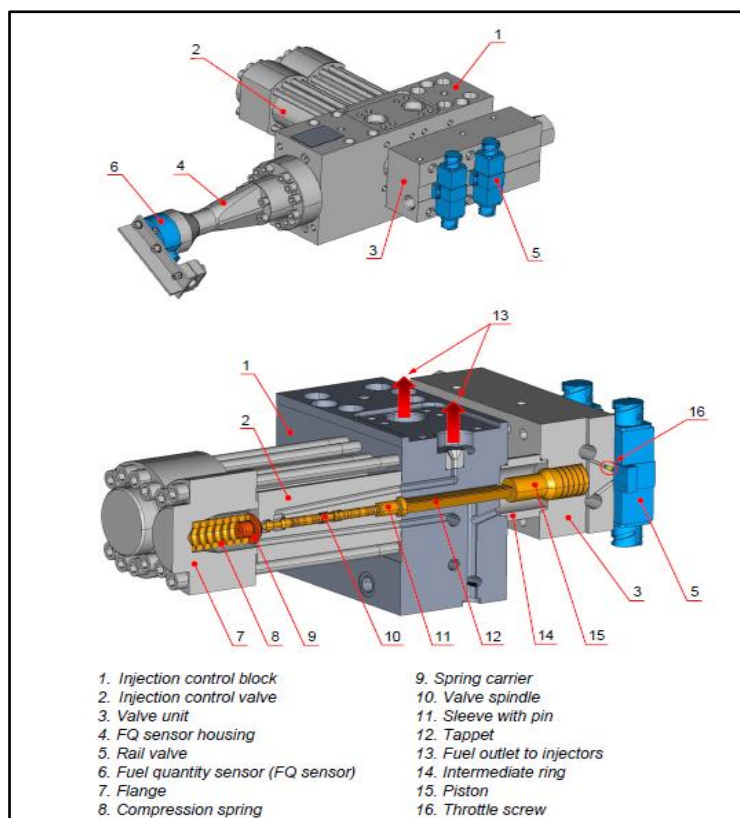
**Figure 6: Fuel injection control unit  
(Credit: Wärtsilä technical bulletin)**

- 2.36 The ICU was a key component of the RT-Flex engine. Figure 5 shows a photograph of the ICU removed from the *Funing* after the accident, and Figure 6 shows a labelled image.

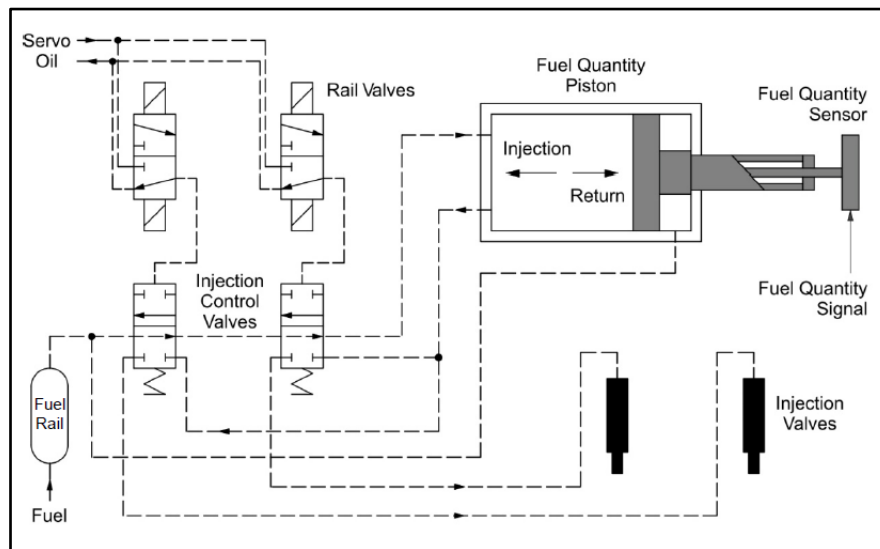
**Figure 7: Schematic showing the working principle of the ICU (image taken from a Wärtsilä technical bulletin)**

- 2.38 The WECS controlled the functions of the main engine. For each combustion cycle of each cylinder, the WECS sent an 'injection command' to the FCM-20, which was relayed to the electro-hydraulic rail valves on the ICU (Figure 7).

<sup>11</sup> See Figure 7, Item 5.

<sup>12</sup> See Figure 7, Item 15 labelled on the cross-sectional view of the ICU.
