Final report Tuhinga whakamutunga

Maritime inquiry MO-2020-204 Container Vessel, Rio De La Plata Serious injury to crew member during unmooring operations, Timaru Port 14 November 2020

May 2022

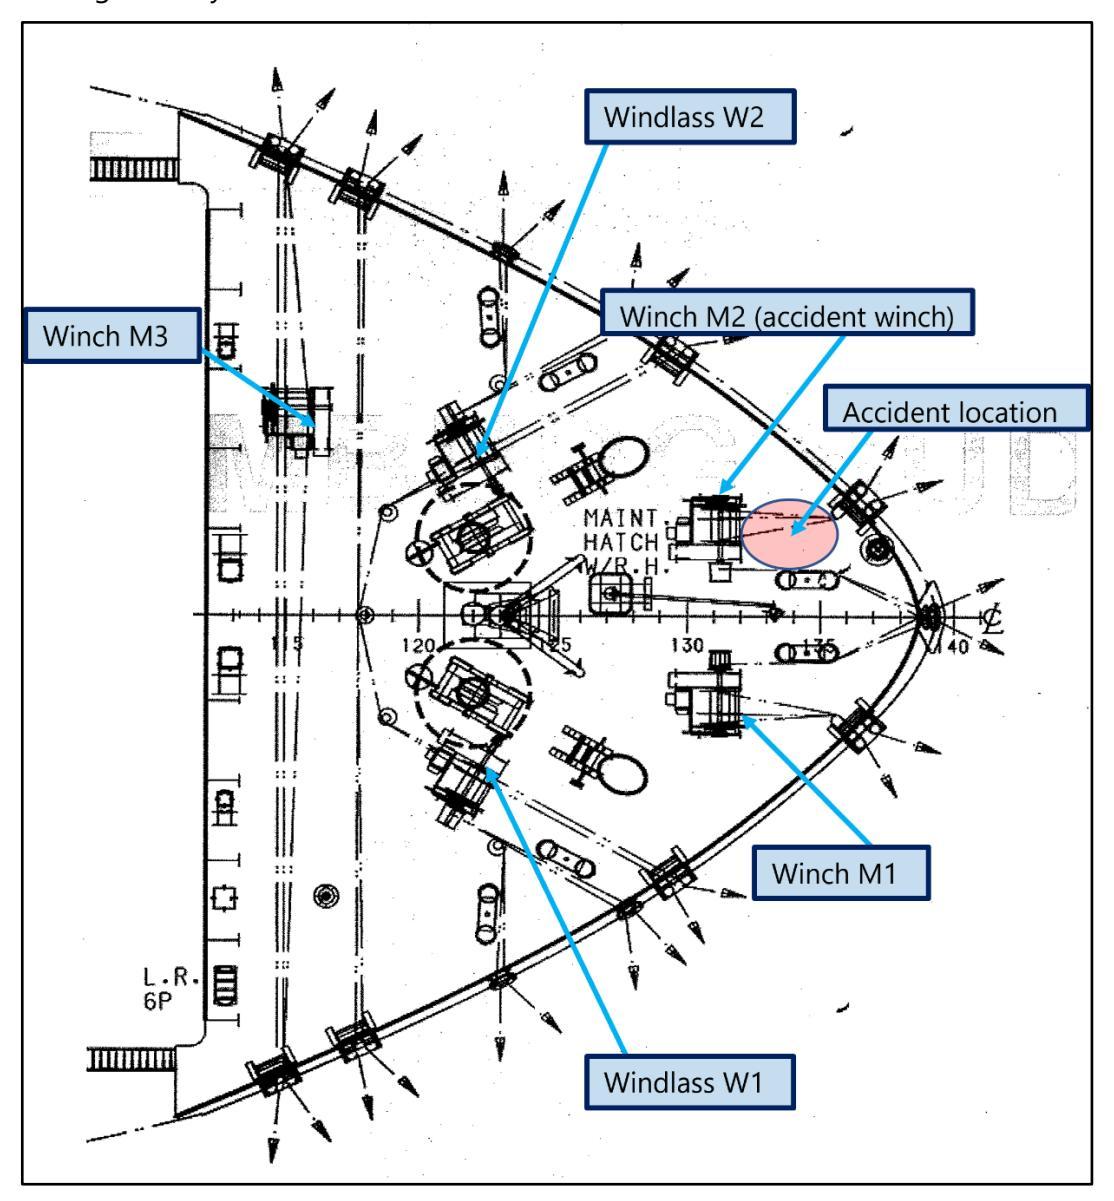
Figure 3: Forward mooring deck layout

2.11 The forward mooring deck (where the accident occurred) was equipped with three mooring winches¹⁷ and two windlasses.¹⁸ Figure 3 shows a drawing of the forward mooring deck layout.

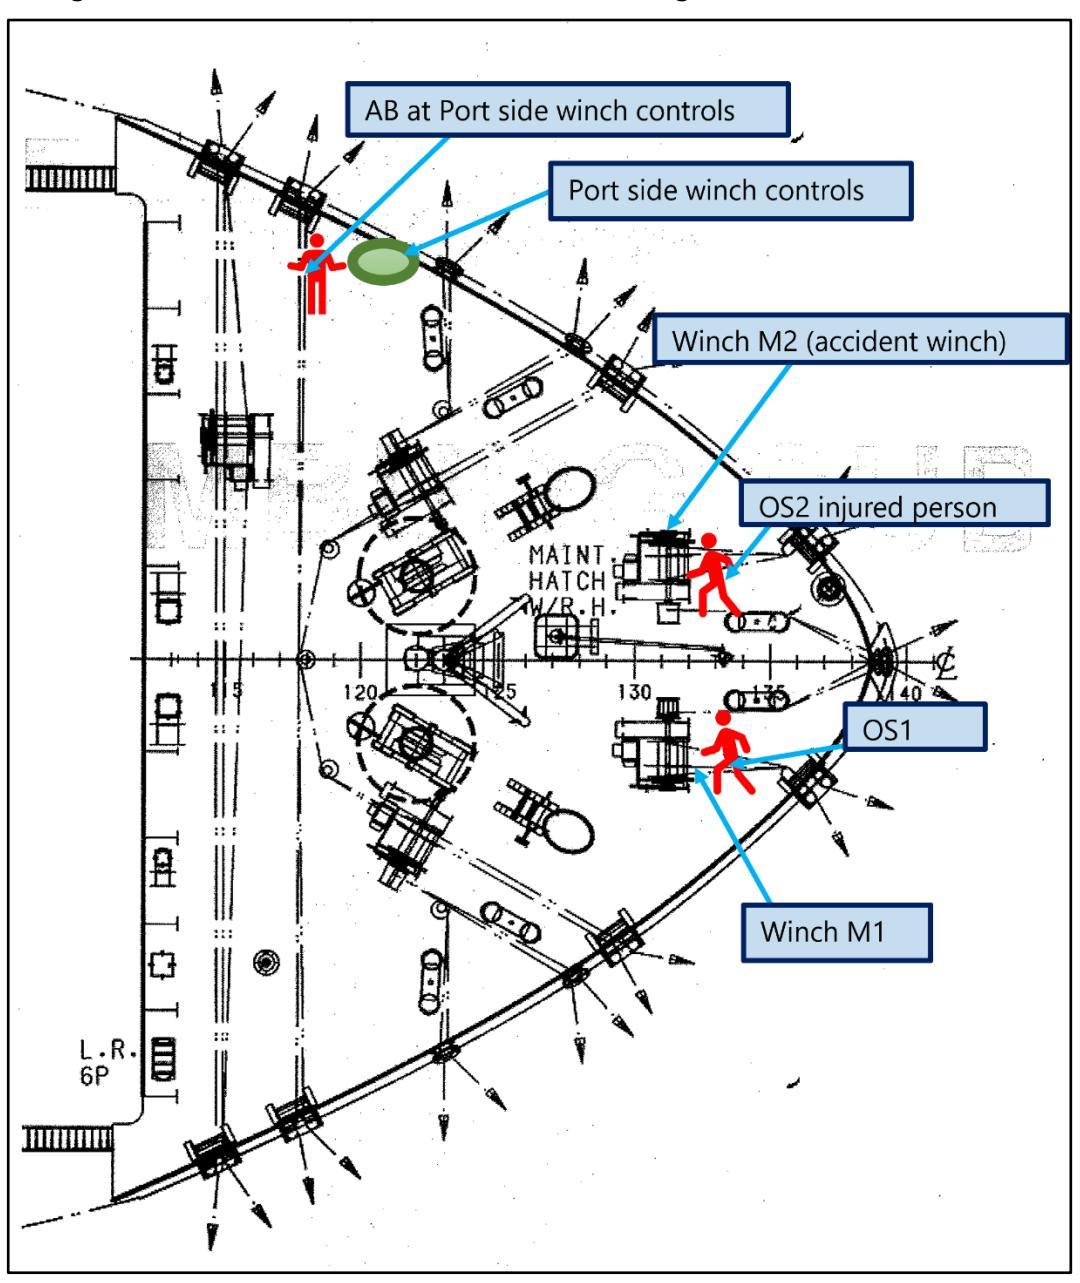
Figure 4: Forward mooring deck with remote winch controls

2.12 The deck equipment was operated from remote control stations located on either side of the forward mooring deck. The remote control stations were located away from the mooring winch, towards the aft end of the deck (see figure 4).

2.13 The AB seaman positioned himself at the port side remote control station and took control of the mooring winches, while OS1 and OS2 (injured person) took up their positions near winch M1 and winch M2, respectively. From this position the AB did not have a direct line of sight of the two OS's when they worked close to the winches.

2.36 At the time of the accident, the AB operating the winch was positioned at the port control station. From this position, there was no direct line of sight between the AB and the two OS's working and handling the ropes forward of winch M1 and winch M2 (see figure 4 and figure 5). The forward mooring team therefore relied on verbal and/or hand signals to communicate. This issue is further discussed in the analysis section of the report.
