Final report Tuhinga whakamutunga

Marine inquiry MO-2021-201 Jet boat KJet 8 Loss of control Shotover River, Queenstown 21 March 2021

May 2022

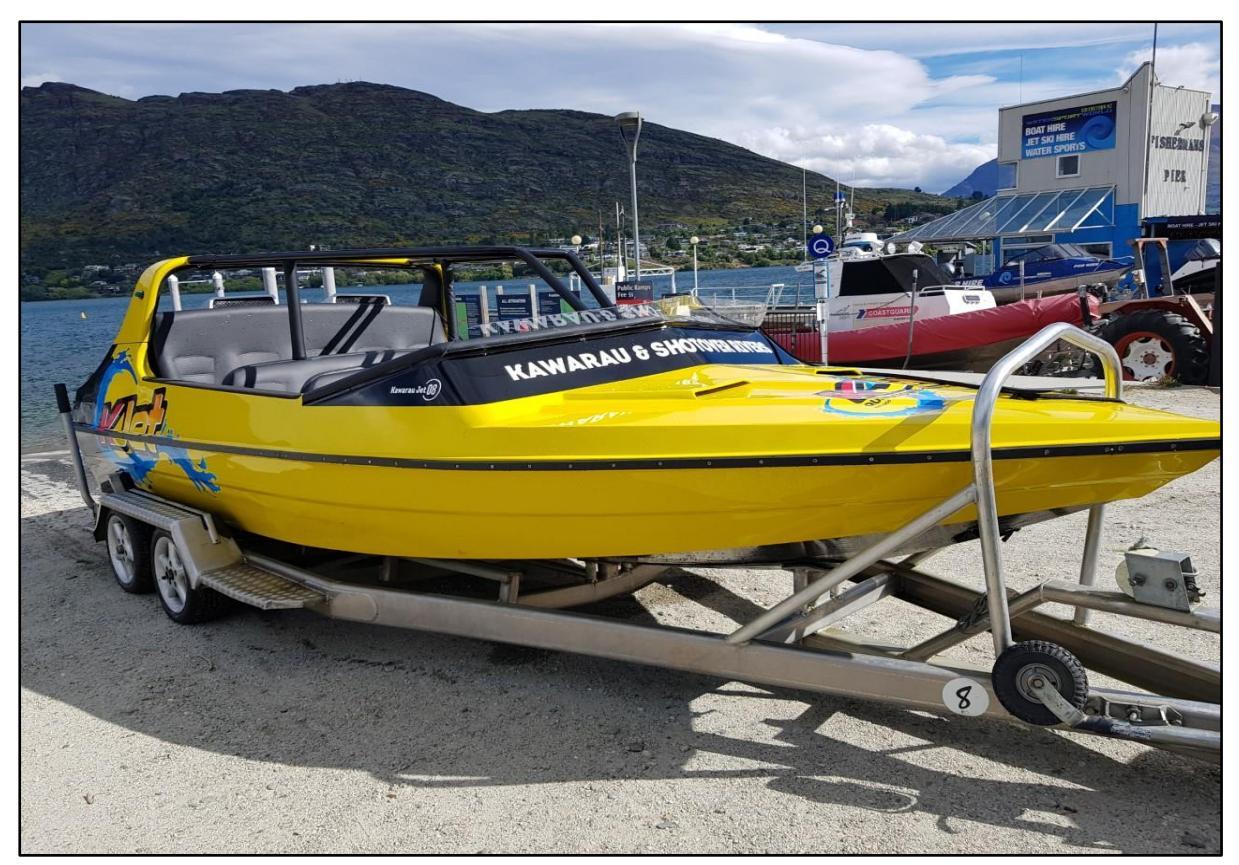
Figure 1: Jet boat *KJet 8* (Credit: KJet)

- 1.1 On 21 March 2021, the jet boat *KJet 8* (figure 1) was travelling on the Shotover River (figure 2) with a driver and 12 passengers on board. As it rounded a right-hand bend the engine stopped and as a result the driver lost control of the jet boat.
- 1.2 It continued moving forward under its own momentum and collided with a low overhanging branch of a tree on the bank of the river.
- 1.3 The driver and one passenger were struck on the head by an overhanging branch and received moderate head injuries. They were airlifted to hospital and discharged the same day.

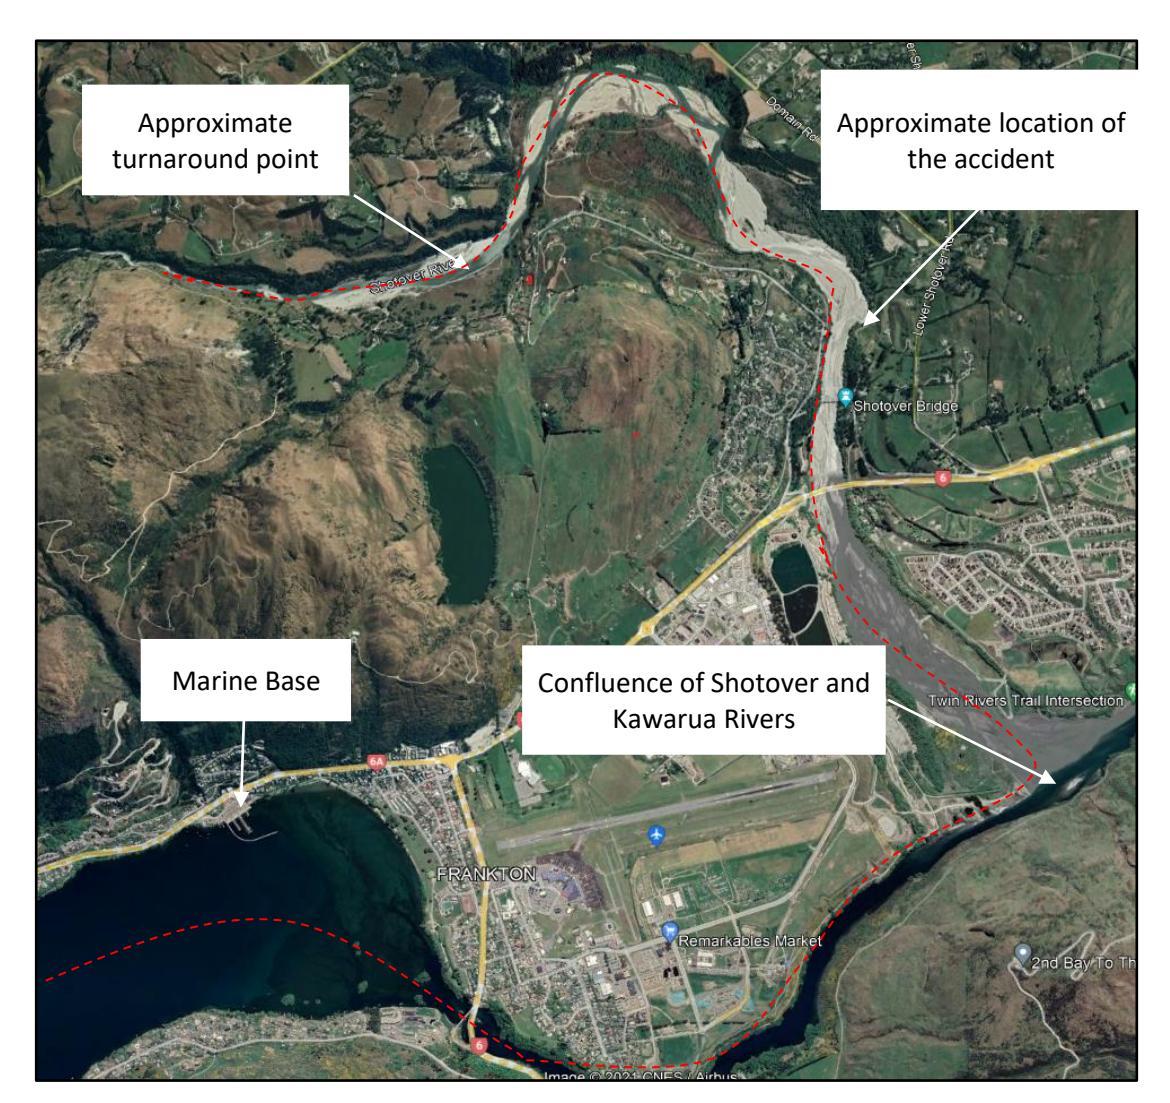
Figure 3: Location of the accident and key route positions (Credit: Google Earth)

- 2.8 At about 1100, *KJet 8* departed on its second trip of the day with 12 passengers on board. The outbound trip proceeded up the Kawarua and Shotover Rivers (figure 3), turning around at approximately 1135 and heading back down the river. Approaching a right-hand bend, the driver recalled not hearing any engine noise and the boat levelled out, lost steerage and continued to travel straight ahead.

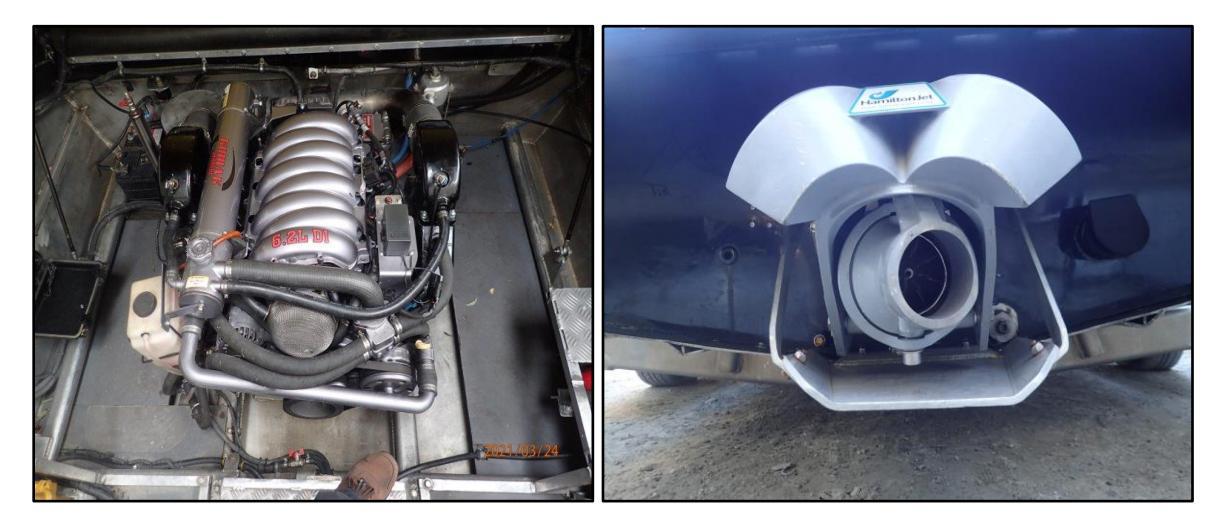
Figure 4: Left – single 6.2 litre DI V8 Kodiac (Chevrolet) engine. Right – Hamilton Jet type 212 jet unit

- 2.21 *KJet 8* was a 6.5 metre jet boat built by Mackraft in Bluff, New Zealand. It was initially inspected in 2003.
- 2.22 It had a maximum speed of 95 kilometres per hour and a total seating capacity of 13, permitting 12 passengers and a driver to be seated.
- 2.23 It was powered by a marinised² single petrol-driven 6.2 litre Direct Injection V8 Kodiak engine³ supplied by KEM Equipment based in Oregon, United States of America (USA) (figure 4 left). On 31 March 2021, the engine running hours totalled 1311. Propulsion was provided by a Hamilton Jet type 212 jet unit (figure 4 right).

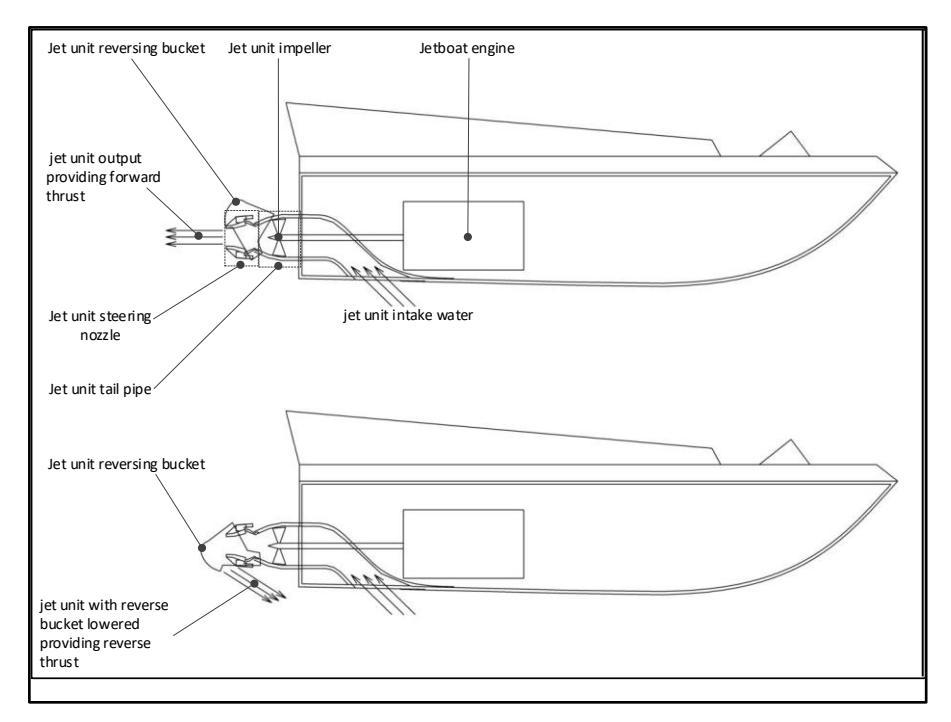
Figure 6: General arrangement of a jet unit on a jet boat (not to scale)

2.29 A jet boat is propelled and steered through the water by a jet unit (figure 6). The jet unit is an impeller water pump powered by the jet boat's internal combustion engine.

- 2.30 The pump sucks water in through an intake under the hull and forces it out through a pipe and steering nozzle mounted on the transom,⁴ thereby providing thrust to the boat.
- 2.31 The steering nozzle can be rotated either side using the driver's steering wheel to direct the thrust and provide steering.
- 2.32 A bucket-shaped deflector is attached to the unit, which can be lowered down over the end of the steering nozzle. The deflector redirects the water jet forwards, which provides reverse thrust. The deflector is named the 'reverse bucket' and is lowered using a lever located beside the driver's seat.
