# **Final report**

***Marine inquiry MO-2021-202***

***Factory fishing trawler Amaltal Enterprise***

***Engine room fire***

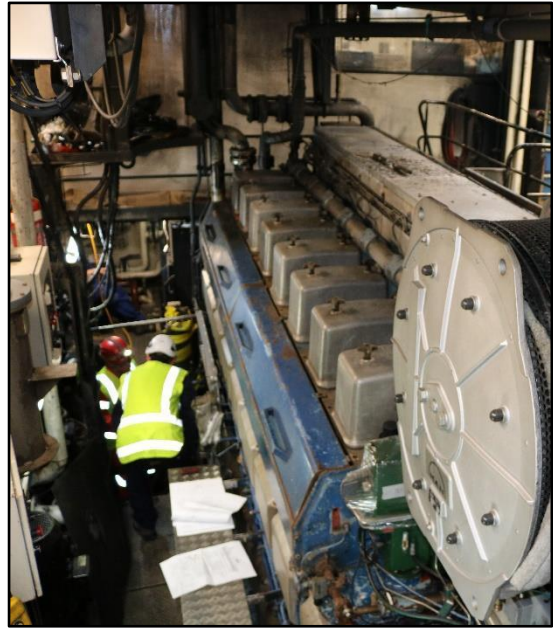
Statements from the Chief Engineer reported that following the fire the accumulator had been found in the sump below the diesel oil filters.

There were normally two accumulators located around the vicinity of the fuel filters. The accumulators are made from steel and use a diaphragm to dampen pressure fluctuations and therefore ensure a constant diesel oil pressure is provided to the engine. It normally runs at 8bar (800kPa).

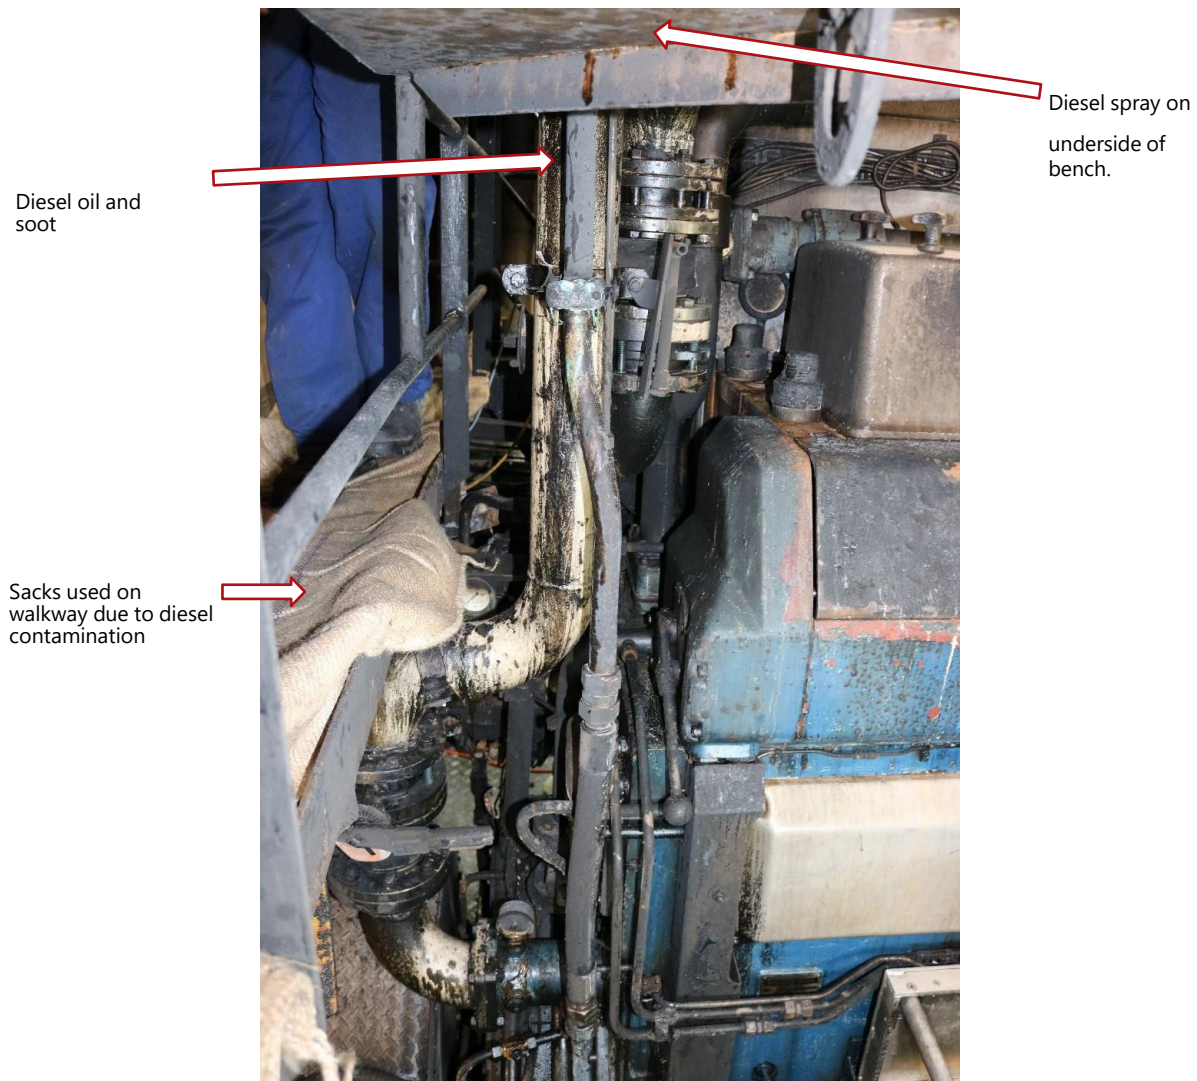
Normal location of  
2<sup>nd</sup> Accumulator,  
with cap in place.
