Transport Accident
Investigation
Commission

Final report

Marine inquiry MO-2021-203
Collision between Fishing Vessel ‘Commission’
and container ship ‘Kota Lembah’
84 nautical miles northeast of Tauranga, Bay of
Plenty, New Zealand
28 July 2021

April 2022

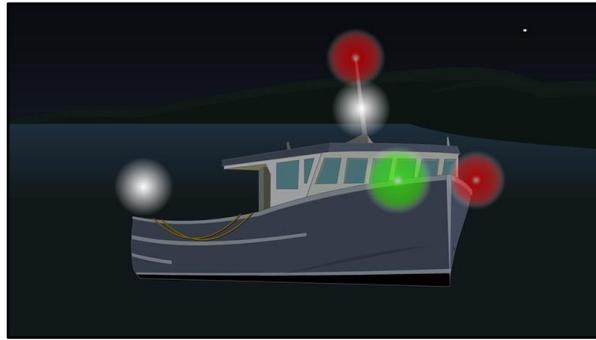
Figure 6: Navigation lights required for a fishing vessel of similar size and purpose as the *F.V. Commission*

- 3.6 This collision occurred in open waters where no other special rules applied. Fishing vessels that are engaged in fishing have special considerations under the COLREGS. The *F.V. Commission* was engaged in fishing and was displaying the appropriate lights to show that it was, being two all-round lights in a vertical line, the upper being red and the lower being white.¹⁶ As the *F.V. Commission* was underway¹⁷ it was also displaying red and green side lights and a stern light (see figure 6).

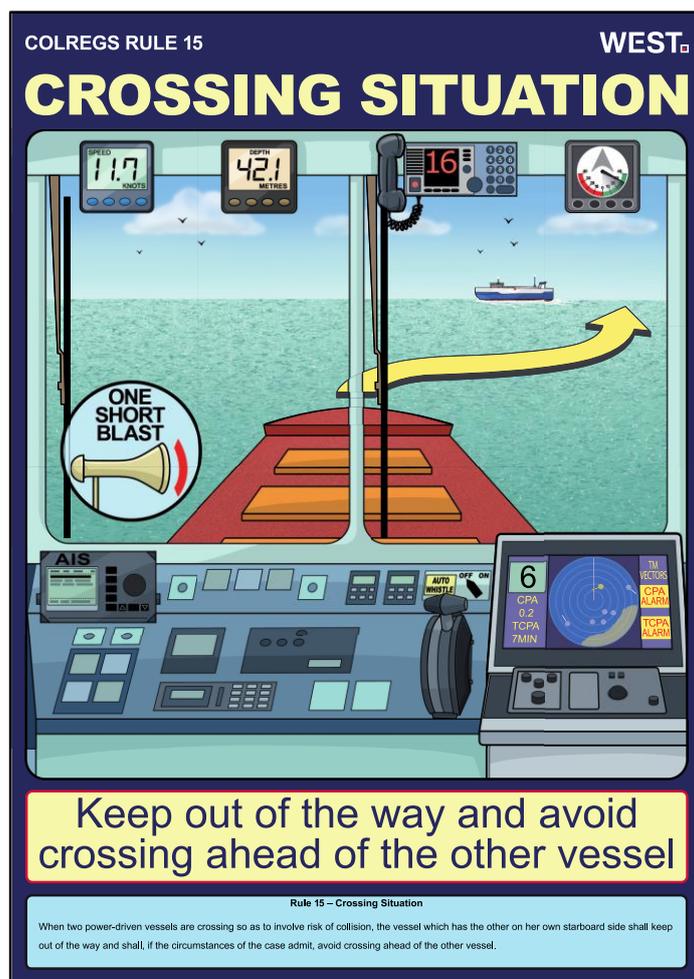
Figure 7: COLREGS Rule 15 Crossing Situation
 (Credit: West of England Protection and Indemnity provider)

- 3.11 The *Kota Lembah* bridge crew had detected and were plotting the progress of the *F.V. Commission* on their radar. They had identified the *F.V. Commission* as a crossing vessel, but it did not occur to them that they needed to take action to give way (refer to figure 7). The bridge crew were working on two false assumptions. First, that because their vessel was drifting this entitled their ship to be given way to by others. Secondly, because the *F.V. Commission* was probably a fishing vessel, it would give way to them by virtue of their size.
