Transport Accident
Investigation
Commission

Final report

Maritime inquiry MO-2021-204
Recreational vessel
Capsize and sinking with three fatalities
Manukau Harbour entrance
16 October 2021

May 2023

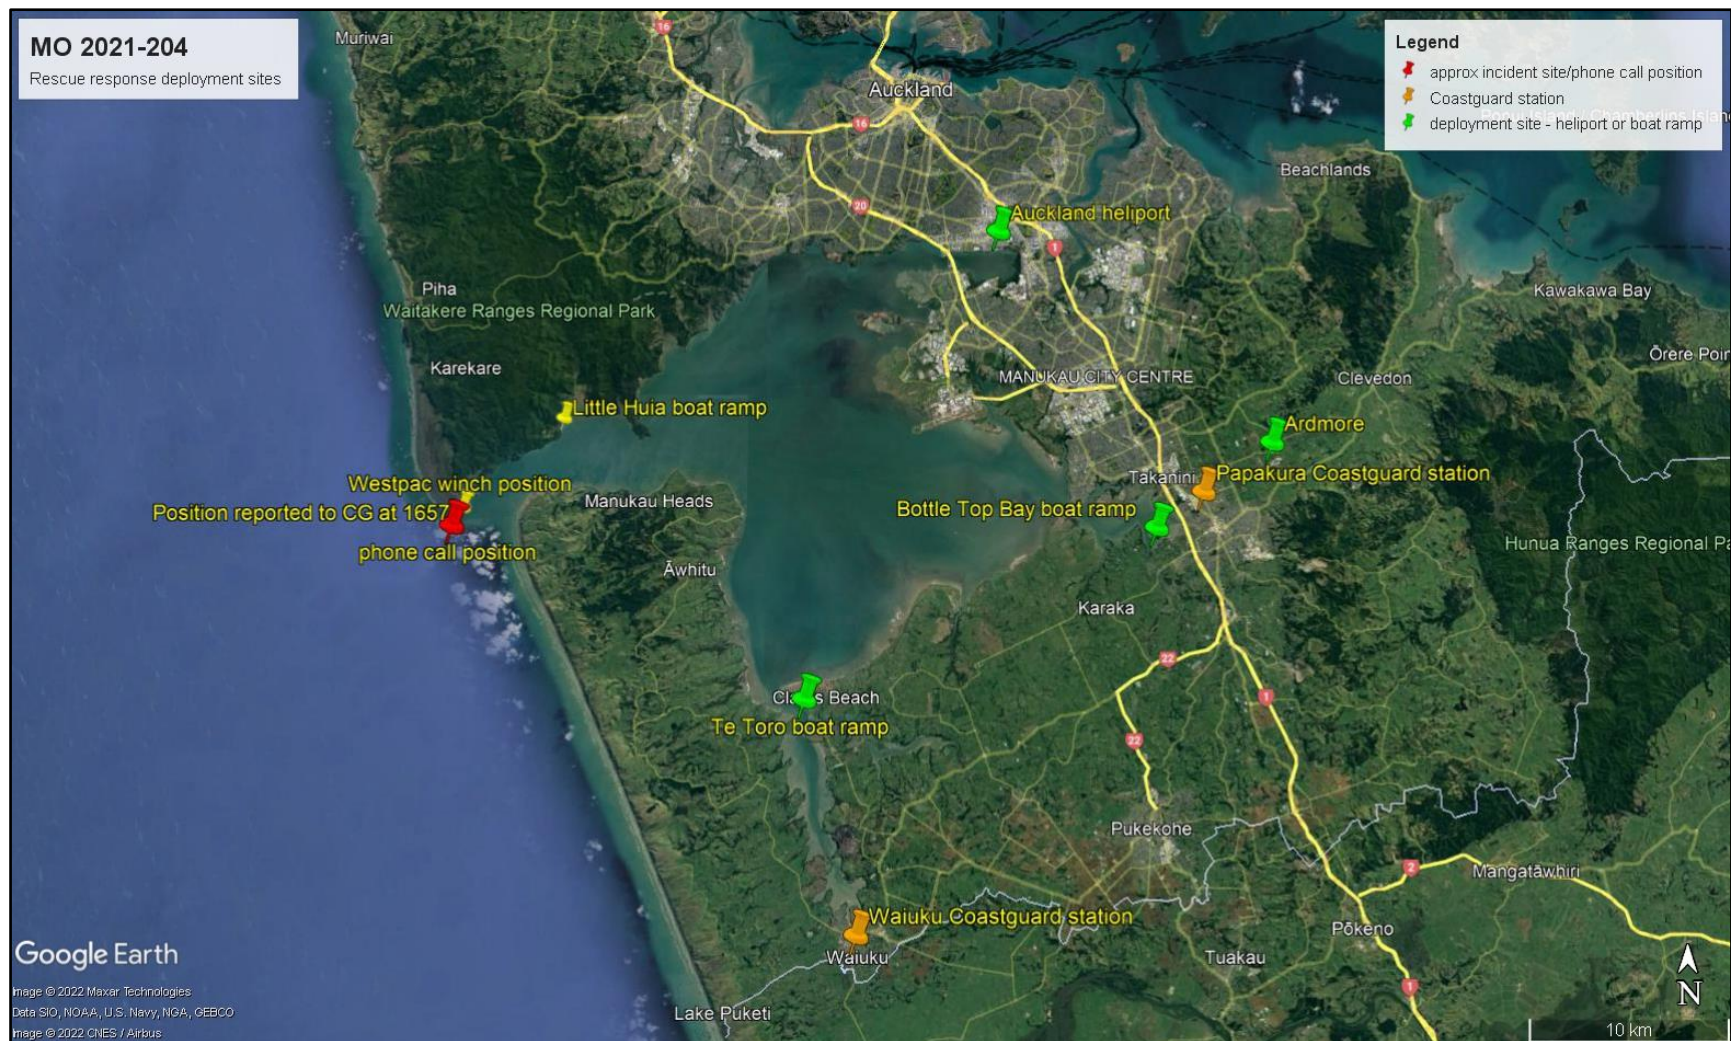
Figure 4: Rescue responder deployment sites around the Manukau Harbour

- 2.48 When not engaged in air ambulance services or Police work, Westpac Rescue⁵ and Police Eagle helicopters are well located to attend search and rescue missions in Auckland's west coast waters (see Figure 4). Each Westpac Rescue Helicopter is able to winch two persons from the water. Eagle helicopters do not have winching capabilities but can deliver rescue and flotation devices to persons in the water. If appropriate, a rescue swimmer can be dropped into water to aid survivors.

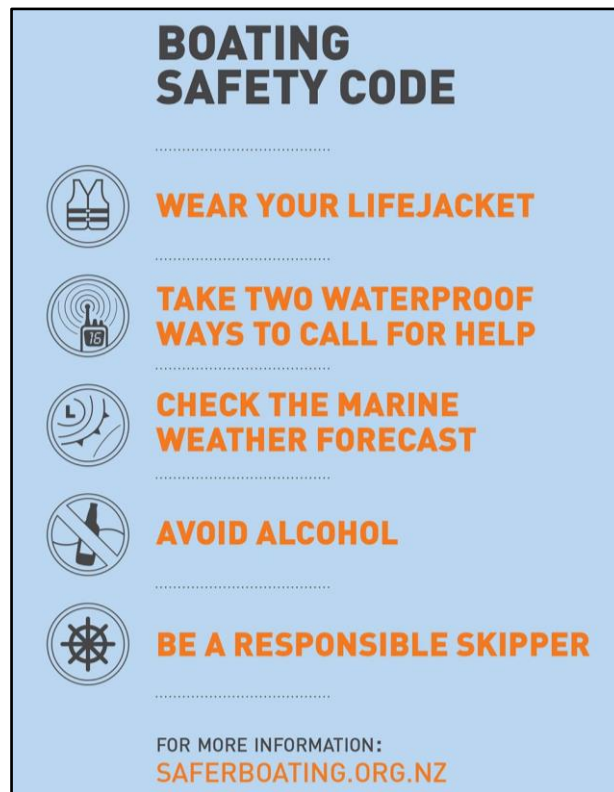
- 3.15 The role of a responsible skipper encompasses the first four items on the boating safety code list, as shown in Figure 6. By making informed decisions based on the intended voyage, the maritime area and the capabilities of the vessel and its equipment, the skipper can ensure that their boat and the people on it have the best chances of surviving an adverse event. Several factors reduced the survival capacity of the skipper and the passengers: their not wearing PFDs; their being tired from exertion and lack of food; the consumption of alcohol; and the boat not remaining afloat once it had been swamped.

Figure 6: Key safety messages used in current New Zealand boating safety campaigns

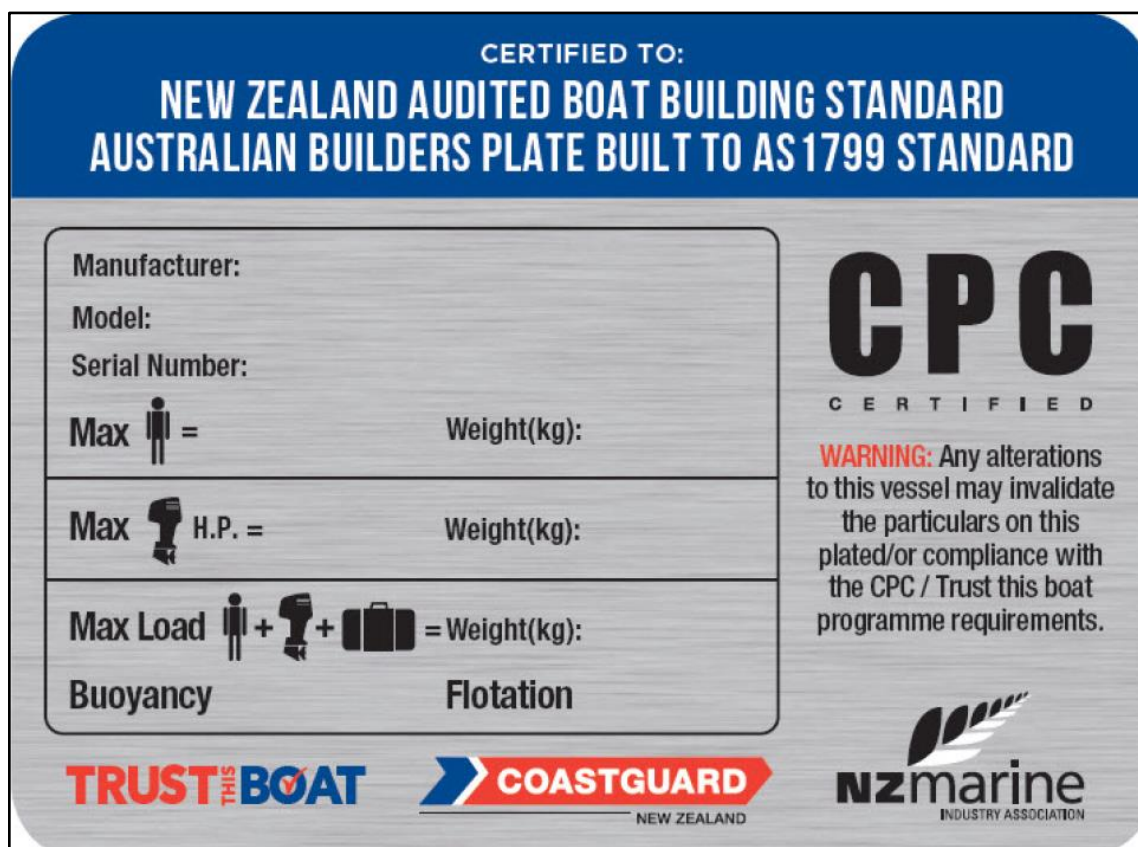
3.40 Newer vessels may have been built under the New Zealand Audited Boat Building Standard, which is a voluntary standard and safety initiative adopted by many New Zealand boat manufacturers. Vessels built using the Compliance Plate Certification (CPC) programme display CPC plates similar to that shown in Figure 10. The programme was introduced in 1999 and covers manufacturing processes, materials, construction methods and fuel and electrical systems. Vessels less than 6 metres in length must have enough reserve buoyancy to prevent their sinking if they are swamped. The buoyancy is provided by the installation of buoyant materials, distributed around the hulls to provide either basic¹⁹ or level flotation (see Appendix 1).

3.42 To maintain the CPC standard, a manufacturer must keep records of a vessel's ownership as well as maintenance, repairs and alterations. A compulsory and enduring record of a vessel's background is an important factor that is missing from the recreational boating sector in New Zealand. A boat is a large investment and most recreational skippers are likely to conduct their research diligently, but there is no guarantee that sub-standard older vessels will not be purchased or that newer vessels will be operated safely. Currently there are more than 400 boat-manufacturing companies in New Zealand and only about 20 participate in the CPC programme.

Figure 10: Example of a manufacturer's plate showing CPC programme compliance

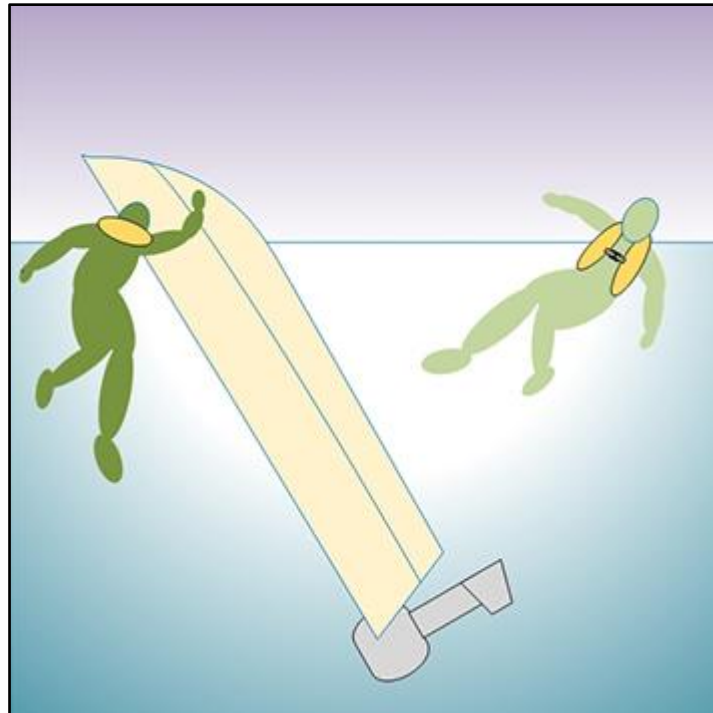
Figure 11: Basic flotation

Basic flotation ensures that a boat is fitted with enough flotation to keep the vessel floating in some form (typically upturned and largely submerged) in the case of swamping, flooding or capsizing. In this circumstance, the occupants will be partially submerged in the water, clinging to an upturned hull and risk becoming hypothermic.

Pictured: A vessel with basic flotation can end up largely submerged

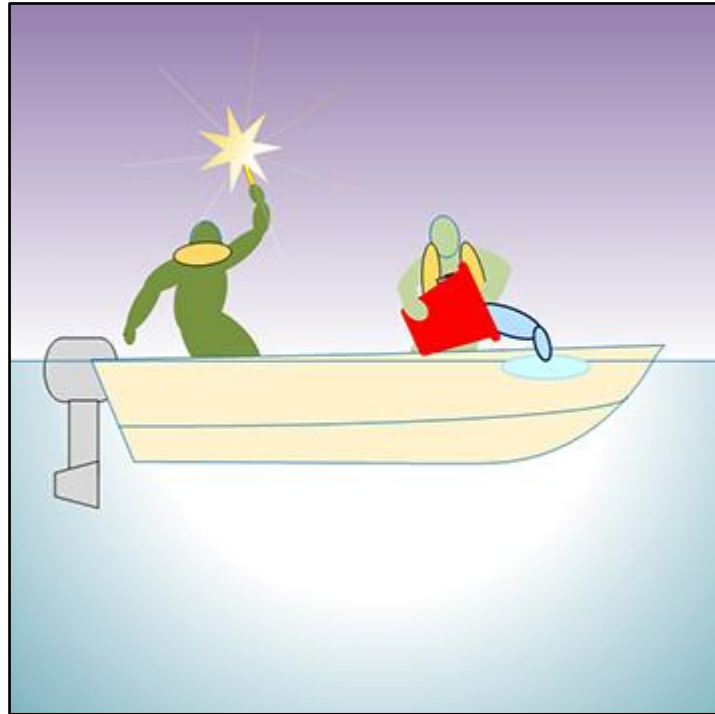
Figure 12: Level flotation

Level flotation ensures that a boat is fitted with adequate and well-located flotation, meaning the vessel should float level with the waterline, providing a safer place of refuge in the case of swamping, flooding or capsizing. If the vessel becomes swamped or flooded, it is less likely to capsize due to the location of buoyancy under the gunnels.²⁶

Pictured: A vessel with level flotation provides the best chance that occupants will not be submerged in water
