Transport Accident
Investigation
Commission

Final report

Maritime inquiry MO-2022-201
Charter fishing vessel Enchanter
Capsize
North Cape, New Zealand
20 March 2022

August 2023

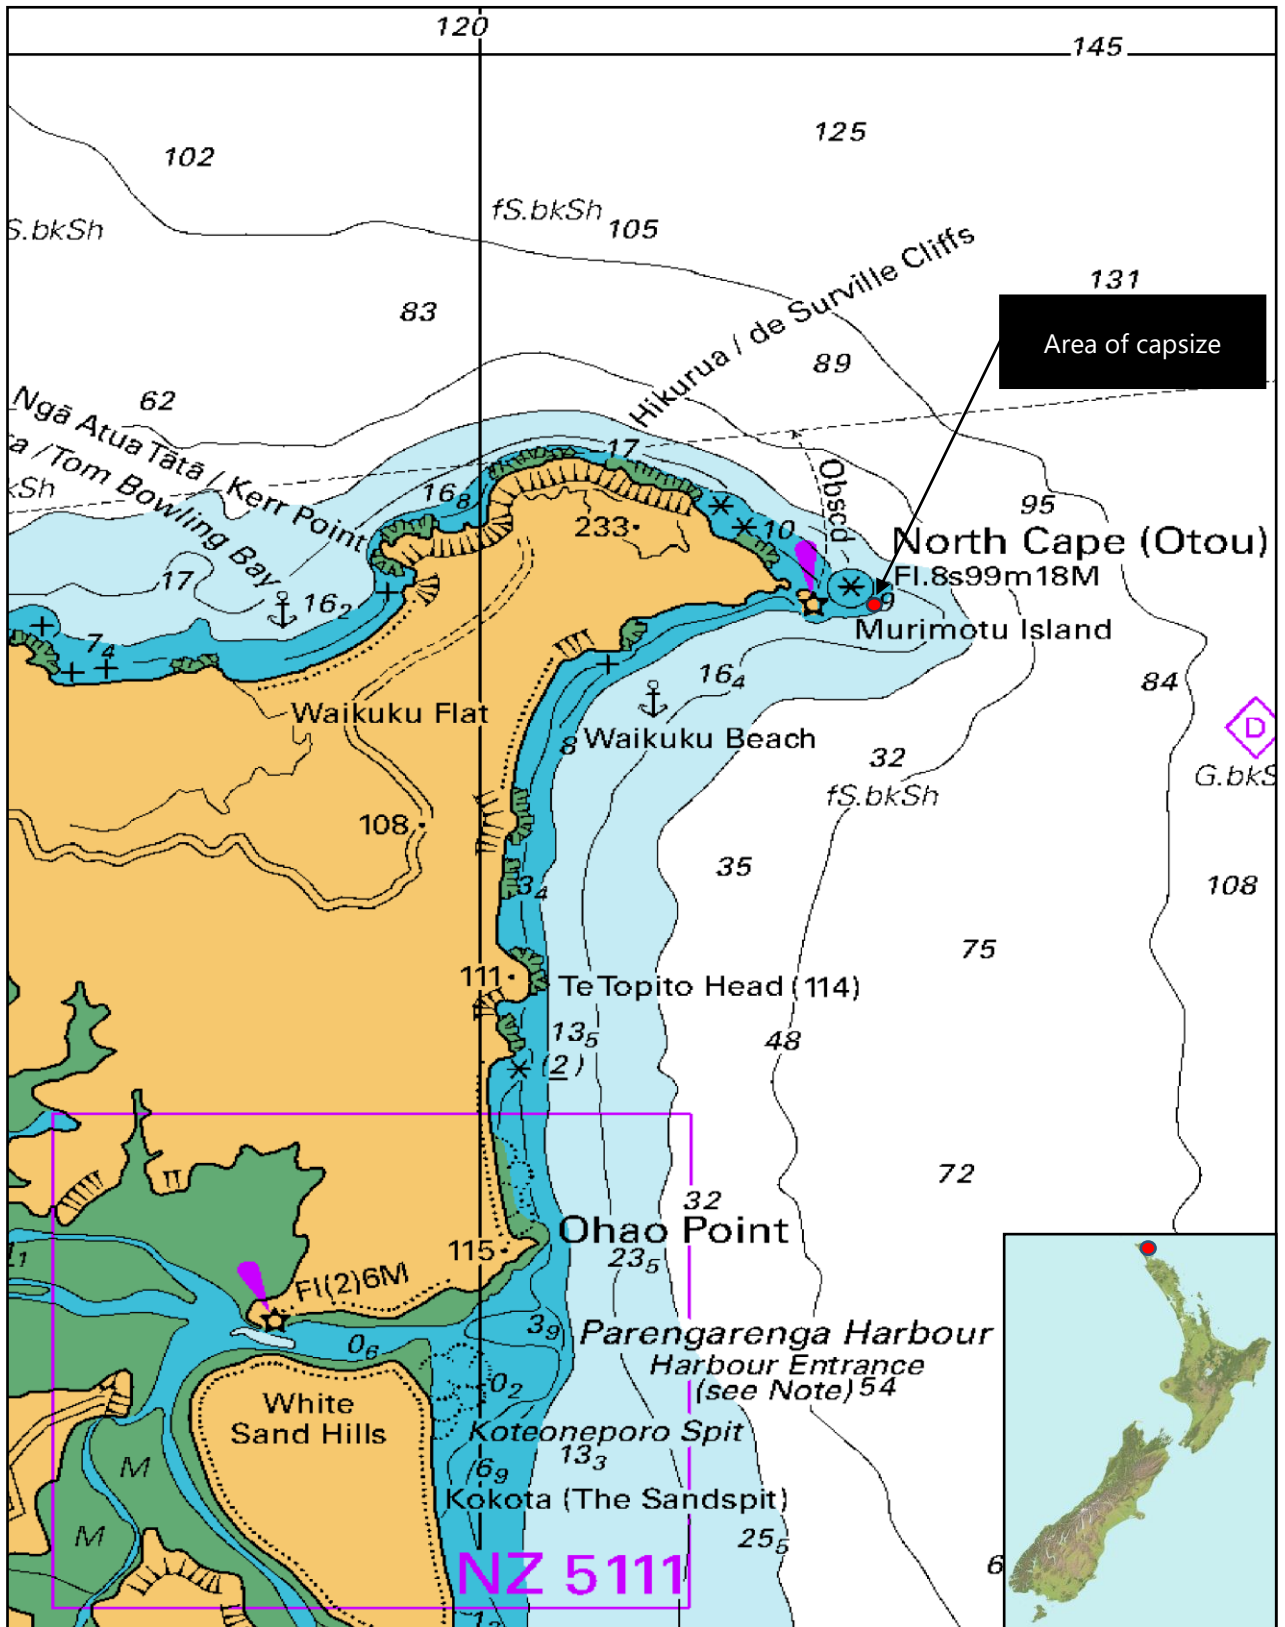
Figure 2: Area of capsized as calculated by the Commission

- 1.5 The *Enchanter* should easily have coped with the sea conditions off North Cape at the time of the accident. However, it is **about as likely as not** the vessel had strayed into shallower water off Murimotu Island, an area that is prone to occasional, naturally occurring, larger waves peaking as they entered the shallowing water.

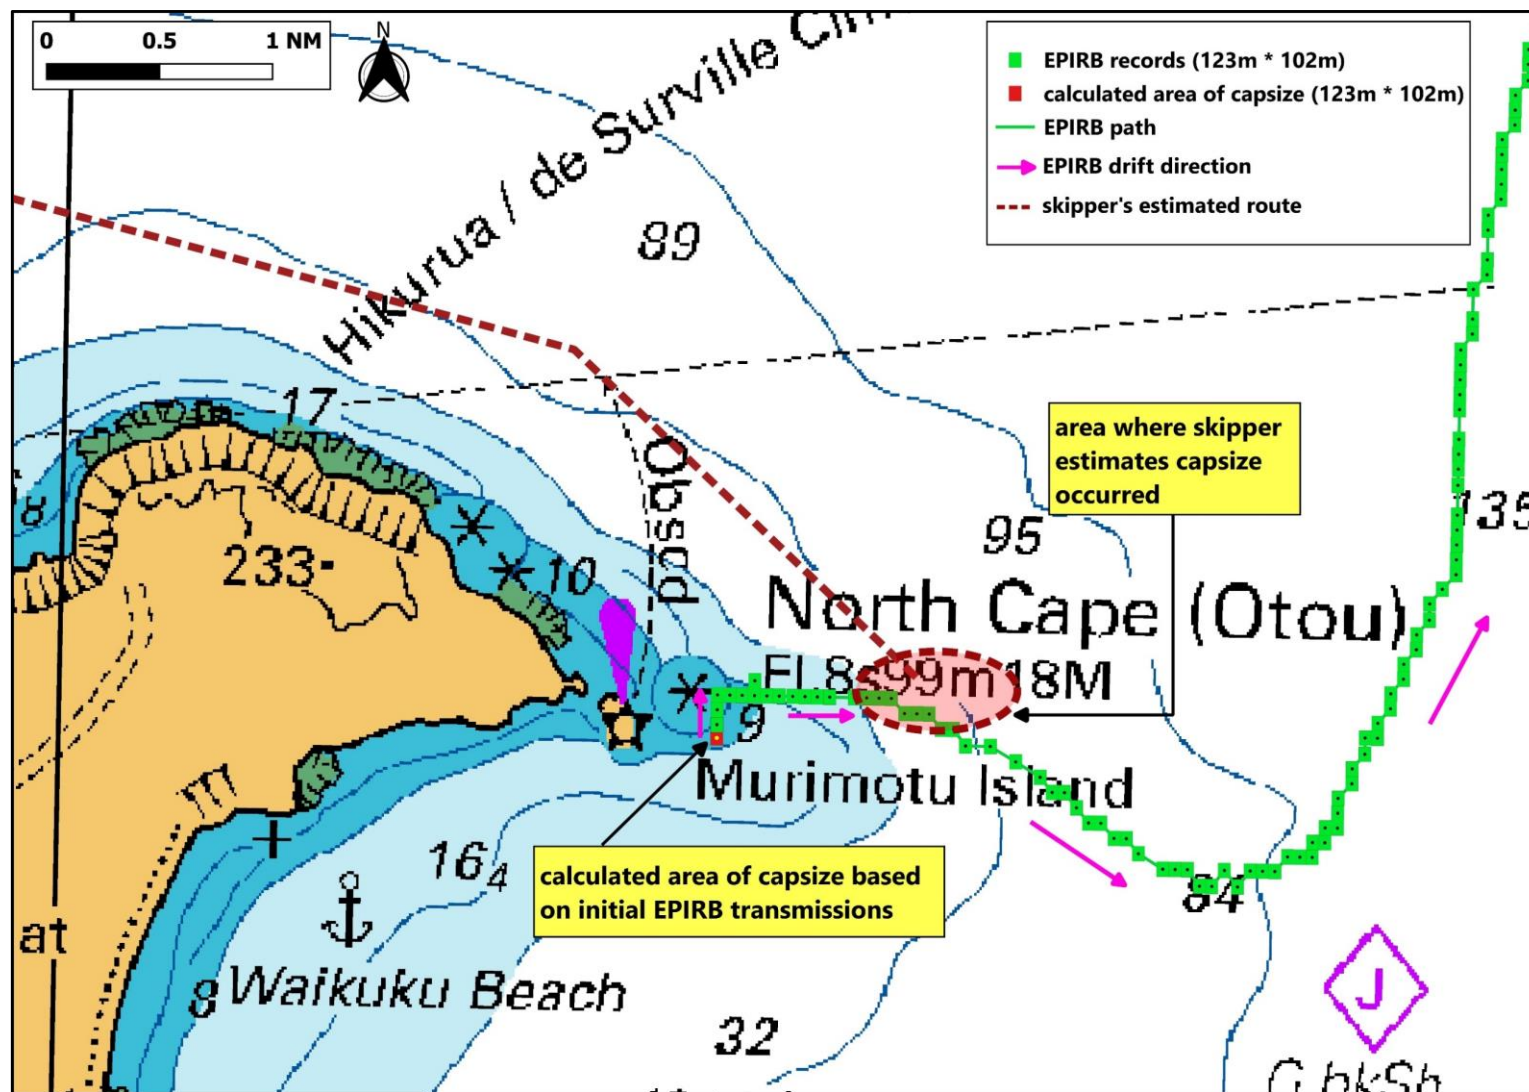
Figure 12: Part of Chart NZ51 showing the track of the EPIRB encoded GNSS positions (green rectangles, representing location area of certainty) and *Enchanter's* track as estimated by the skipper (red)

- 3.25 Using the encoded positions transmitted by the EPIRB, the initial drift of the flybridge was northward at about 0.14 knots. Taking into consideration the encoded positions area of certainty, as shown by the green rectangles in Figure 12, the EPIRB's rate of drift was between about 0.06 to 0.17 knots.

- 3.26 When considering all the factors that could affect the drift of the flybridge, the Commission concluded it was **about as likely as not** that its rate and direction of drift after the EPIRB had been activated was similar to the 30 minutes prior to the EPIRB being activated (noting the EPIRB was attached to the flybridge). Therefore, it is **about as likely as not** that the location of the capsized vessel would have been within an area about 0.07 nautical miles (about 130 metres) south of the first encoded position, as shown in Figure 12.

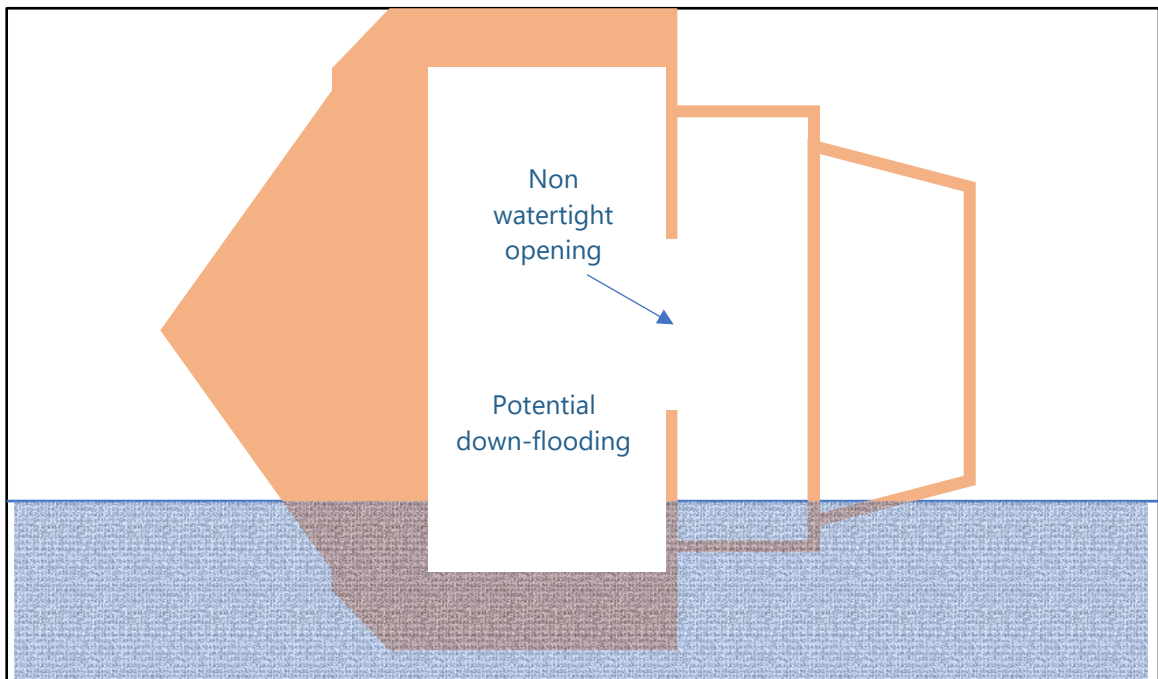
Figure 17: Representation of a vessel floating on its side with openings near the centreline (not to scale)

- 3.51 The naval architect conducting the stability analysis explained that the basis for considering the hull as watertight was that these openings would remain above the waterline when the vessel was heeled to its maximum angle before losing positive stability. The three main openings through which down-flooding could occur were all located around the centreline of the vessel and were calculated to be well above the waterline if the vessel were floating on its side (see Figure 17).

superstructure would have provided buoyancy and thus contributed to the dynamic stability of the vessel (see Figure 17). It is not possible to say definitively whether it would still have eventually capsized. That would depend on whether the vessel righted itself with successive waves and what openings there were in the superstructure to allow seawater to invade the saloon space – for example, open windows and the main rear door.

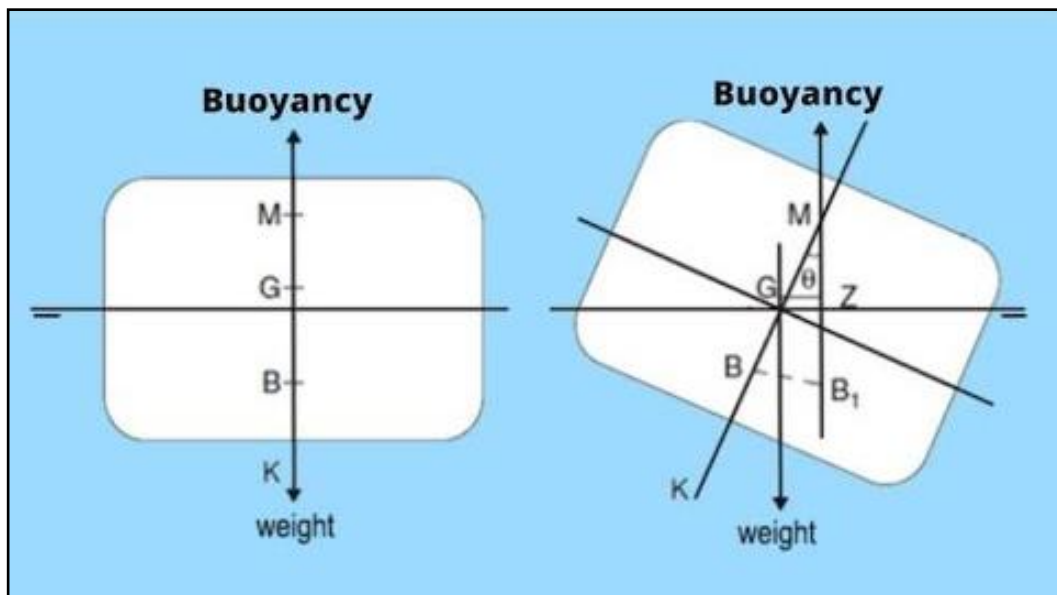
Figure 28: Relationship between buoyancy, weight and centre of gravity

- 2.1 Part of a stability analysis is to calculate what is called a GZ Curve. GZ is the theoretical righting lever that forces a vessel back upright when it is heeled by any forces such as wind and waves. The longer the GZ lever, the more force is imparted to return the vessel upright. If a vessel has a negative GZ righting lever, then the force is acting to capsize the vessel rather than returning it upright. In Figure 28, when the vessel is upright (left) the upward thrust of buoyancy (**B**) is equal to and vertically aligned with the downward weight acting through the vessel's centre of gravity (**G**). The vessel is floating in equilibrium when force of **G** equals **B**.

- 2.2 When the vessel heels due to wind and/or waves (right), the position of the vessel's centre of gravity (**G**) remains the same but the position of the centre of buoyancy moves across to the new centroid of the underwater volume (**B1**). The upward thrust through **B1** is no longer aligned with **G**. A righting lever (GZ) is thus created, which in this case tries to return the ship upright until **G** and **B** align again. The length of the righting lever GZ changes as the vessel heels through a range of angles.

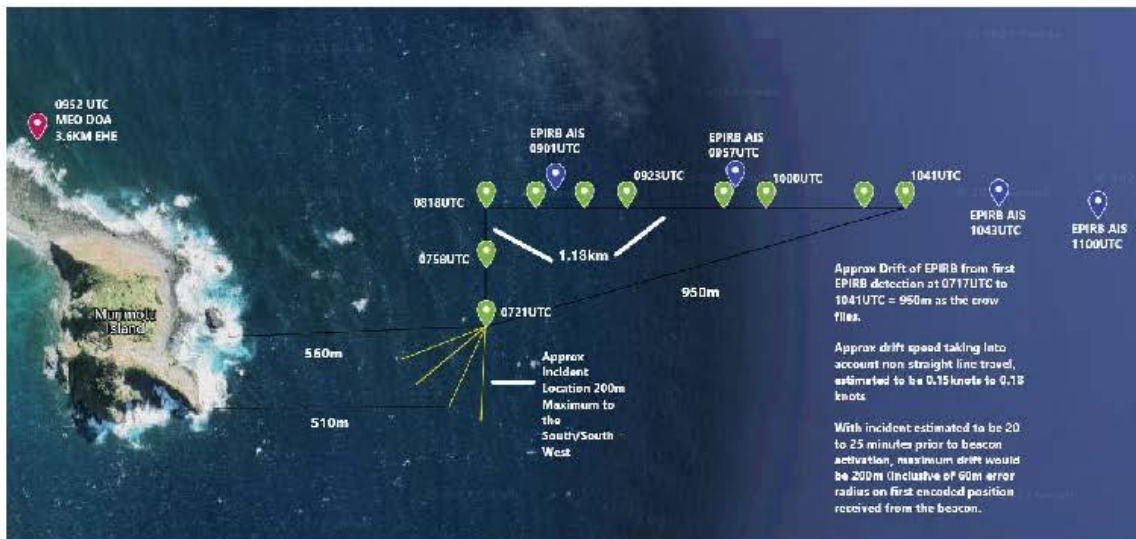
Image 1

- The above image shows a plot of encoded positions and AIS transmission from the EPIRB for the first 3.5 hours. The first plot at 0721 UTC provides a position approx. 560 metres off shore (with a 60 metre error radius to be applied around the position).
- Noting a very straight line drift of the encoded position, this is due to the limitations of COSPAS-SARSAT data processing, and limiting the encoded position to 2 decimal places on the SIT 185 sent to RCCNZ, which rounds the positions up or down.

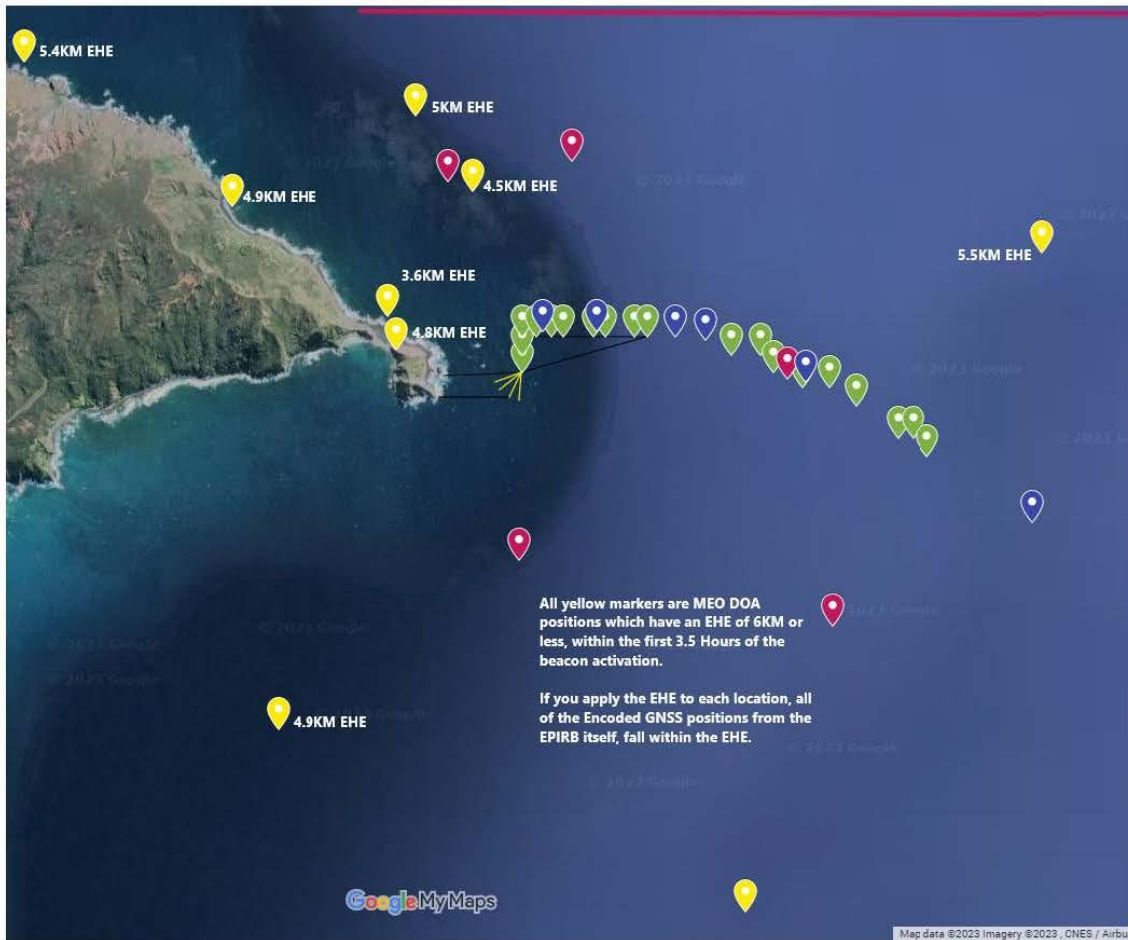
Image 2

- To provide context, the yellow markers indicate MEOSAR DOA positions (independent of the EPIRBs GNSS position) which have an EHE of less than 6 kilometres. These position were all received within the first 3.5 hours of the beacon activation, and when you apply their relevant EHE, the GNSS position with the same timestamp is encompassed with the radius of the EHE.
- The pink location markers on this image indicate positions which provided an EHE of more than 6km, which still encompasses their corresponding encoded positions provided by the beacon.

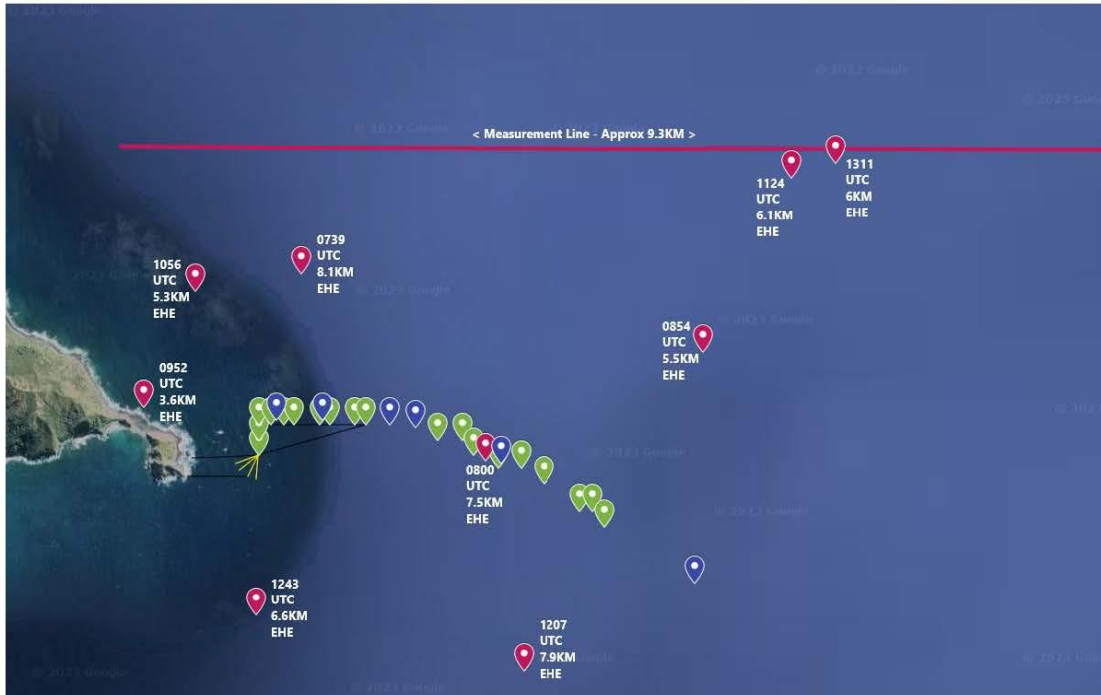
- Image 3 provides further MEOSAR independent hits including positions with an EHE greater than 6 kilometres.
- The pink line at the top of the image measures approx. 9.3km, to give context to the EHE provided, which shows that the EPIRBs GNSS position is inside the radius of all MEO DOA positions.

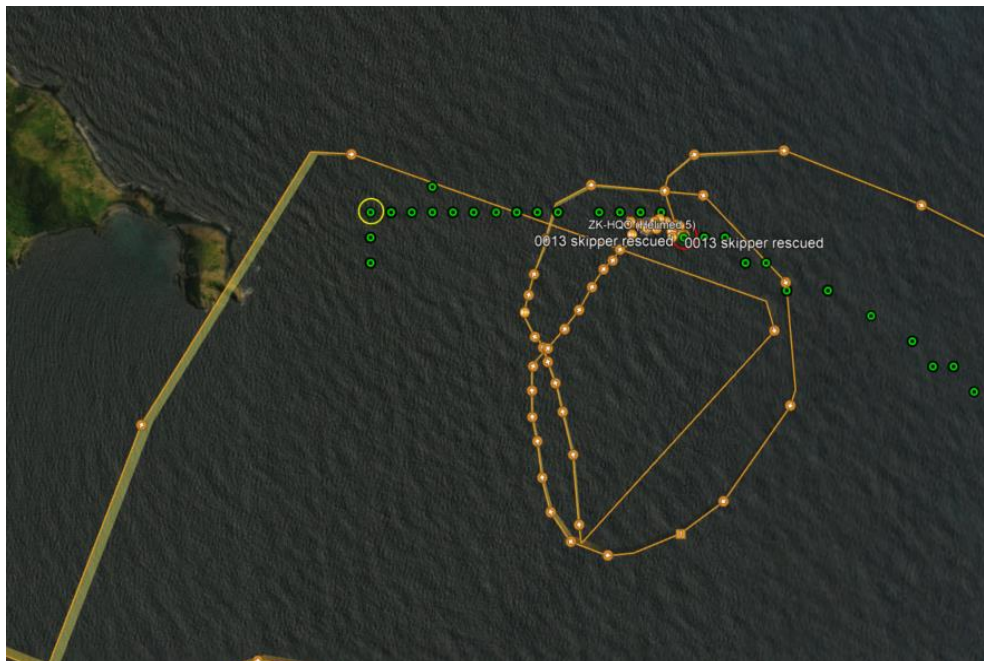
Figure 33: Flight data showing helicopter hovering over EPIRB encoded position (green dots)

Flight data from the rescue helicopter confirms that the first rescue helicopter on scene retrieved the three survivors from the flybridge within 61 metres of the EPIRB's encoded position (see Figures 33 and 34).

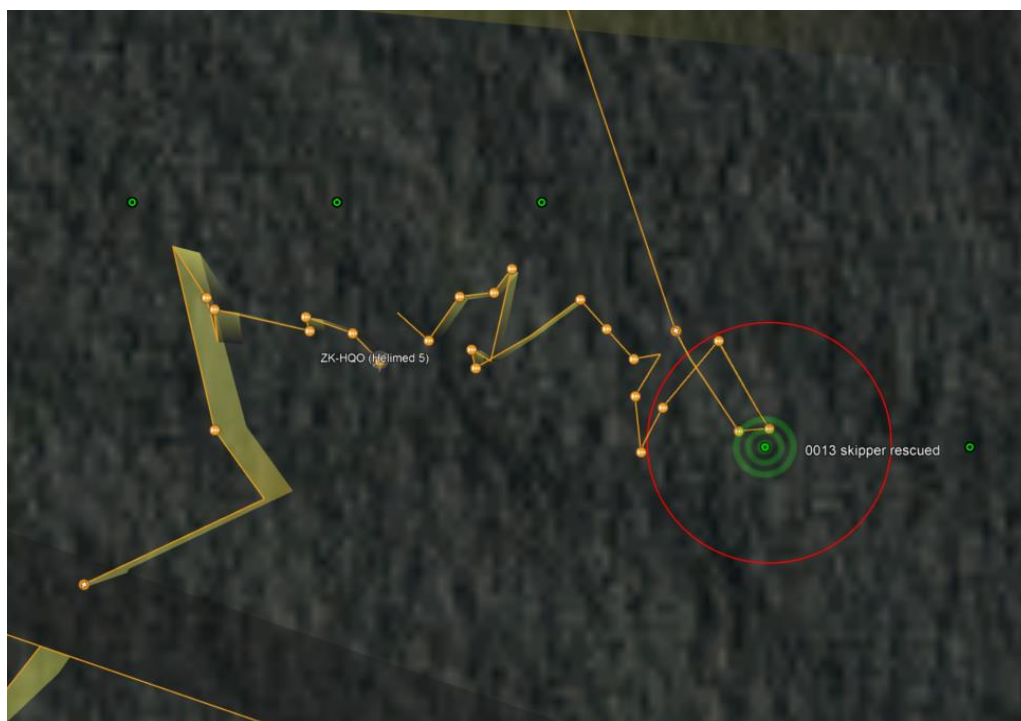
Figure 34: Close up of helicopter flight path hovering over EPIRB encoded position (green dot). Red circle indicates the 61-metre accuracy around the EPIRB encoded position at 0013
