Transport Accident
Investigation
Commission

**Report of the Transport Accident Investigation Commission into
two stevedoring accidents in April 2022**

***Maritime inquiry MO-2022-203
Container vessel, Capitaine Tasman
Stevedore fatality during container loading operations
Port of Auckland
19 April 2022***

***Maritime inquiry MO-2022-202
Bulk carrier, ETG Aquarius
Stevedore fatality during coal loading operations
Lyttelton Port
25 April 2022***

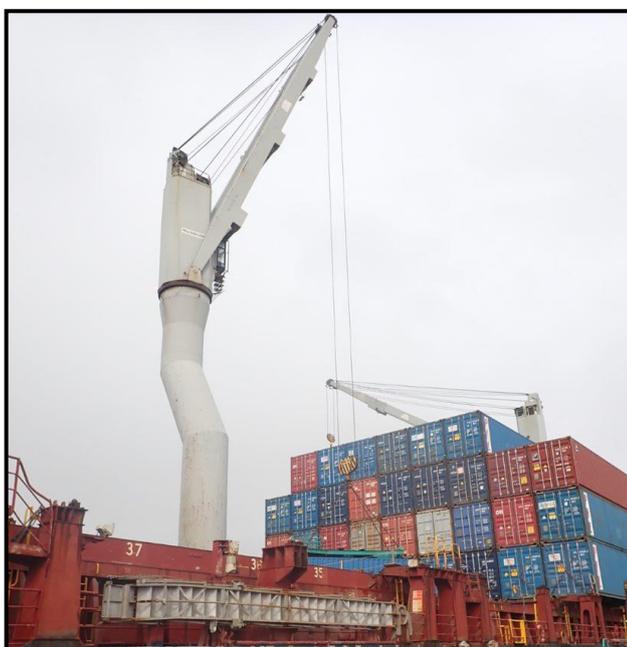
Figure 13: Crane number three

- A1.32. The vessel's cargo-handling equipment consisted of three onboard cranes. Each crane was operated from a cab that was accessed via internal ladders within the crane pedestals.
- A1.33. Each crane had the ability to slew⁵⁹ 360 degrees and had a safe lifting weight of 45 tonnes. Crane number three (see Figure 13) had a work radius⁶⁰ of 3.5 metres to 29.0 metres and the maximum hoist speed with a load was 19 metres per minute.

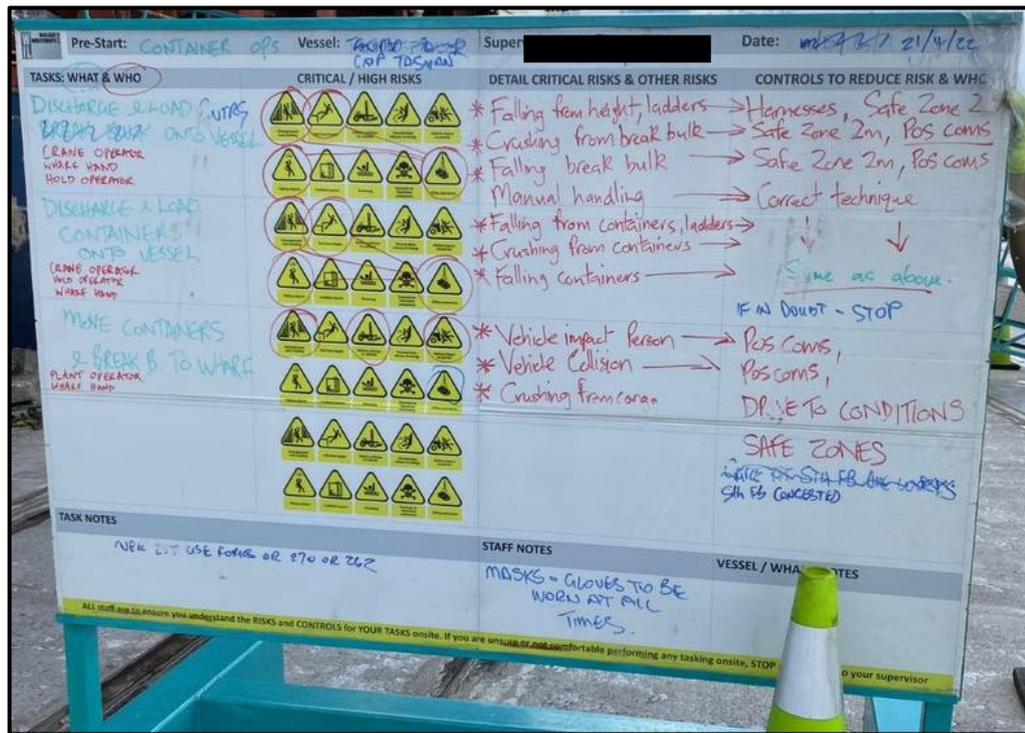
Figure 14: Pre-start meeting board
(Credit: Wallace Investments Limited)

- A1.61. The supervisors overseeing the gangs conducted pre-start meetings at the beginning of every shift on an operational worksite. Critical risks associated with each role within the gang were identified along with the applicable lifesaver controls. The briefings were recorded on a whiteboard and were photographed and uploaded to Mango for safety assurance purposes. The pre-start board for 19 April 2022⁷³ is shown in Figure 14.

⁷³ The date on the board has been changed to reflect the pre-start briefing which took place when operations resumed following the accident, however, the content remains the same as it was on the morning of the event.

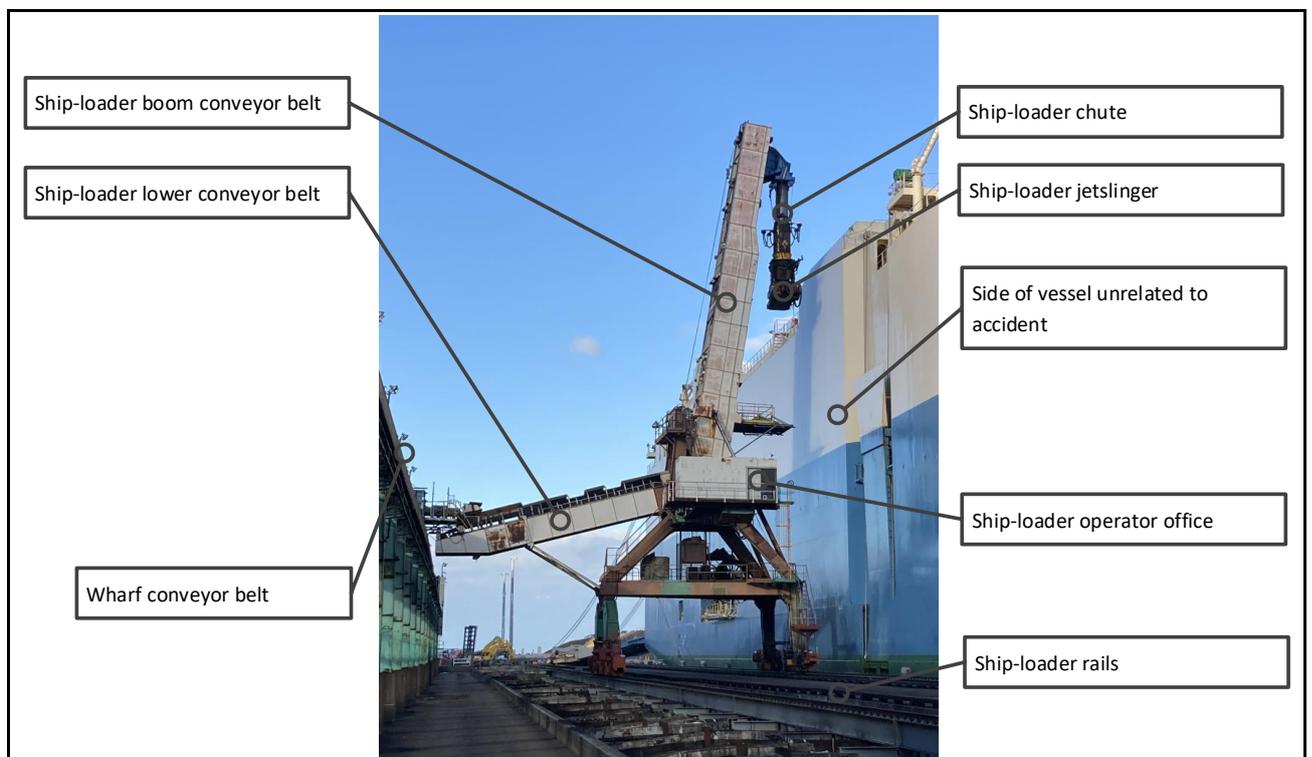
Figure 16: LPC ship-loader in its stowed position next to a car carrier vessel

- B1.4. Lyttelton Port has a coal stockpile facility and coal loading operation. The coal was moved from the stockpile to the vessel via conveyor belts. The final stage of the process, loading coal into the vessel's hold, used specialist equipment known as a ship-loader.
- B1.5. The ship-loader travelled on rails parallel to the edge of the wharf. The wharf conveyor belt fed coal onto the ship-loader lower conveyor belt, which then fed the coal onto the boom conveyor belt, which in turn fed it into the loader chute, from which it passed out through the jetslinger and into the ship's hold (see Figure 16 and Figure 17).
- B1.6. The jetslinger incorporated a short conveyor belt moving at high speed to direct the coal in the direction and elevation required.

- B1.12. The ship-loader operator made their way to the ship-loader operator office within the ship-loader (see Figure 16) and at about 0700, after a limited handover from the ship-loader operator going off-shift, they assumed control of the ship-loader. The signalman had made his way onboard the vessel and began their shift at about 0700.

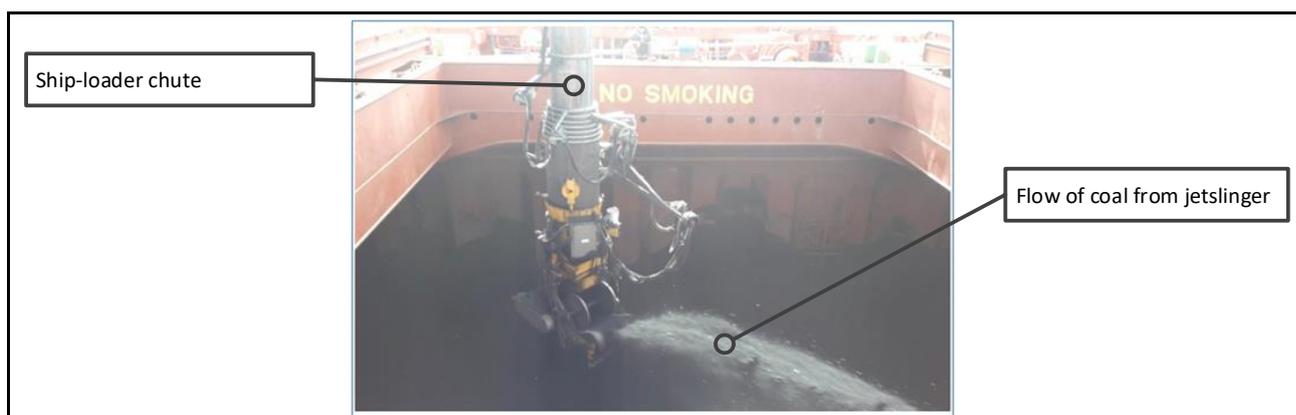
Figure 17: Jetslinger in operation, loading coal onto a different vessel

- B1.16. Throughout the loading process, coal was flowing from the jetslinger (see Figure 17) continuously. Usually, the flow of coal was only stopped by the ship-loader operator when it was necessary to move the ship-loader between cargo holds.
