# **Final Report**

***Maritime inquiry MO-2022-206***  
***Charter fishing vessel, i-Catcher***  
***Capsize***  
***Goose Bay, New Zealand***  
***10 September 2022***

**April 2025**

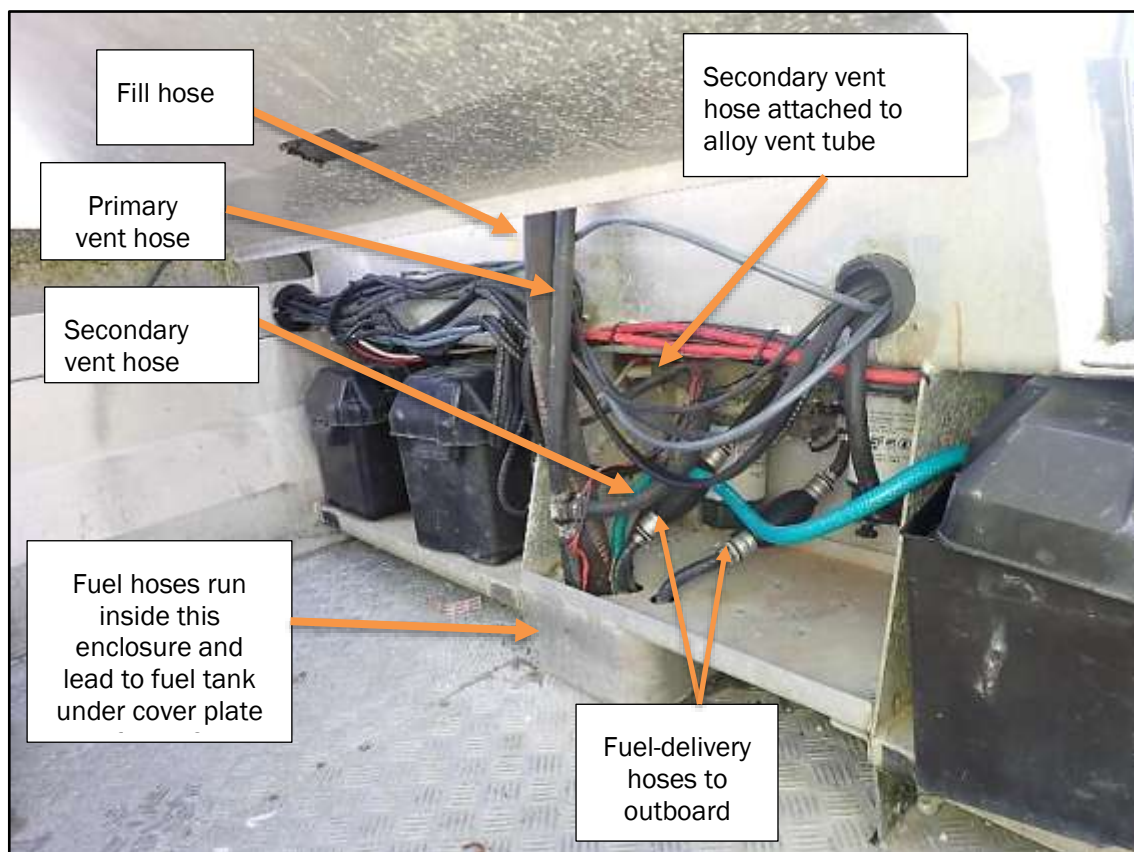
**Figure 10: The *i-Catcher's* fuel system components (after accident)**

- 2.60. Initial inspection of the fuel system revealed a hole measuring approximately 12 mm x 6 mm in the alloy vent tube used as a secondary fuel vent (see Figure 11). The alloy vent tube was situated above the battery cluster switch located within the interior of the stern of the vessel (see Figure 12).

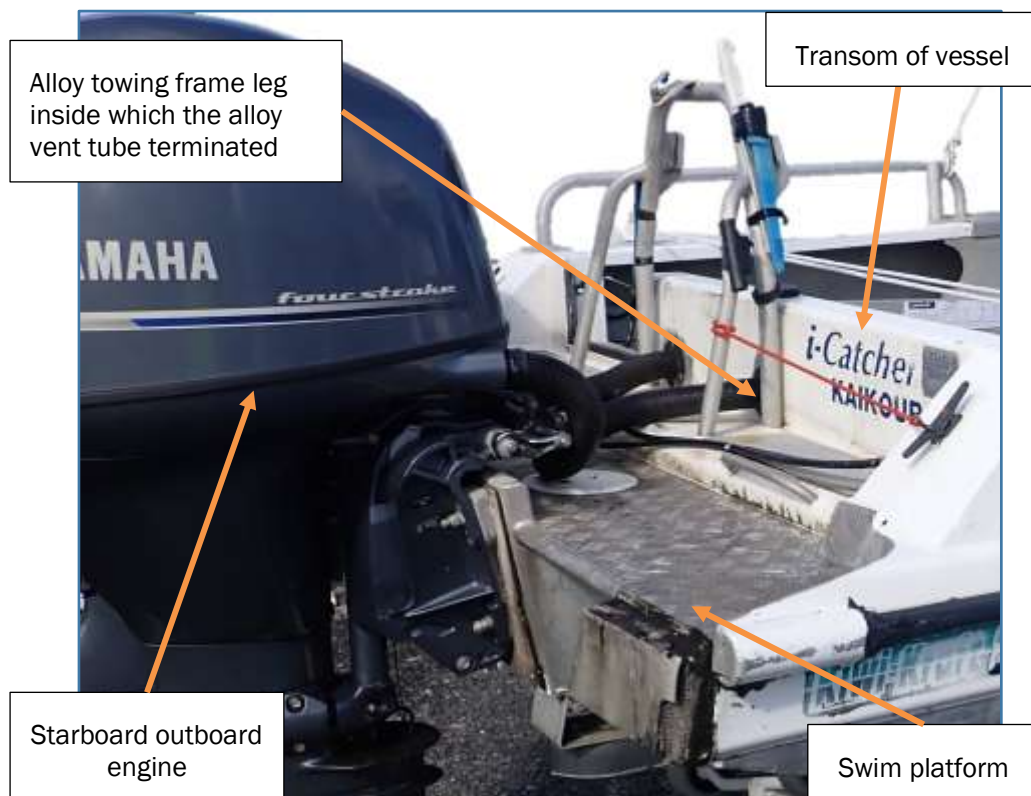
**Figure 15: Alloy towing frame on stern**

- 2.62. The alloy vent tube terminated inside an alloy towing frame on the transom just forward of the swim platform (see Figure 14 and Figure 15). A pressure test of the alloy frame revealed that it was closed off from the atmosphere, preventing fuel vapours from venting to open air and rendering it ineffective as a fuel-tank vent.

Alloy towing frame leg inside which the alloy vent tube terminated

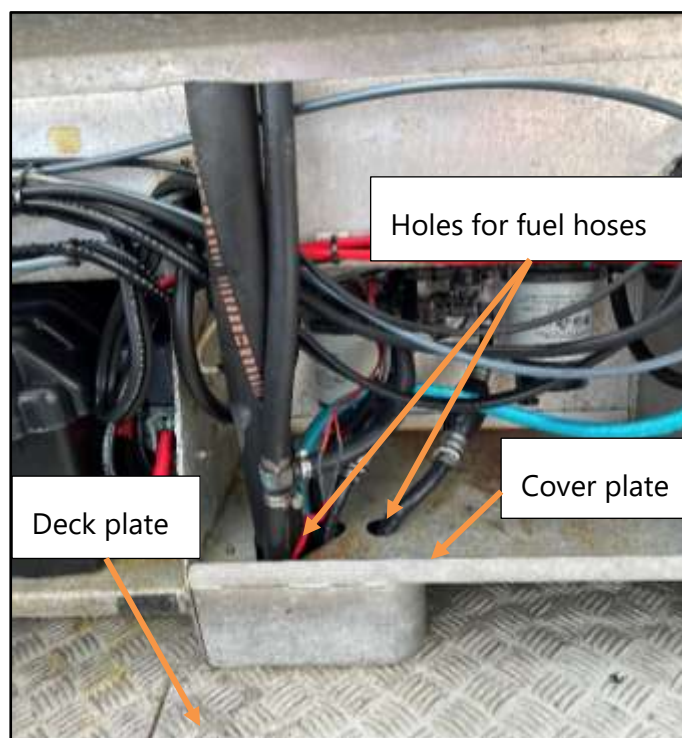
**Figure 16: Disassembly of fuel system for TAIC inspection**

- 2.63. The vessel's fuel-delivery hoses ran from the fuel tank through two holes in a cover plate (see Figure 16)

- 2.64. To enable inspection of the fuel tank and its connections, investigators removed the cover plate and the deck plate and partially disassembled the fuel system. Upon disassembly, investigators found the primary vent hose was not secured with a hose clamp, a critical component to ensure a secure connection to the fuel tank (see Figure 17).
- 2.65. A sealant had been applied around the plating where the fuel and vent hoses connected to the fuel tank. It was observed that a portion of the sealant had broken away, leaving a section of the primary vent hose connection exposed. The fuel tank and its fuel hoses were pressure-tested by Commission investigators, which revealed a leak from the base of the primary vent hose.

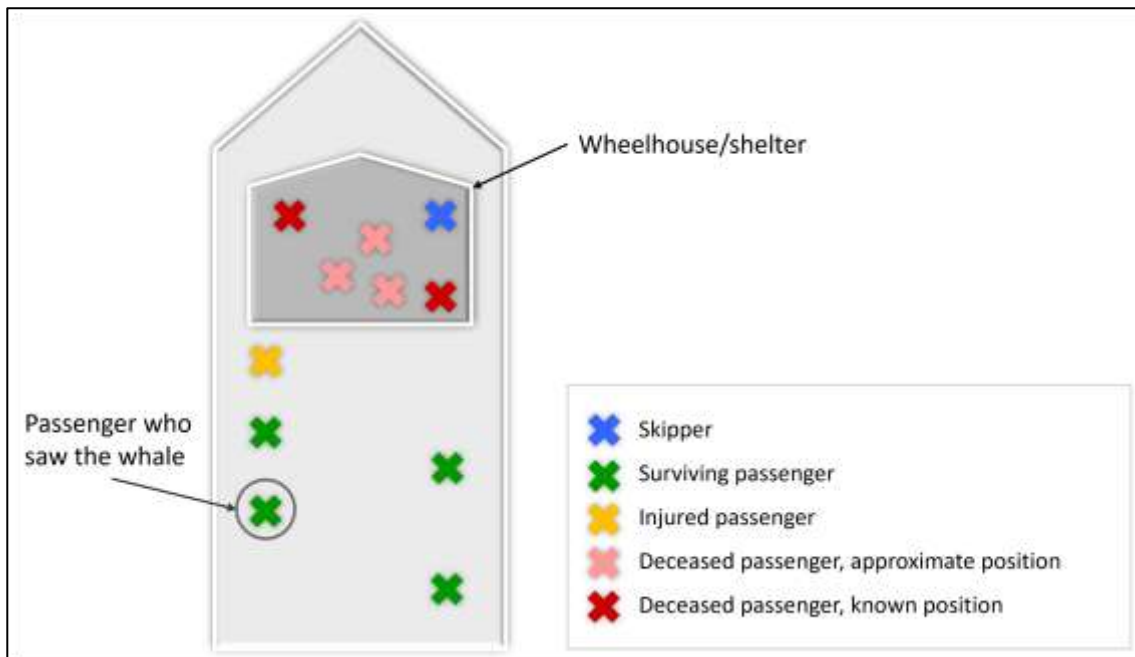
**Figure 22: Likely position of passengers immediately before capsizing**

- 3.6. Immediately before the accident, the passengers were evenly distributed throughout the vessel, having minimal impact on vessel stability (see Figure 22). The skipper was seated at the helm on the starboard side of the wheelhouse.
- 3.7. Passengers were generally limited to five people each side because of the size of the vessel. When wildlife was sighted nearby, the skipper would turn the vessel 180° allowing for both port and starboard side passengers to view and photograph the wildlife.
- 3.8. All five surviving passengers were located on the aft deck on the port and starboard sides. Survivors recalled that all the deceased passengers were located under the shelter of the wheelhouse before the capsize.

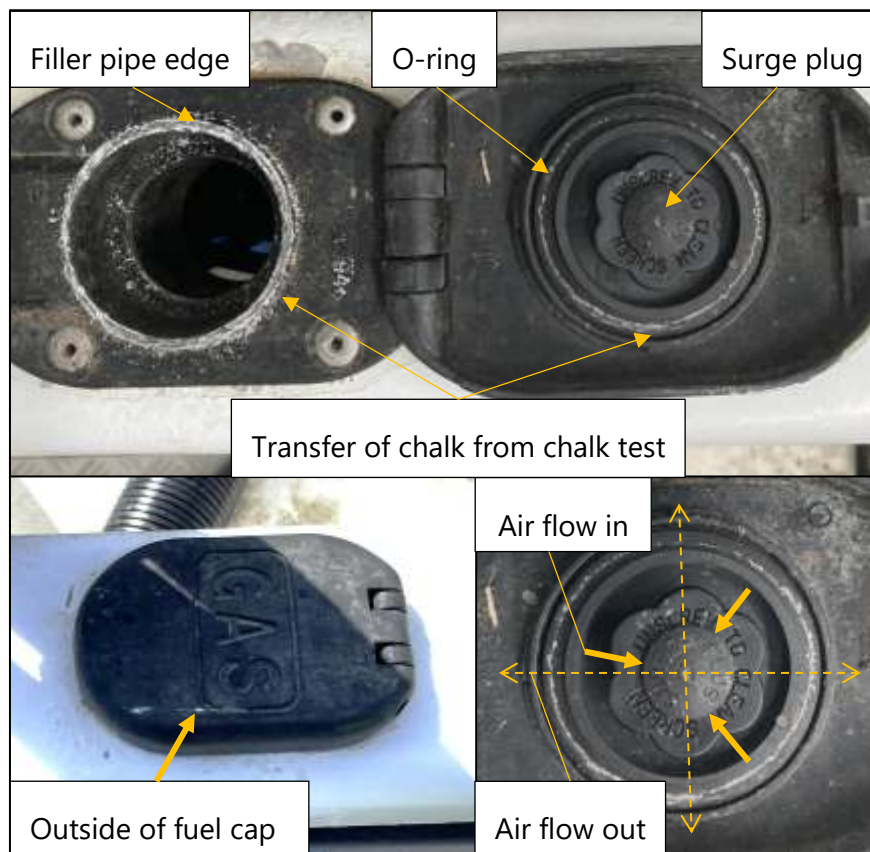
**Figure 27: Fuel cap components**

- 3.22. For the cap to seal, it requires that the surge plug is depressed, and the O-ring completes a seal with the edge of the filler pipe (see Figure 27). When inverted, head pressure from the fuel will apply a downward force on the surge plug and fuel cap, which may break the seal.

- 3.24. Commission investigators tested the seal of the fuel cap's O-ring by conducting a chalk test. The chalk test revealed that when the cap was closed, the O-ring contacted the entire edge of the filler pipe (see Figure 27).
- 3.25. If the fuel cap had leaked, a significant petrol sheen would have been visible outside the hull by the outboard motors and swim platform. Survivors who were sitting on the upturned hull for nearly forty minutes while awaiting rescue, reported seeing very little fuel in the water. Therefore, it is **unlikely** that the fuel cap contributed to the fuel leak.

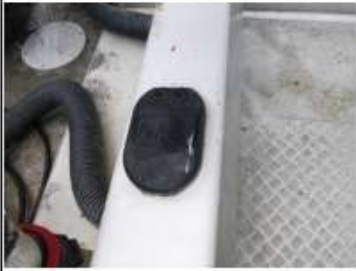
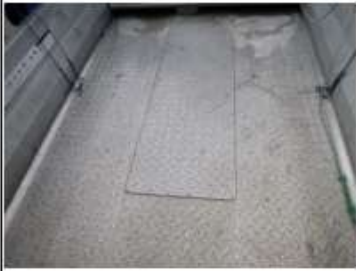
**Figure 29: Example of survey report fuel system description for *i-Catcher***

- 3.45. All *i-Catcher's* survey reports provided minimal description of the vessel's fuel system and did not include details of any inspection of the fuel system below the deck plate (see Figure 29). Similarly, the survey reports did not identify that the secondary fuel tank vent was ineffective.
