Transport Accident  
Investigation  
Commission

# **Final report**

***Maritime inquiry MO-2023-206***  
***Fishing vessel, Austro Carina***  
***Stranding at Red Bay, Banks Peninsula***  
***24 September 2023***

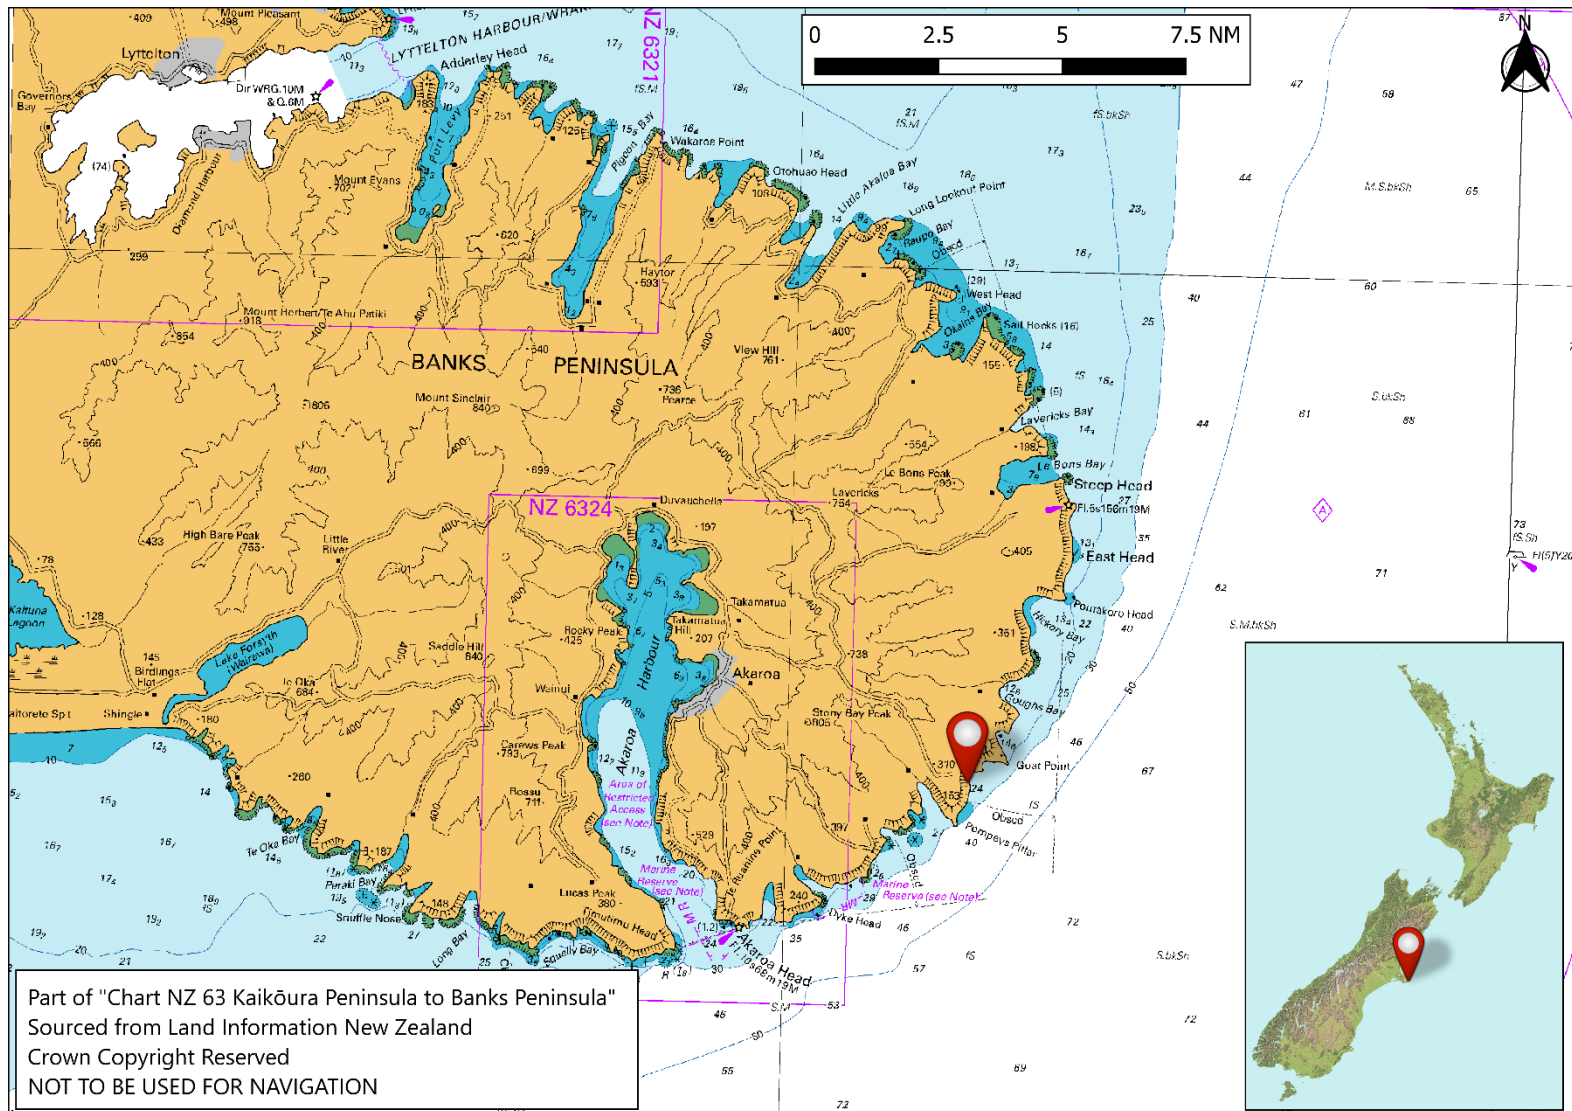
Figure 2: Location of accident

- 1.1. On 24 September 2023, at about 2137, the *Austro Carina* stranded<sup>1</sup> while fishing at Red Bay, Banks Peninsula. The vessel suffered extensive damage and was unsalvageable. It was subsequently declared a constructive total loss<sup>2</sup> by the insurer.
- 1.2. The four crew members abandoned the vessel and were rescued by helicopter and returned to Christchurch.
