Final report Tuhinga whakamutunga

Maritime inquiry MO-2024-203 Fishing vessel, Chokyu Maru No.68 Grounding The Noises, Hauraki Gulf 16 April 2024

June 2025

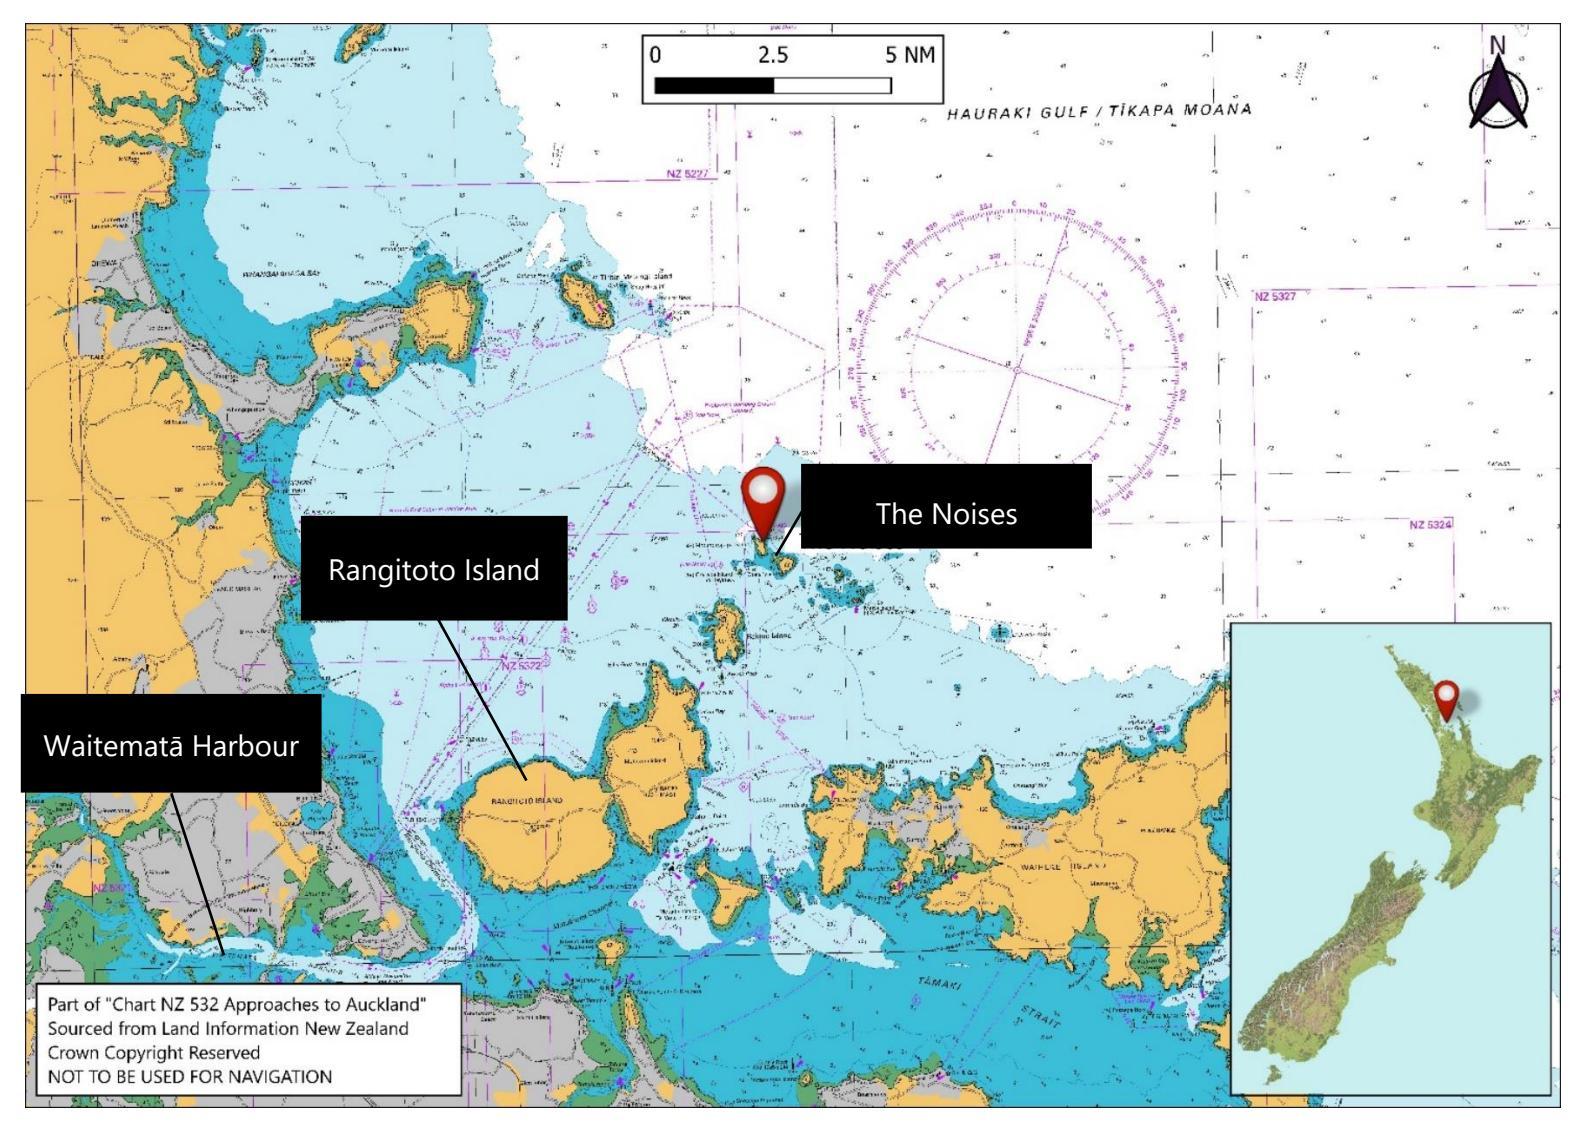
Figure 2: Location of accident

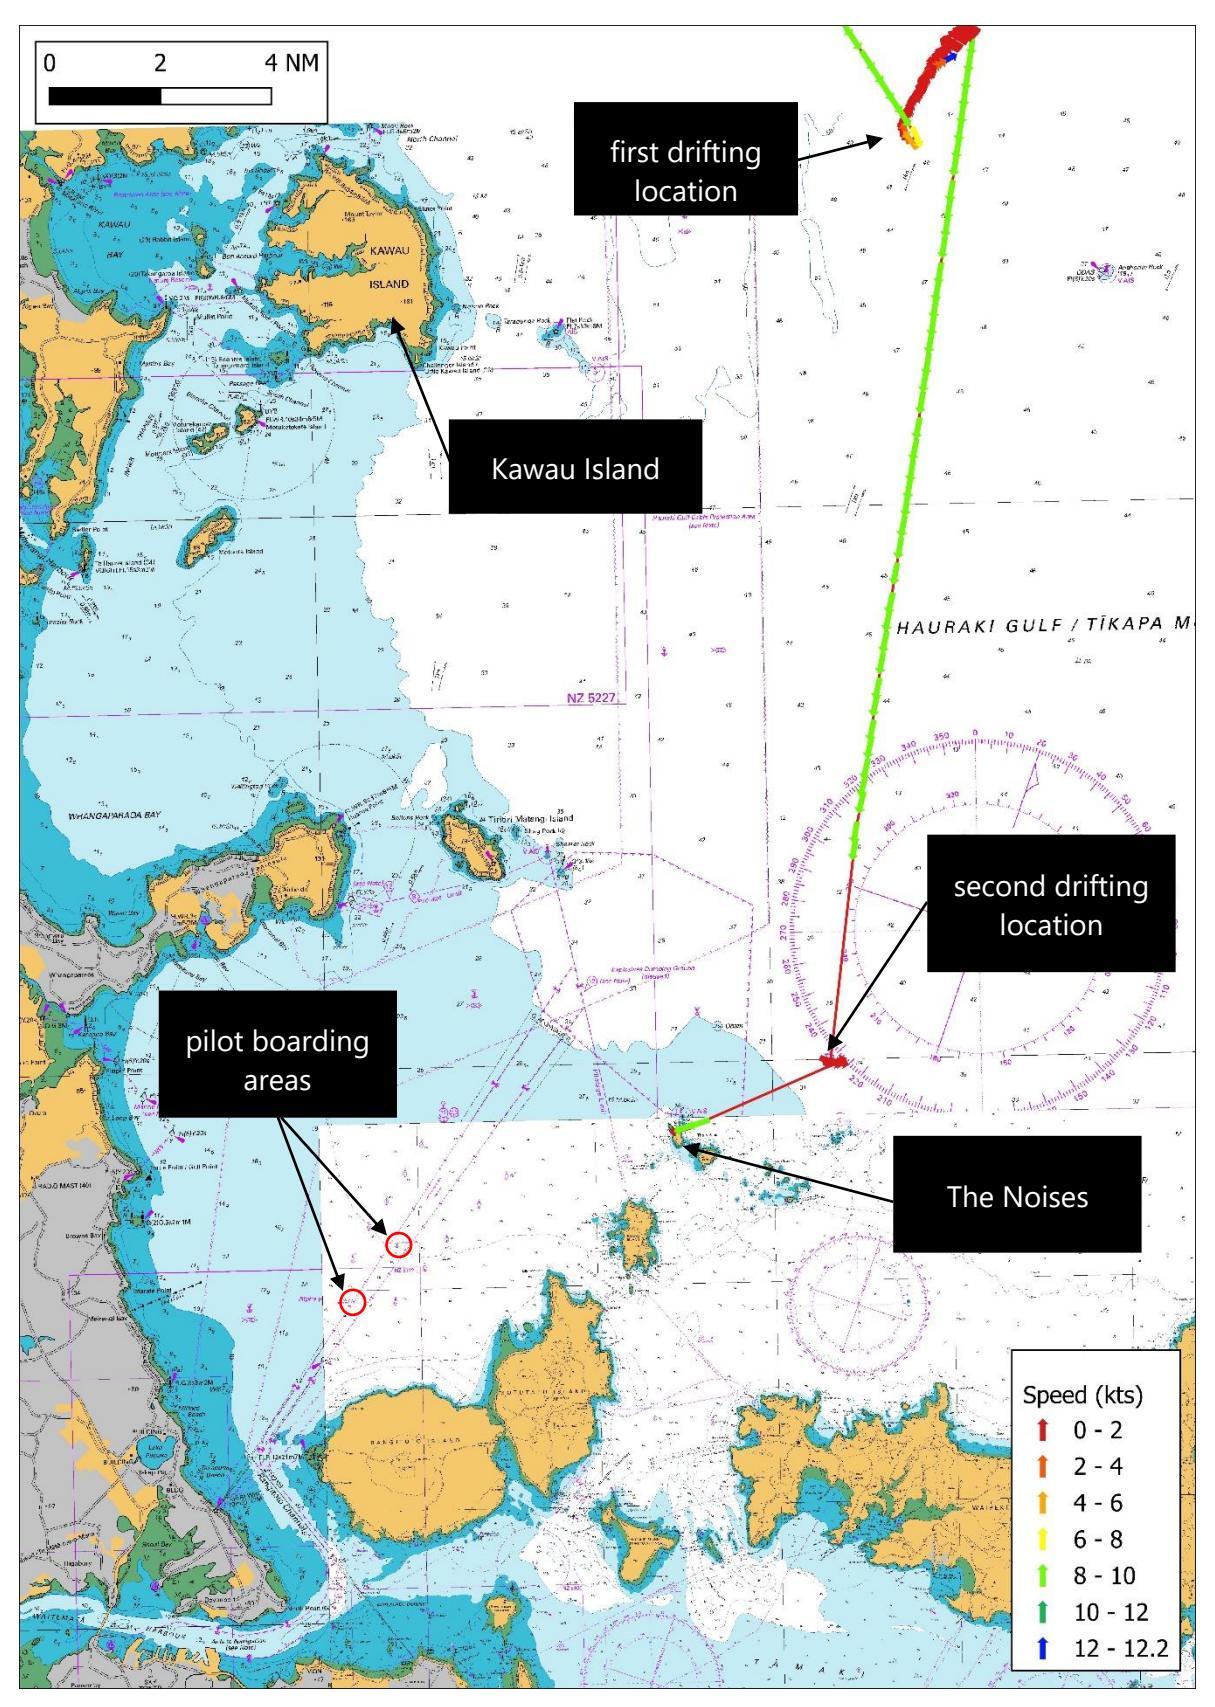
- 2.3. The *Chokyu Maru No.68* arrived in New Zealand waters on 15 April 2024, but was not due at the Auckland pilot boarding area until 0800 (NZST)³ the following day. The master instructed watchkeepers to stop and drift overnight. At about 1825 the watchkeeper stopped the vessel and it drifted east-northeast of Kawau Island for the next five and a half hours. At about 2355 the watchkeeper resumed the vessel's passage, and at about 0200 they stopped the vessel outside the pilotage limit⁴ and northeast of The Noises⁵ (see Figure 3).

Figure 3: Track of Chokyu Maru No.68 into Hauraki Gulf/Tīkapa Moana (Credit: Land Information New Zealand Toitū Te Whenua, labelled by the Transport Accident Investigation Commission)

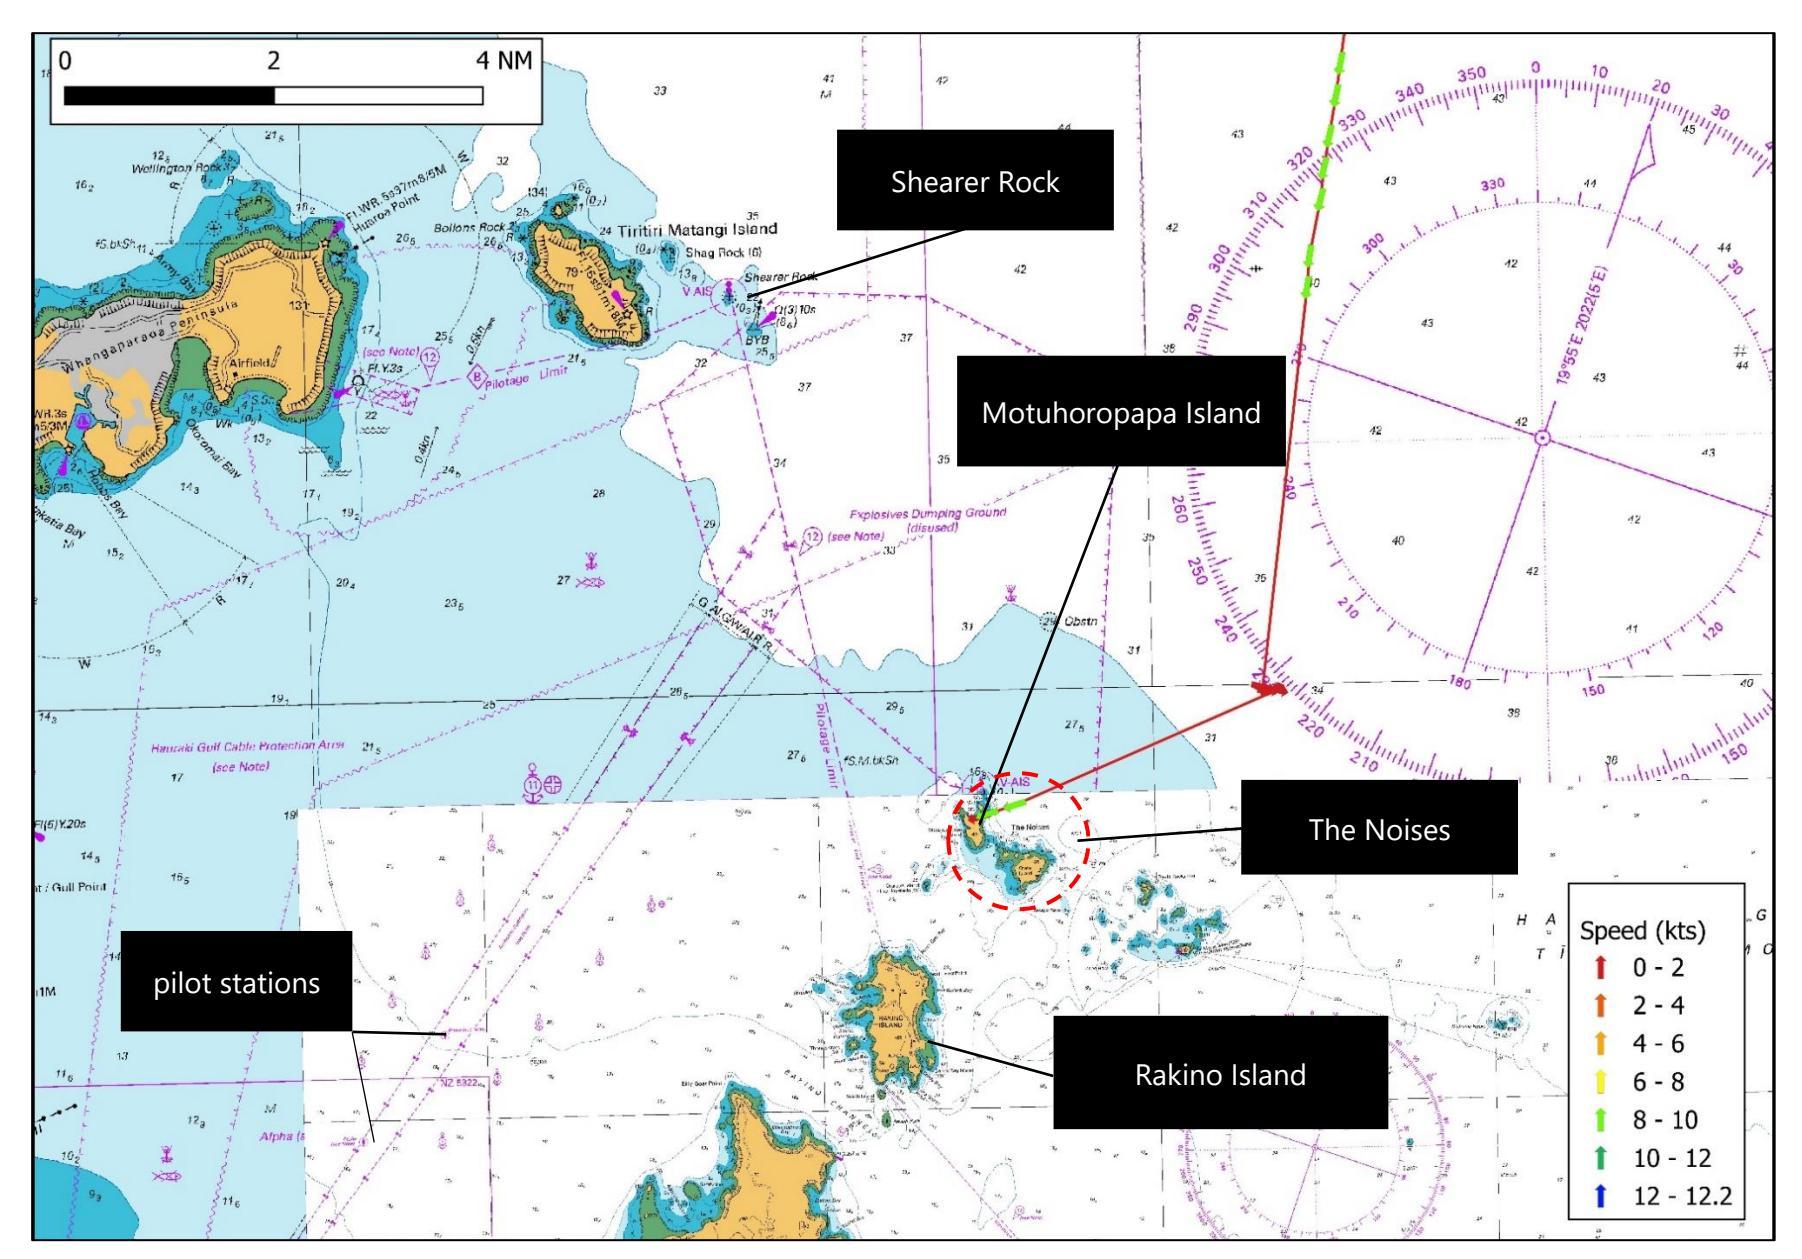
3.12. The chart plotter on *Chokyu Maru No.68* did not have the electronic charts for New Zealand installed and therefore did not display the small islands of the Hauraki Gulf (*see* Figure 10 and Figure 11). The differences in detail between the vessel's installed electronic charts for Japan and those for New Zealand are shown in Figure 12.

Figure 11: Overview of accident area
