Final report R0-2017-105: Collision between freight Train 353 and heavy motor vehicle,
Lambert Road level crossing, near Kawerau, 6 October 2017

Rail inquiry R0-2017-105
Collision between freight Train 353 and
heavy motor vehicle
Lambert Road level crossing, near Kawerau

6 October 2017

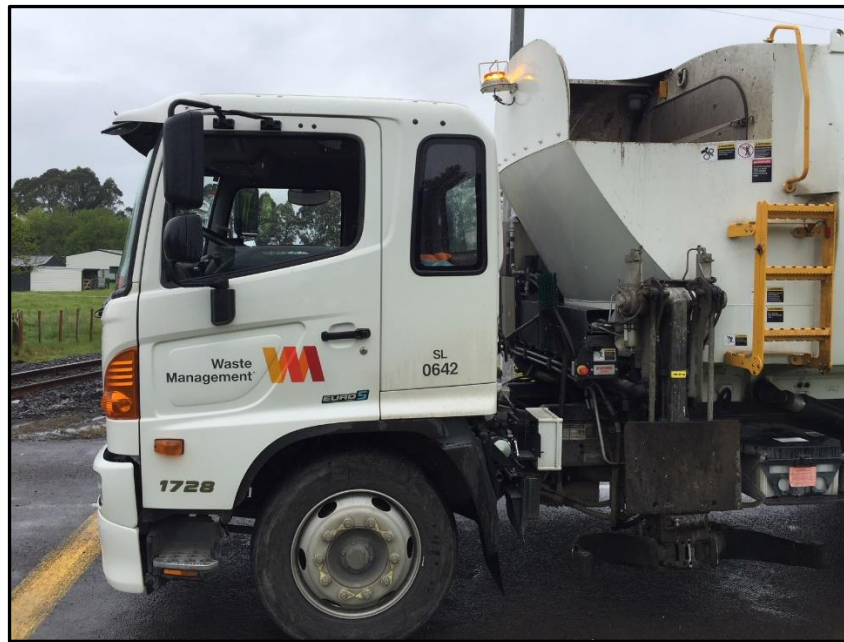
Figure 7
A Hino 500 heavy motor vehicle configured similar to the accident truck
(photograph provided by New Zealand Police)

- 3.3.1. The truck was a special-purpose, dual-steering, automatic Hino 500 series vehicle that had been converted for the purpose of emptying bins. It was fitted with a large container on the rear and a hydraulic arm on the left side of the truck behind the cab (see Figure 7). The truck had a single steering axle at the front and two axles at the rear. Records showed that the most recent certificate of fitness inspection had been carried out on 17 August 2017, and that the certificate was due to expire on 22 February 2018. The truck had undergone three certificate of fitness inspections since first entering service.

- 3.3.2. The truck was subjected to a regular maintenance regime. An 'A' maintenance service was required every 150 hours or 5,000 kilometres and a 'B' maintenance service every 300 hours or 10,000 kilometres. A comprehensive brake check was carried out during the 'B' service because of the frequent stop/start activity that the truck performed. The maintenance services were contracted out to a third party.
