Transport Accident
Investigation
Commission

Rail inquiry RO-2018-102

Freight train SPAD and wrong-routing

Taimate

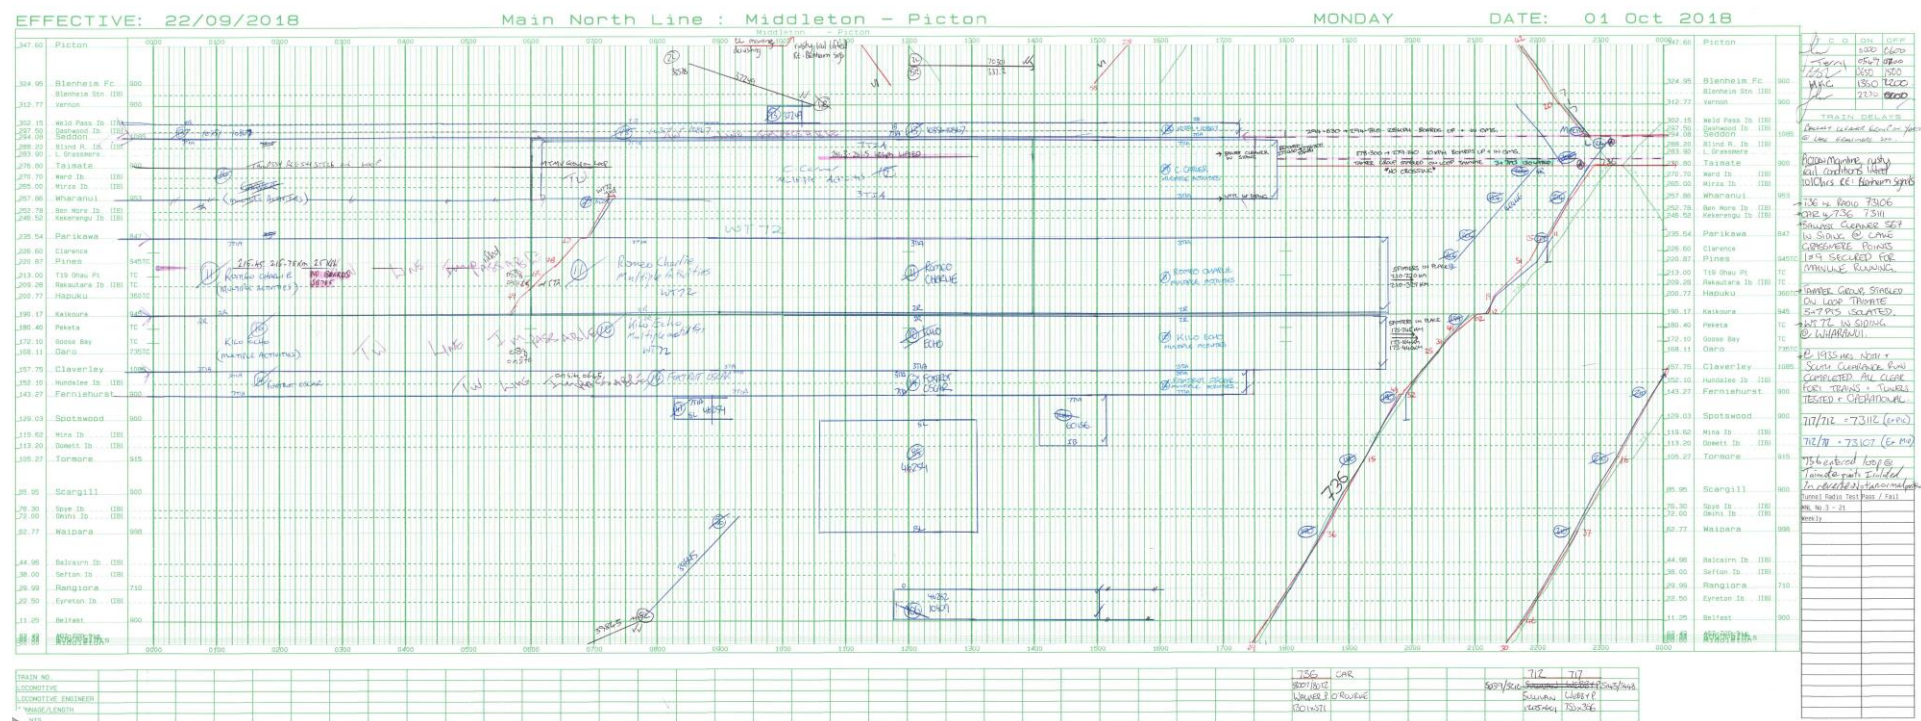
Appendix 2: Train Control diagram

train controller noted on the train control diagram that the track machines were on the loop and that the points had been set and isolated in the normal (main line only) position.
