Final Report

Rail inquiry RO-2019-102 Clinton derailment 29 March 2019

February 2020

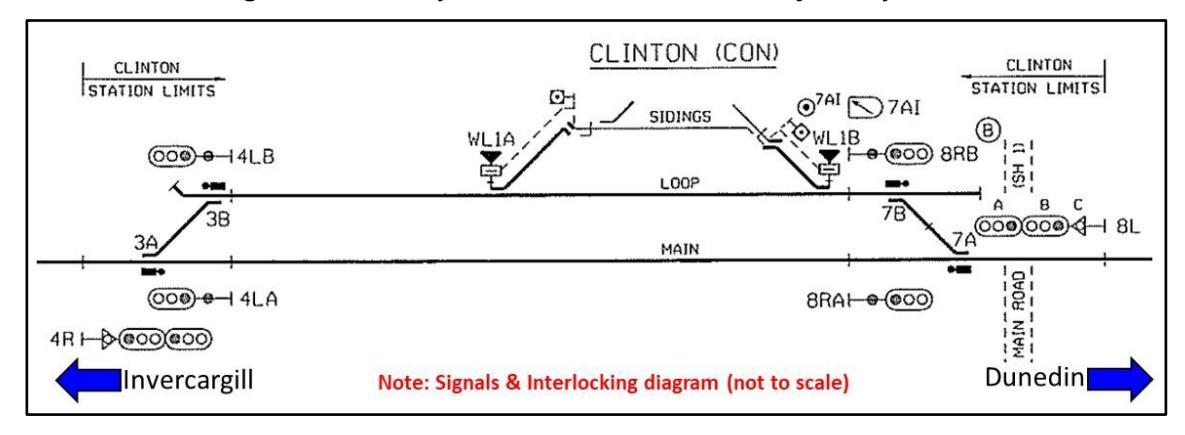
Figure 2: Clinton crossing loop

3.13. Witness marks confirmed that the point of derailment (see Figure 5) was on the left-hand rail in the direction of travel, between 7B and 7A points (see Figure 2), a section of track that was still within the crossing loop (see Figure 8).

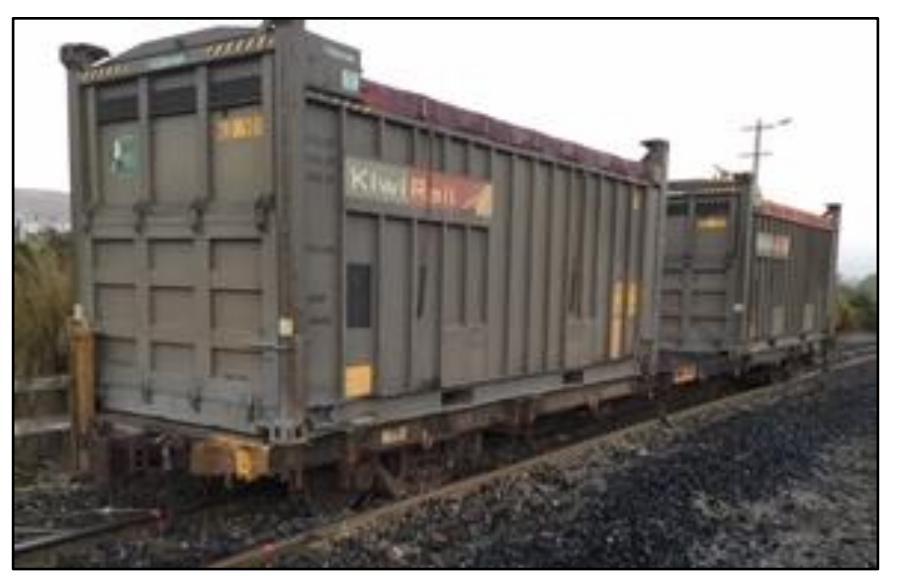
Figure 4: Wagon with two coal containers

2.9. The level crossing was clear of wreckage, but the bells and barriers continued to activate. Each of the three derailed wagons were carrying two containers of coal (see Figure 4).

- 2.14. The first wagon to derail was also one of the two wagons that overturned onto their sides. Both the wagons were extensively damaged, such that their decks were written off and no attempt was made to repair them. Maintenance records for the wagons did not indicate any pre-derailment issues.
- 2.15. The bogies from the first wagon to derail were seized by the Commission. They subsequently underwent post-incident inspections. Both bogies were transported to KiwiRail's Hutt Workshops facility, where they were systematically taken apart and all the
