Transport Accident  
Investigation  
Commission

# **Final Report**

***Rail inquiry R0-2019-103  
Derailment of Train 626  
Palmerston North  
4 April 2019***

**April 2020**

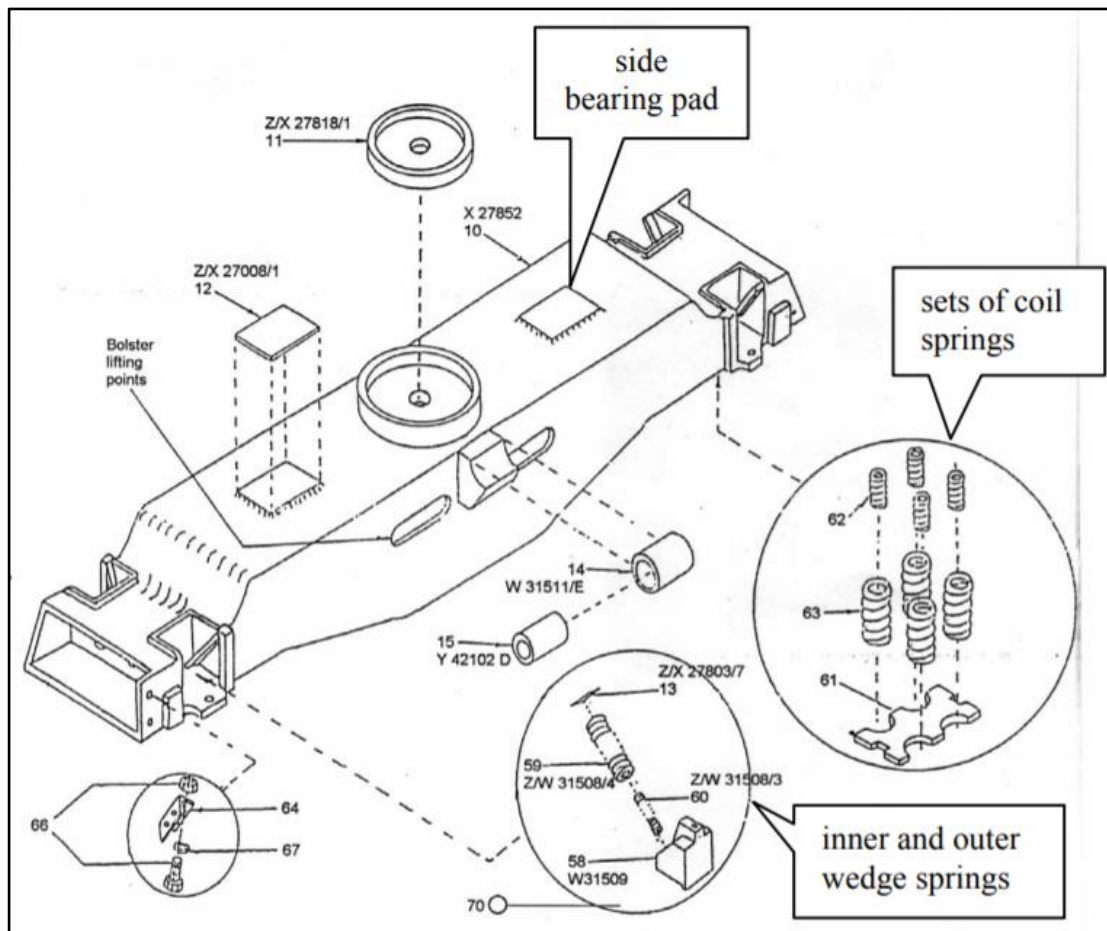
**Figure 6: Diagram of bogie bolster**

Bolsters also have small-diameter wedge springs fitted to reduce the oscillation (movement back and forth in a regular rhythm) of the moving wagon (see Figure 6).
