Transport Accident  
Investigation  
Commission

# Final Report

***Rail inquiry RO-2019-104***  
***Unsafe entry into worksite***  
***Taimate***  
***5 June 2019***

December 2020

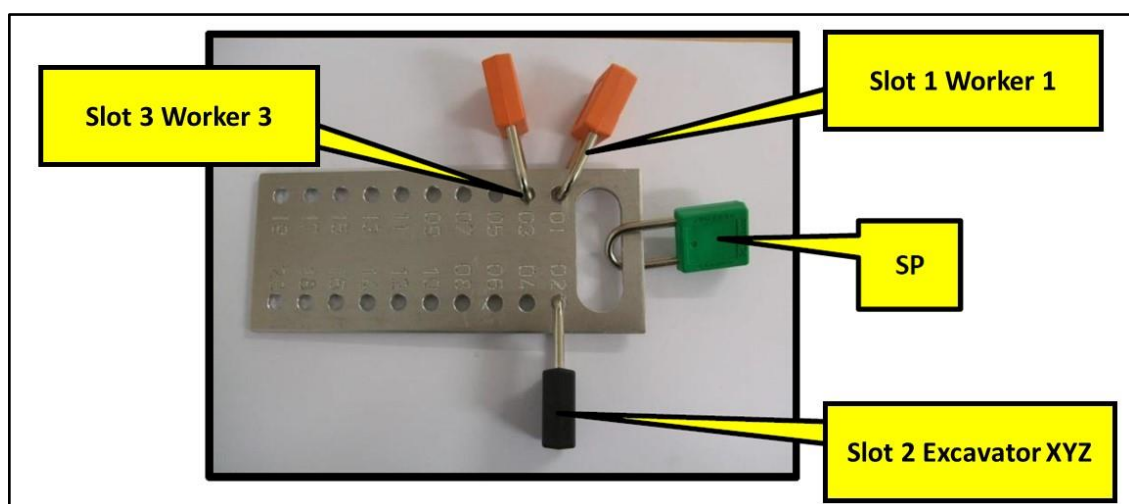
**Figure 5: Example 'lock-on' frame in use**

- 2.27 Rule 902 requires everyone working on or near the track at a worksite in a PWA to lock their individual, uniquely keyed padlock onto a metal frame held by the site protector, in a procedure known as 'locking on' (see Figure 5). The metal frame is then held by the site protector at the defined safe place – a place where people and equipment cannot be struck by passing rail traffic.

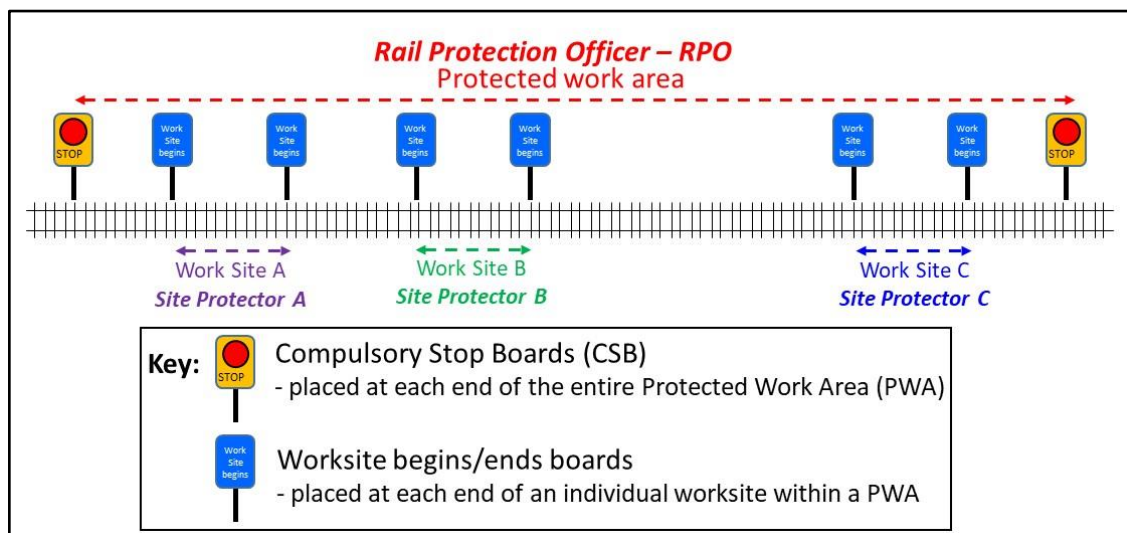
**Figure 6: Example PWA layout**

- 2.28 An RPO has overall responsibility for personnel in the entire PWA. Each individual worksite or set of workgroups has an appointed site protector who is responsible for personnel safety in a specified worksite in a multiple-worksite PWA (see Figure 6).
