Transport Accident
Investigation
Commission

Final report

***Rail inquiry RO-2019-105
Express freight Train 268
Derailment
Wellington
2 July 2019***

December 2020

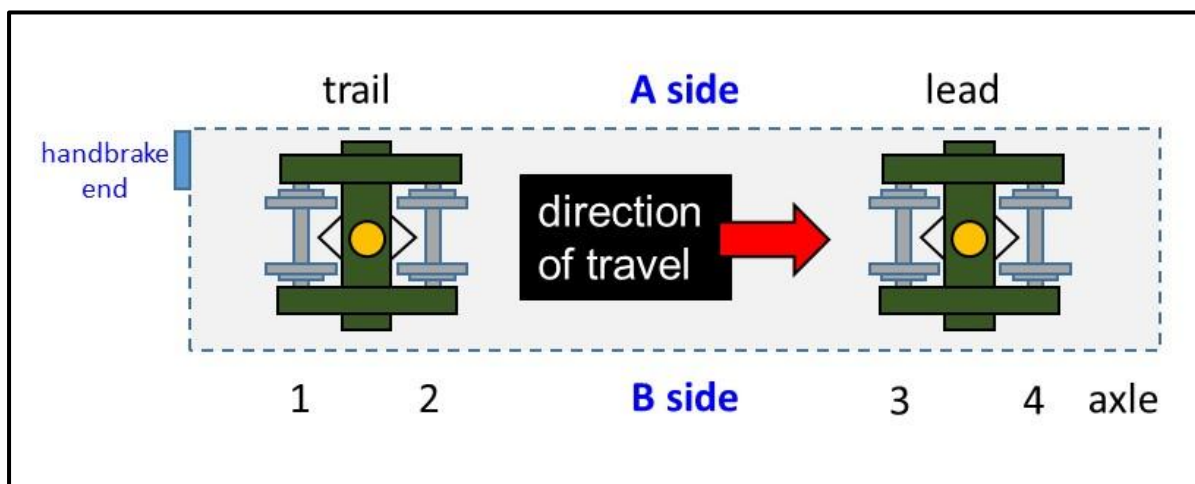
Figure 6: Schematic of wagon and bogie layout

- structural repairs to the wagon underframe and hand-grab
- the brake valve was replaced and tested
- the coupler at the handbrake end of the wagon was replaced
- the bogie at the non-handbrake end of the wagon (the leading bogie in the direction of travel at the time of the derailment) was replaced with an overhauled bogie
- the wheelsets at the non-handbrake end were re-profiled on a wheel lathe
- a wheelset on the bogie at the handbrake end (trailing bogie) was re-profiled.

2.31 Figure 6 is a schematic showing the wagon and bogie layout.
