Transport Accident
Investigation
Commission

Final report

Rail inquiry RO-2019-107

Passenger service SPAD and near collision

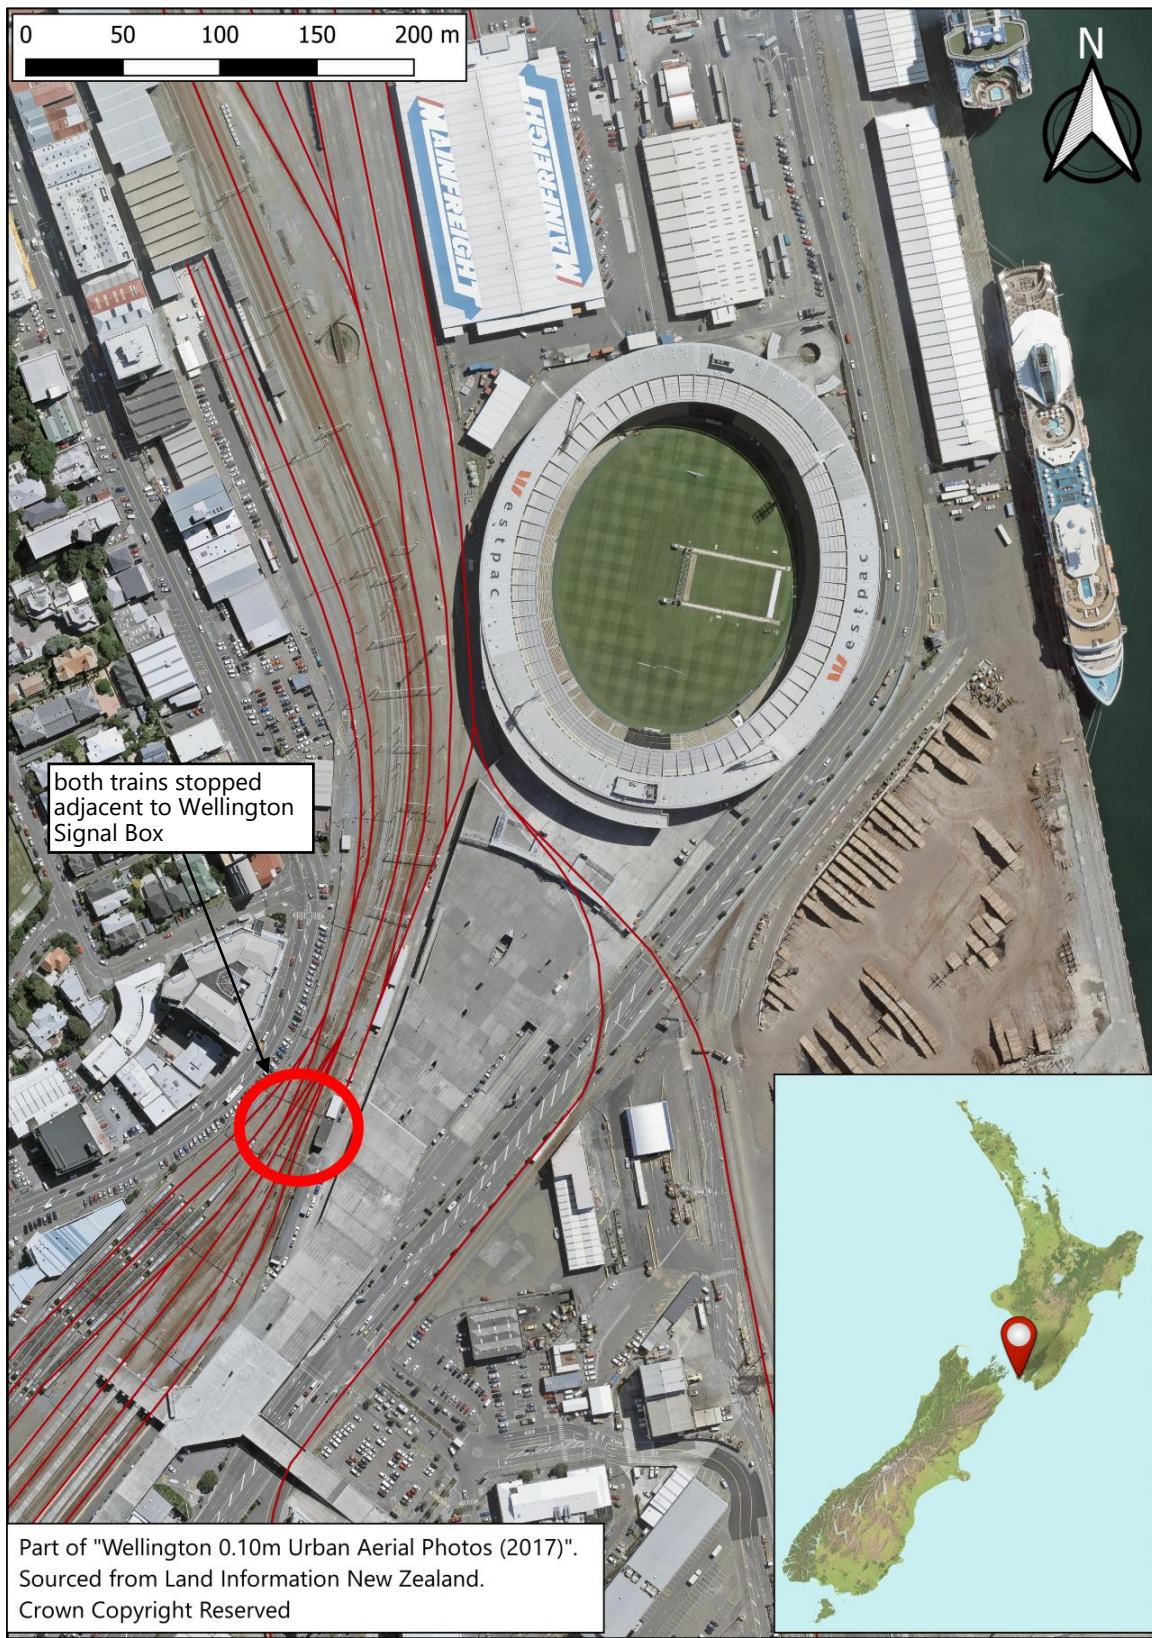
Figure 2: Location of accident
(Credit: Wellington 0.10m Urban Aerial Photos – 2017)

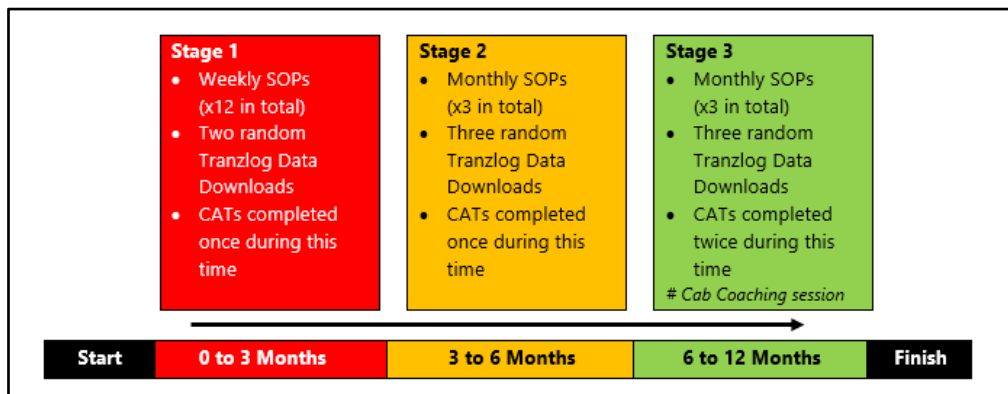
- 2.16 Transdev Wellington monitors train drivers with a support programme for a minimum of 12 months from certification. This support programme is broken down into three stages (see Figure 5).

Figure 5: Locomotive engineer 12-month support programme
