Transport Accident
Investigation
Commission

Final report

***Rail inquiry RO-2020-101
Level crossing collision
Mulcocks Road, Flaxton
10 February 2020***

February 2022

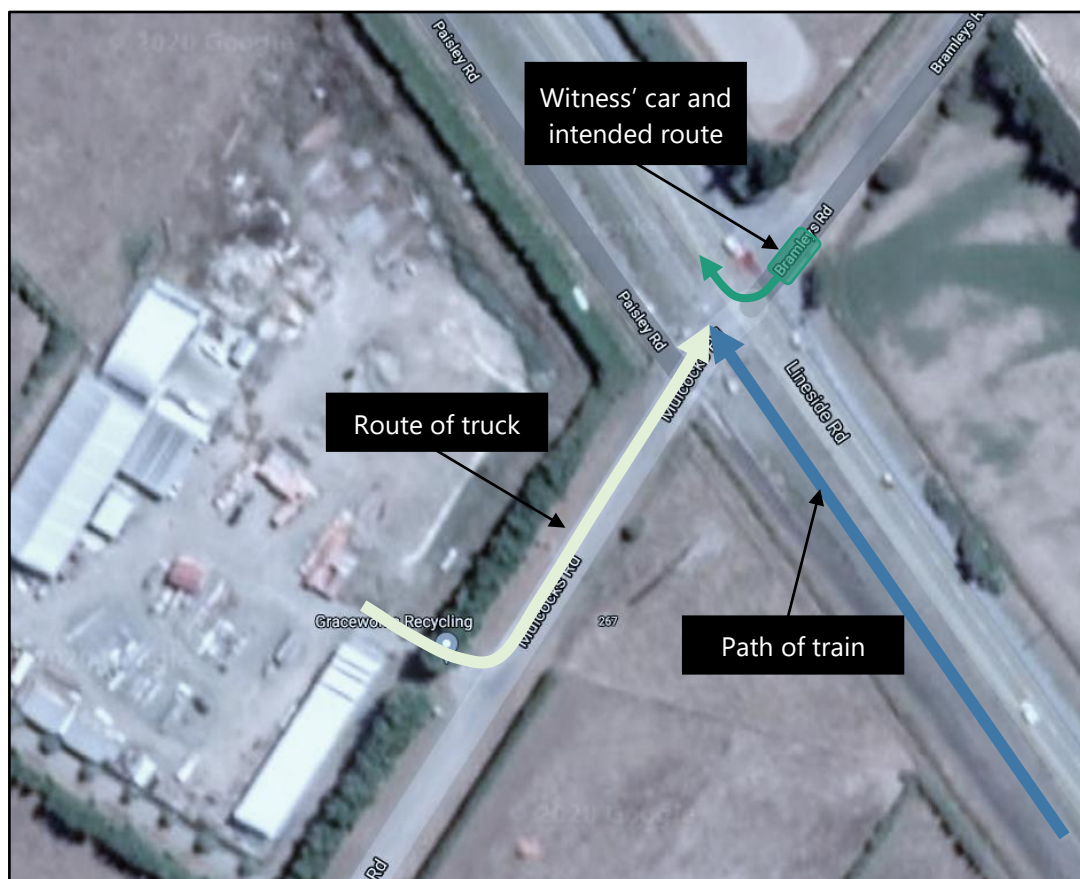
Figure 3: Route of truck, path of train and position of witness

- 2.2 At the same time the Coastal Pacific passenger train (the train) was approaching the level crossing northbound from Christchurch towards Picton carrying 98 passengers.

- 2.3 Meanwhile a car was at the intersection of Bramleys Road and State Highway (SH) 71 Lineside Road, opposite the level crossing, waiting for a gap in traffic to allow it to turn right onto the northbound lane of SH71 Lineside Road. The car was directly opposite Mulcocks Road level crossing and its driver, who was the only identified witness to this accident (the witness), observed the truck's approach.
