Transport Accident
Investigation
Commission

Rail inquiry RO-2020-102

Express freight Train 932

***strikes hi-rail vehicle at Limeworks Road public
level crossing between Milton and Henley***

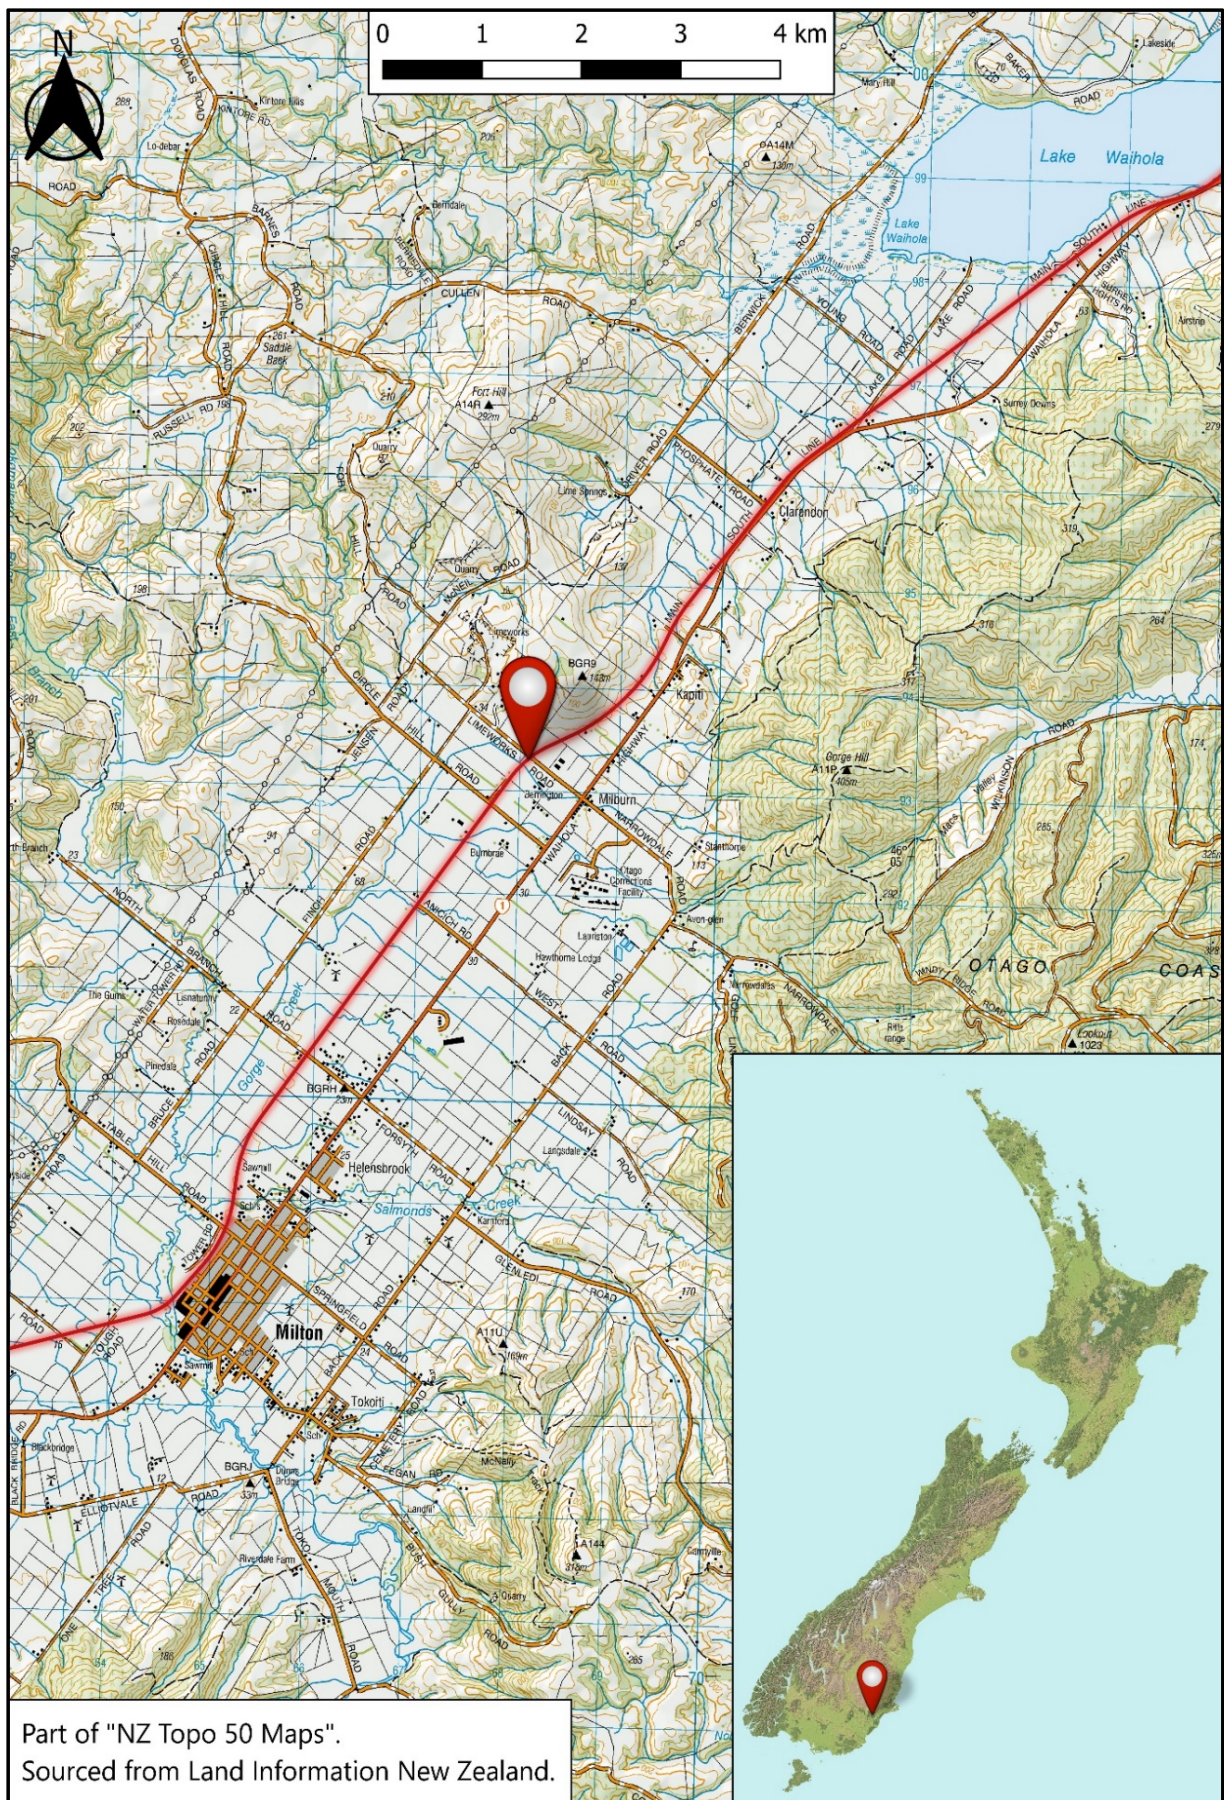
Figure 2: Location of accident

- 1.1 At about 1501 on Friday 24 April 2020, the track ganger – driver of hi-rail vehicle 36783 – received a track warrant conditional on the departure of Train 932 from 429 km Main South line, near Limeworks Road between Milton and Henley.

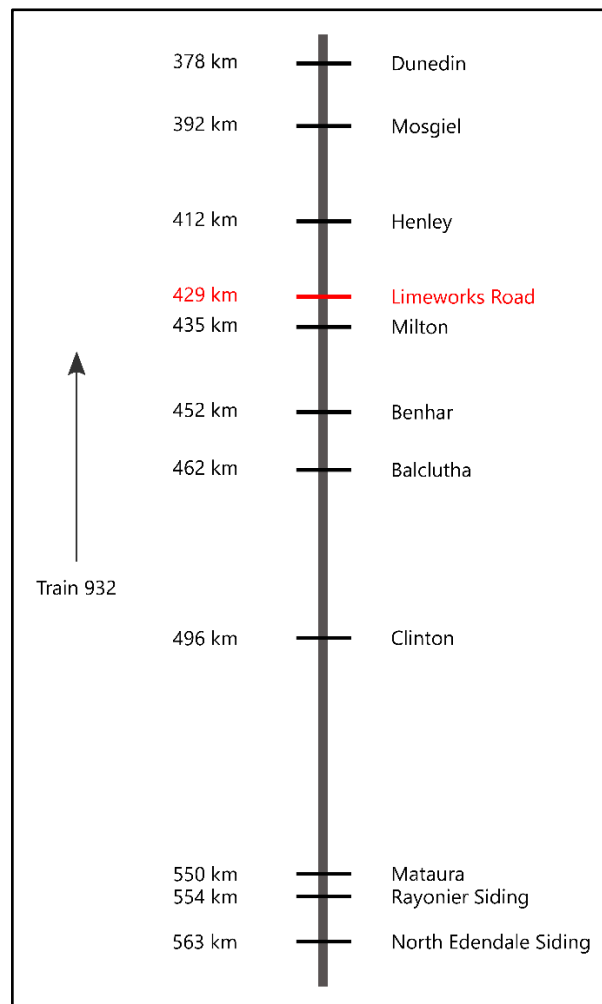
Figure 3: Schematic diagram of train's route

- 2.1 At 1209¹ on Friday 24 April 2020, the train controller² managing the Main South line³ issued track warrant⁴ 51 (see Appendix 1) to the driver of express freight Train 932 (the train). The track warrant authorised the north-bound train to proceed from North Edendale Siding to Mosgiel on the Main South line, a journey of about 170 kilometres (km) (see figure 3). A condition of the track warrant required the train driver to make mandatory radio calls to train control at Matura, Balclutha and Henley.

- 2.2 The train departed from North Edendale Siding at 1212, hauling 16 wagons loaded with milk powder. An additional 16 wagons loaded with custom wood were uplifted from Rayonier Siding, about 10 kilometres north of North Edendale Siding. The 541-metre-long train consisted of 2 DXC-class locomotives hauling 32 wagons with a total weight of 1856 tonnes.
