Transport Accident  
Investigation  
Commission

# **Final report**

***Rail inquiry RO-2021-101***  
***Serious injury during shunting operations on***  
***board the Aratere, Interislander ferry terminal,***  
***Wellington***  
***9 April 2021***

**September 2022**

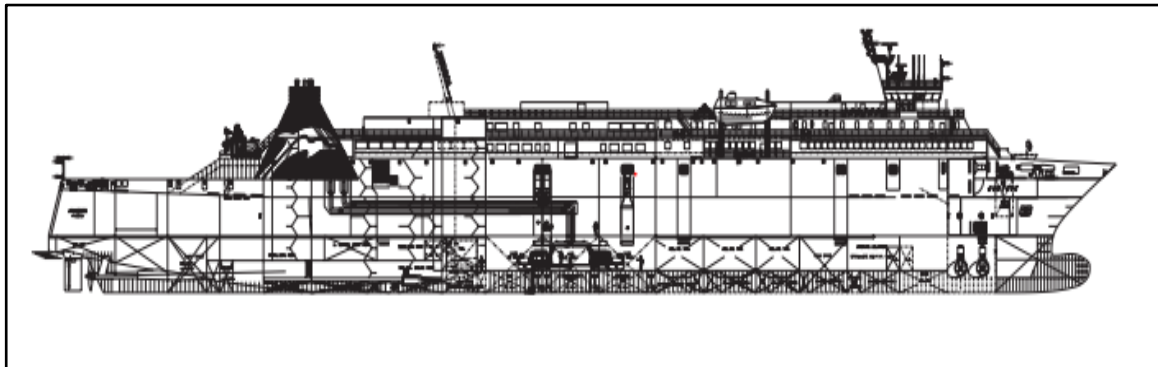
**Figure 3: Cross-sectional view of the *Aratere* showing the location of the rail deck**

- 2.1 The *Aratere* is a rail ferry that can carry up to 32 rail wagons on its lower cargo deck (the rail deck). The rail deck has four rail tracks; the two inner tracks are straight and the two outer tracks are curved at the stern (back) end of the vessel.
- 2.2 At the time of the accident, the *Aratere* had just berthed in Wellington after completing a scheduled voyage from Picton to Wellington.

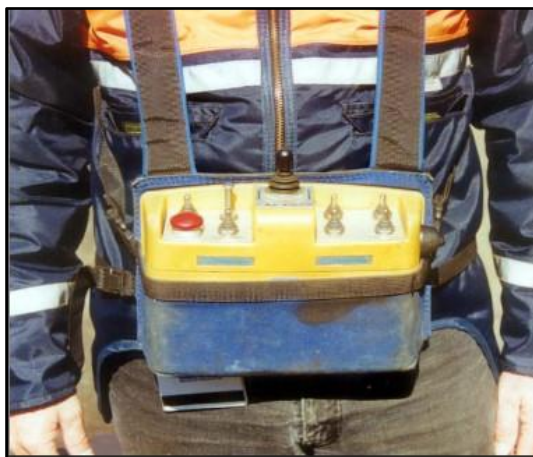
**Figure 8: Remote-controlled pack worn in harness**  
(Credit: KiwiRail)

2.18 The diesel-powered DSG-class shunt locomotive was 12.5 metres long and weighed 56 tonnes. The locomotive was operated remotely by the RCO using a remote-control pack worn in a harness in front of them. The RCO controlled the movement of the locomotive by entering commands into the control pack. These commands were transmitted by radio to the locomotive (see Figure 8).

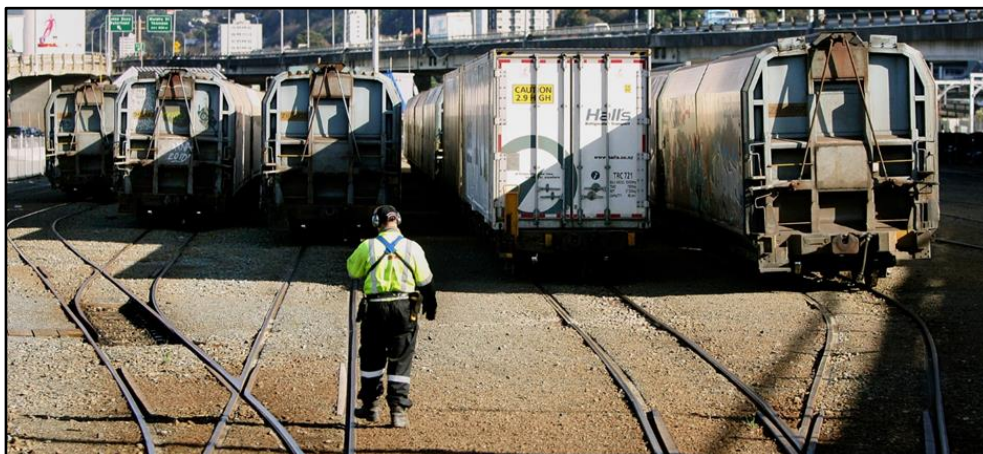
**Figure 9: Ferry marshalling yard Wellington**

2.24 The ferry marshalling yard consists of five railway tracks (see Figure 9).

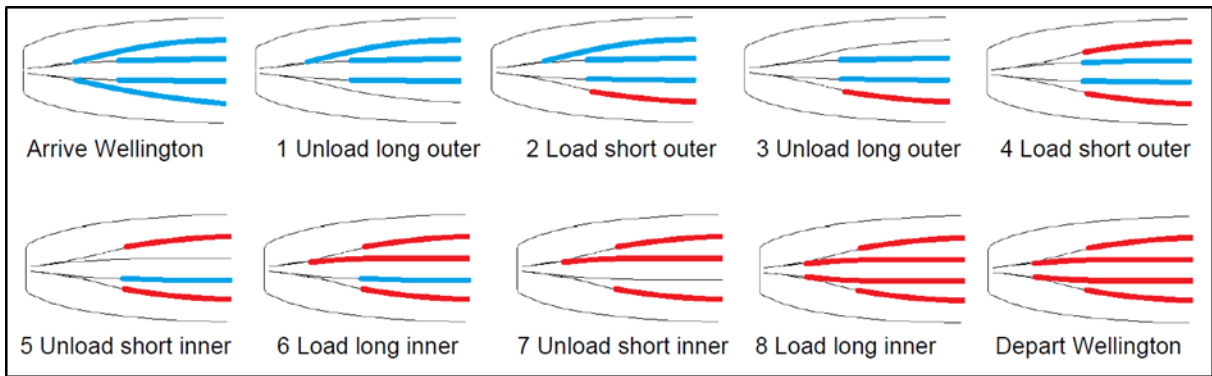
**Figure 10: Aratere loading sequence, Wellington**

2.29 The *Aratere's* loading and discharging sequences in Wellington and Picton are different to facilitate efficient access to the rail deck during loading and discharging operations. The sequence is described in section 10.9 of the Manual. The procedure for Wellington is shown in Figure 10. Blue indicates the rakes unloaded at Wellington and red indicates the rakes loaded at Picton. In summary, the *Aratere* berths at Wellington with the long rakes on the outer tracks and the shorter rakes on the inner tracks. The loading plan for Picton is the reverse, with the longer rakes secured on the inner tracks and the shorter rakes on the outer tracks.
