Transport Accident
Investigation
Commission

Final report

Rail inquiry RO-2021-106
Derailment of Train 220
South of Hunterville
13 December 2021

May 2023

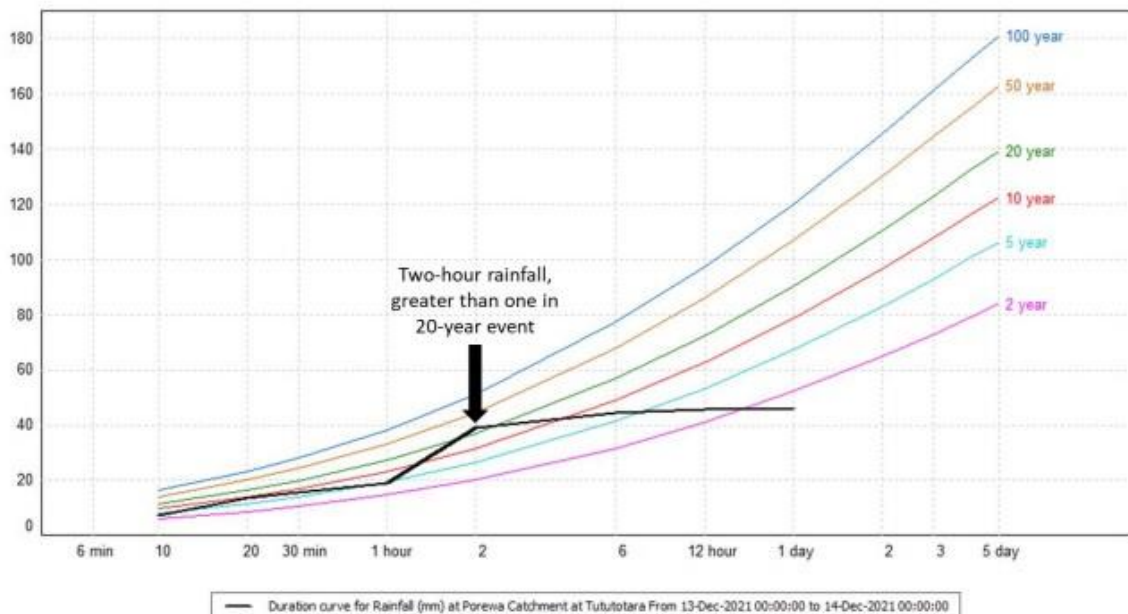
From the above table and plot, it can be seen that the most significant rainfall event that occurred on 13 December 2021 was a two-hour heavy rainfall event (this occurred during 18:00 to 19:59). During this two-hour event, 38.5 mm was recorded, giving an average rainfall rate of 19.3 mm/hr. The results suggest this two-hour rainfall event is an approximately one in 24.5-year event.
