Transport Accident  
Investigation  
Commission

# **Final report**

***Rail inquiry RO-2022-101***  
***Passenger train***  
***Fire in auxiliary generator wagon***  
***Palmerston North station***  
***11 May 2022***

**November 2023**

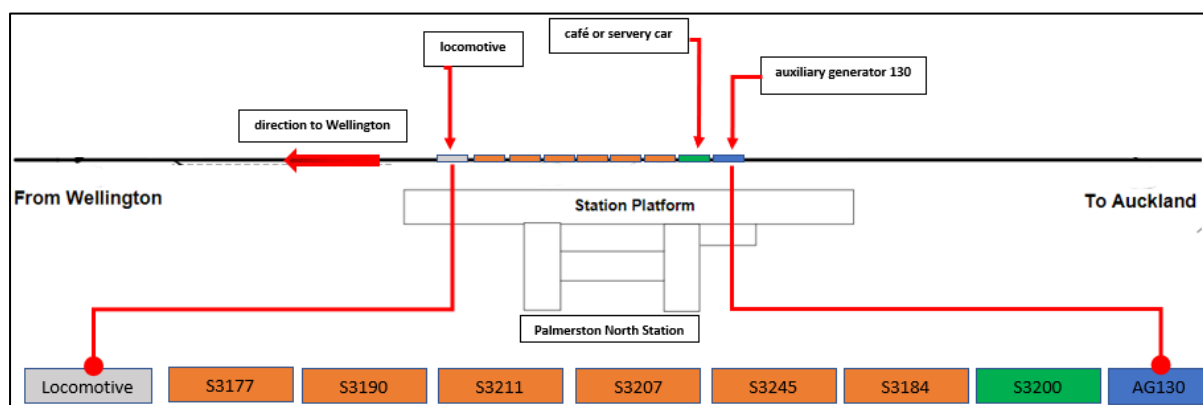
**Figure 3: Capital Connection consist at Palmerston North station**

- 2.4 On Wednesday 11 May 2022, the Capital Connection from Palmerston North to Wellington had a consist<sup>6</sup> of one locomotive attached to seven carriages (six S-class carriages<sup>7</sup> and one serving carriage) and an AG wagon (AG130) at the rear (see Figure 3).

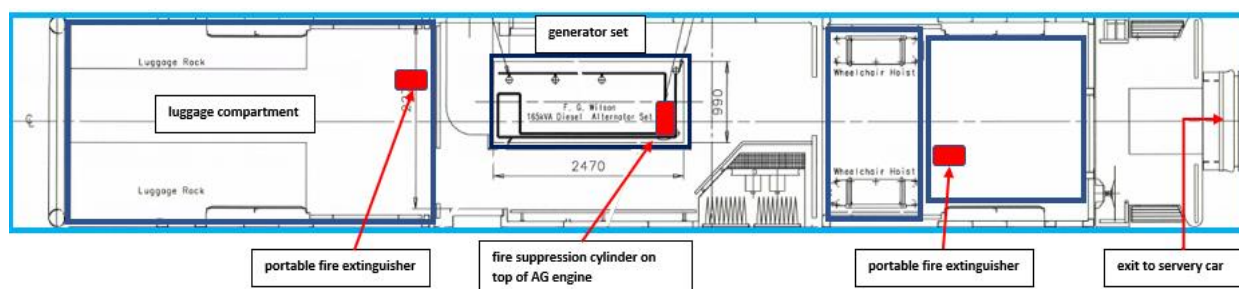
Figure 4: Location of fire extinguishing equipment on AG130

- 2.35 AG130 contained two portable 4.5 kilogram dry-powder fire extinguishers, one located in the luggage compartment, and another located at the other end of the wagon (see Figure 4). There was also one portable fire extinguisher in each passenger carriage of the Capital Connection.

- 2.36 None of the onboard fire extinguishers was used to extinguish the fire.

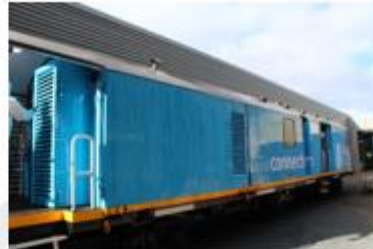
Photo 8.

further inspection and dismantling of the fire affected area of AG130 was undertaken. Concurrent with the examination the opportunity was taken to investigate the exhaust setup of two additional similar AG wagons, AG176 and AG222.

AG176.

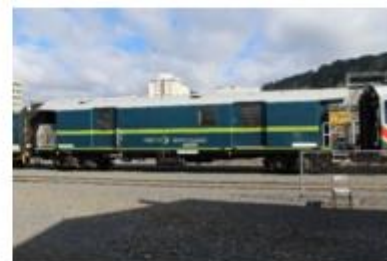
Photo 10.

AG222.
