Transport Accident  
Investigation  
Commission

# **Final report**

***Rail inquiry RO-2022-102***  
***L71 Mainline Shunt***  
***Derailment and subsequent rollover***  
***Tamaki***  
***1 June 2022***

**December 2023**

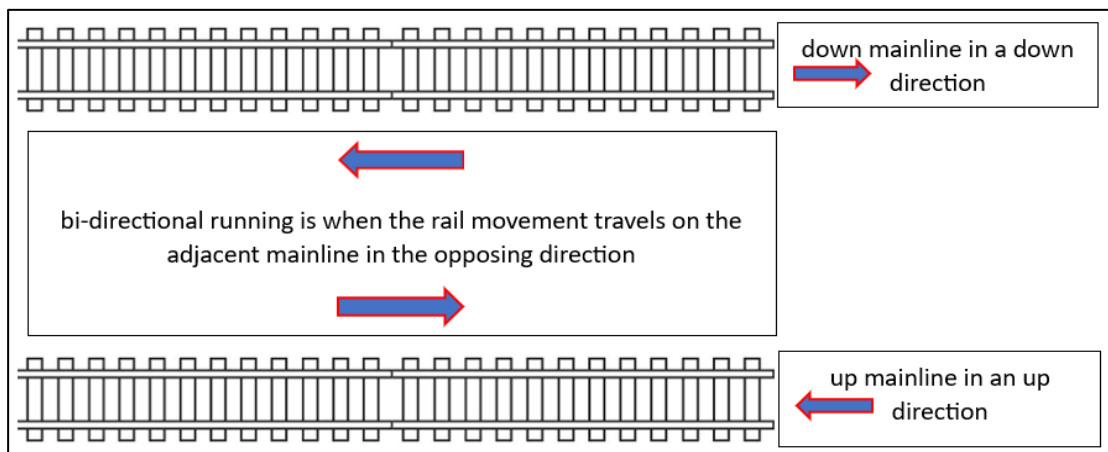
**Figure 3: Bi-directional rail movements**

- 2.1. L71 is the service number assigned to a regularly scheduled shunt service that moves rail freight between the Wiri rail yard (Wiri) and the Port of Auckland rail facility (Port of Auckland) using the North Island Main Trunk (NIMT) line, which incorporates a portion of the Auckland Metro rail network.
- 2.2. The Auckland Metro rail network is a bi-directional track (see Figure 3).

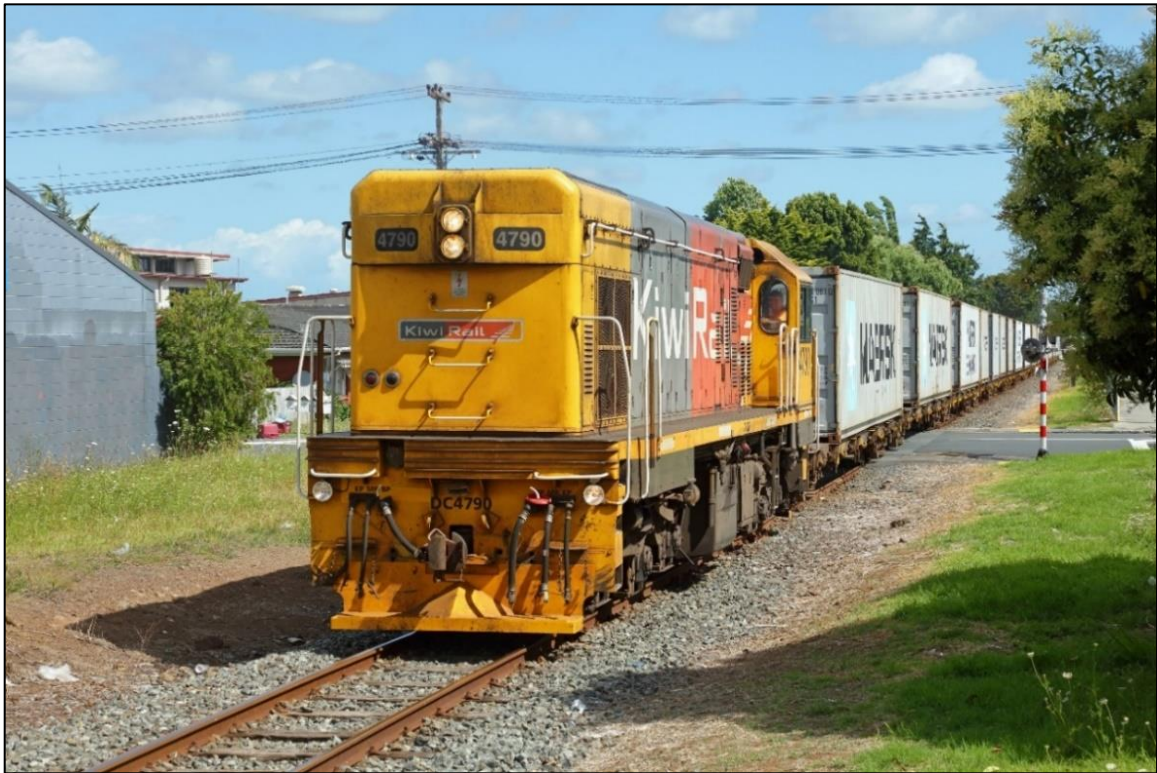
**Figure 5: DC class locomotive operated in a long-hood leading configuration**

signal colours to the LE when the locomotive is being driven in the long-hood leading configuration (see Figure 5).

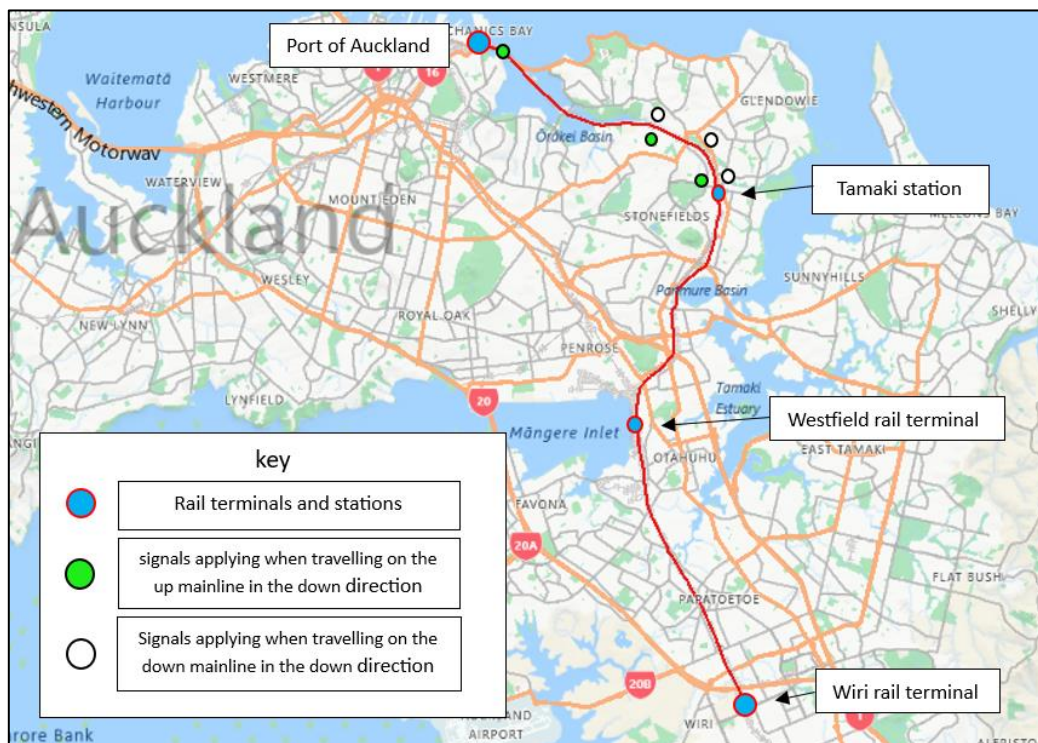
**Figure 8: L71 route and position of signals between Port of Auckland and Tamaki station**  
(Credit: Google maps)

- 2.18. The LE reminded the trainee and minder that there would be fewer signals on the return route to Westfield (see Figure 8) and to be alert for their locations as they would not be visible to the LE from their side of the cab (see Figures 9 and 10).

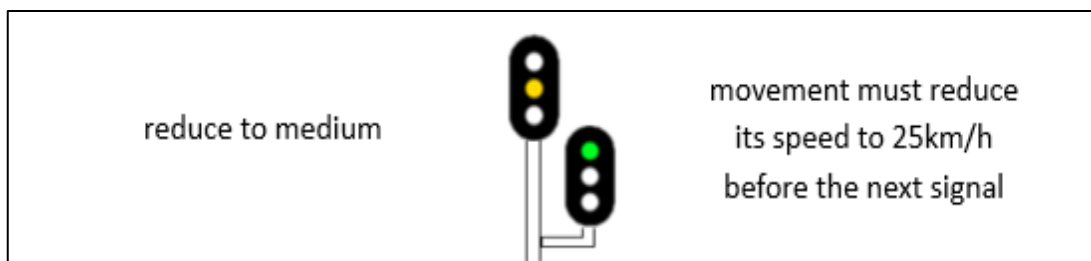
**Figure 12: Signal aspect for 'reduce to medium'**

- 2.19. In accordance with the departure signal (see Figure 11) the LE brought the locomotive up to a controlled line speed of 80 km/h. The next signal was positioned approximately 5.3 km along the track and was displaying 'reduce to medium', being a yellow top, green bottom light aspect (see Figure 12). This signal requires a speed reduction to 25 km/h before the next signal.

- 2.20. The trainee sighted the signal and called 'green'. The LE repeated the signal call back as 'green'. The LE continued at approximately 74 km/h, assuming the call was referring to a 'clear normal' signal, being a green top, red bottom light aspect.
- 2.21. The next signal (signal 507) was a further 1.8 km along the line. The signal was displaying a 'clear medium' aspect, being a red top, green bottom light (see Figure 13). This signal requires a speed no greater than 25 km/h as the signal is passed. The trainee sighted the signal and called 'green' and the LE repeated the signal call back as 'green'. The LE again assumed the call was referring to a 'clear normal' signal, being a green top, red bottom light aspect, and continued at approximately 76 km/h.

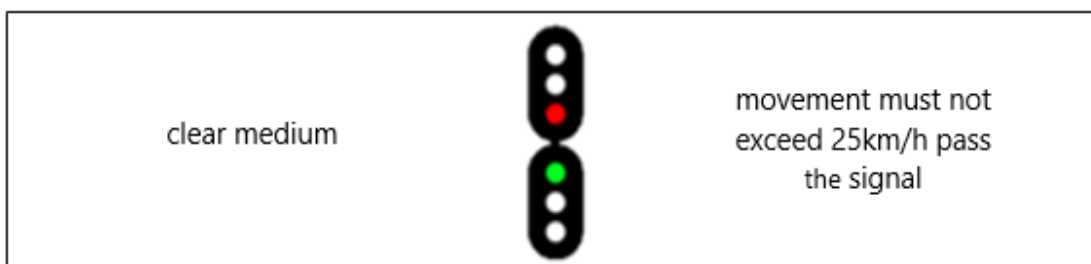
**Figure 13: Signal aspect for 'clear medium'**

- 2.22. At approximately 0103, the locomotive passed signal 507 at a speed of 76.8 km/h, rather than the required 25 km/h. The locomotive travelled a further 153m before entering a set of crossover points directing the locomotive from the up mainline across to the down mainline (see Figure 14).

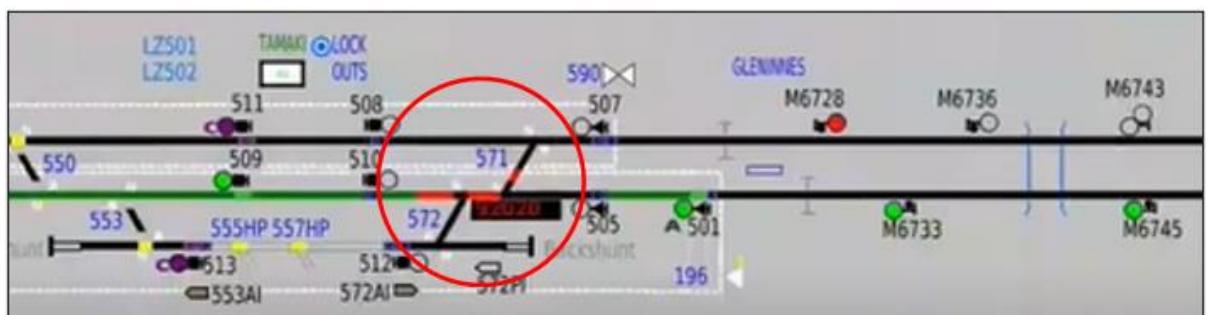
**Figure 19: Train control display for Tamaki**

- 2.29. The trainee helped the minder and LE to stand up before attempting to access the door, that was now above their head, and release the sliding windows. However, both were jammed closed.
- 2.30. Meanwhile, the train controller had observed on their monitor screen a loss of track circuit detection<sup>9</sup> at the Tamaki crossover points (see Figure 19). At about the same time they received the emergency radio base call from the locomotive, as a result of the LE unintentionally depressing the emergency mushroom button. The train controller attempted to contact the crew via the radio system on several occasions but received no response.

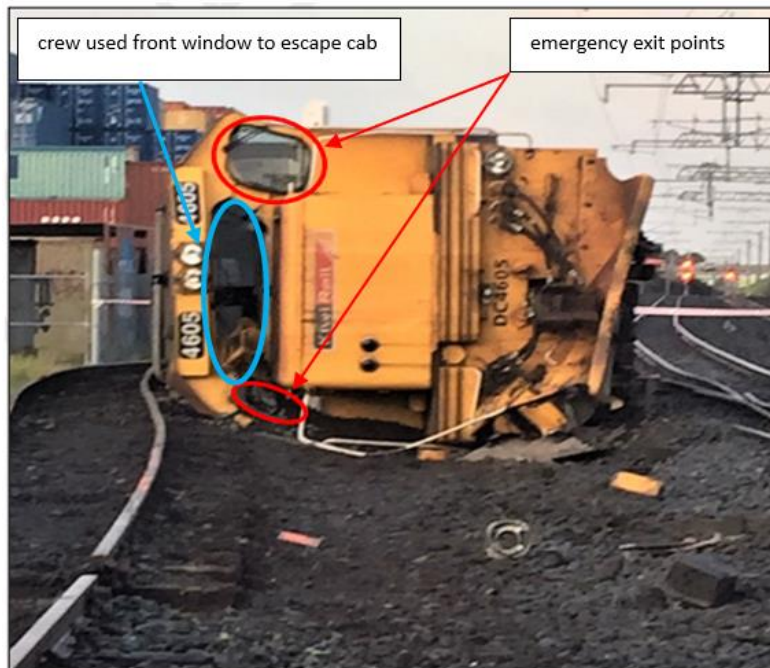
**Figure 21: Window escape location and emergency exit points**

- 2.44. DCP4605<sup>11</sup> was an 82 tonne, 14.1 m, single-cab locomotive built by General Motors and powered by a diesel engine<sup>12</sup>. The locomotive had a maximum line speed of 100 km/h.
- 2.45. All required scheduled maintenance had been carried out in accordance with the KiwiRail maintenance schedule requirements and any fault-related issues rectified.
- 2.46. There were no known mechanical issues with the locomotive at the time of the accident.
- 2.47. There was an escape system fitted to the two side windows at the front of the locomotive's cab (see Figure 21).

- 3.46. KiwiRail did not provide training to staff on how to escape from the cab of a locomotive that had derailed onto its side.
- 3.47. The Commission found that because of the size of the emergency escape windows in the locomotive cab, none of the train crew would be unable to escape if required to do so.
- 3.48. The emergency escape windows were operated by pulling on keystrip pull tabs to release the rubber tube and remove the glass panel. The keystrip pull tab stickers, located on the inside of the cab window, were ambiguous and could cause confusion in an emergency, as the actual location of the tab was outside of the window (see Figure 24). This requires a crew member to extend their arm outside of the side window and reach around to the front of the locomotive in order to pull the tab to release the rubber tube and remove the glass panel (see Figure 25).

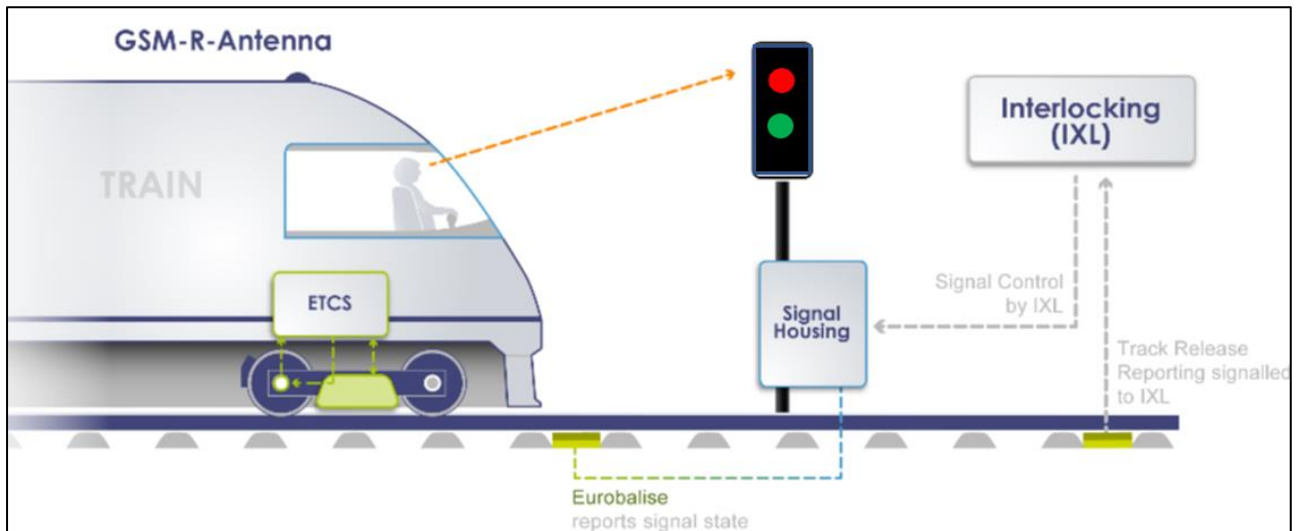
Figure 23: ETCS Level 1

- 3.44. ETCS Level 1 works via lineside electronic equipment connected to the signalling infrastructure system, which translates the signal aspect information into a digital movement authority feeding this information directly to the LE. As the train moves along the track it passes over balise transponders<sup>27</sup>. The train's onboard system reads the signal from the balise, updates its position and calculates the train's maximum allowable speed and route length (see Figure 23).

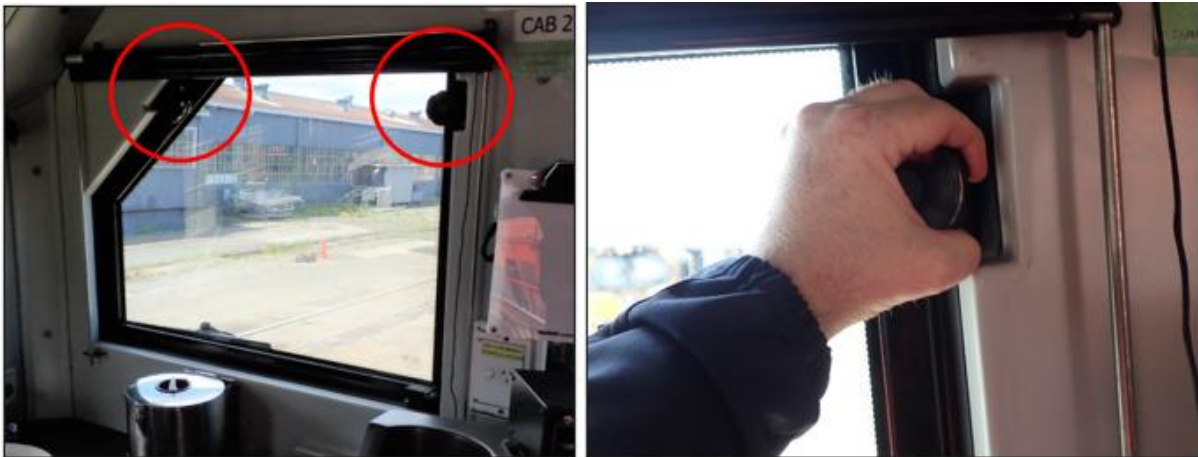
**Figure 26: DL class locomotive egress points**

3.49. By comparison the DL class and EF class 30 locomotives' egress points had easy access to the internal release mechanisms, allowing the window to hinge downward once opened (see Figure 26).

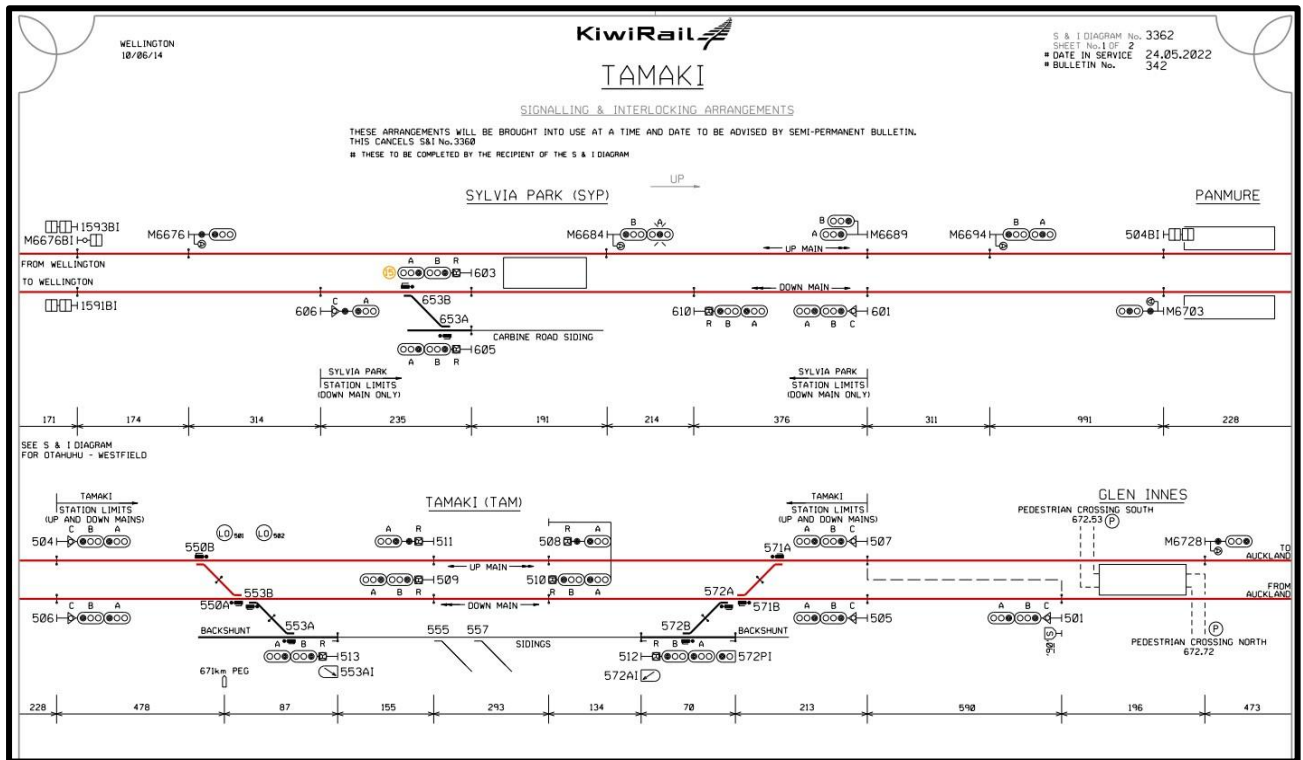
# Appendix 3 Tamaki signalling and interlocking diagram

- 3.20. Signal locations for the KiwiRail network are depicted on signalling and interlocking diagrams (see Appendix 3). The trainee was not provided with any of the diagrams as part of their training. Their signal placement knowledge was based on accumulation of experience as their training progressed. By chance, the trainee happened to have operated along the up mainline in the down direction the previous night and so had some memory of where the signals were located. To place a trainee with limited track knowledge in this position is indicative of inadequate risk management for this type of operation.
