Transport Accident
Investigation
Commission

Final report

Rail inquiry RO-2023-101
Hi-Rail vehicle collision near Te Puna
86.43 km East Coast Main Trunk line
10 January 2023

April 2024

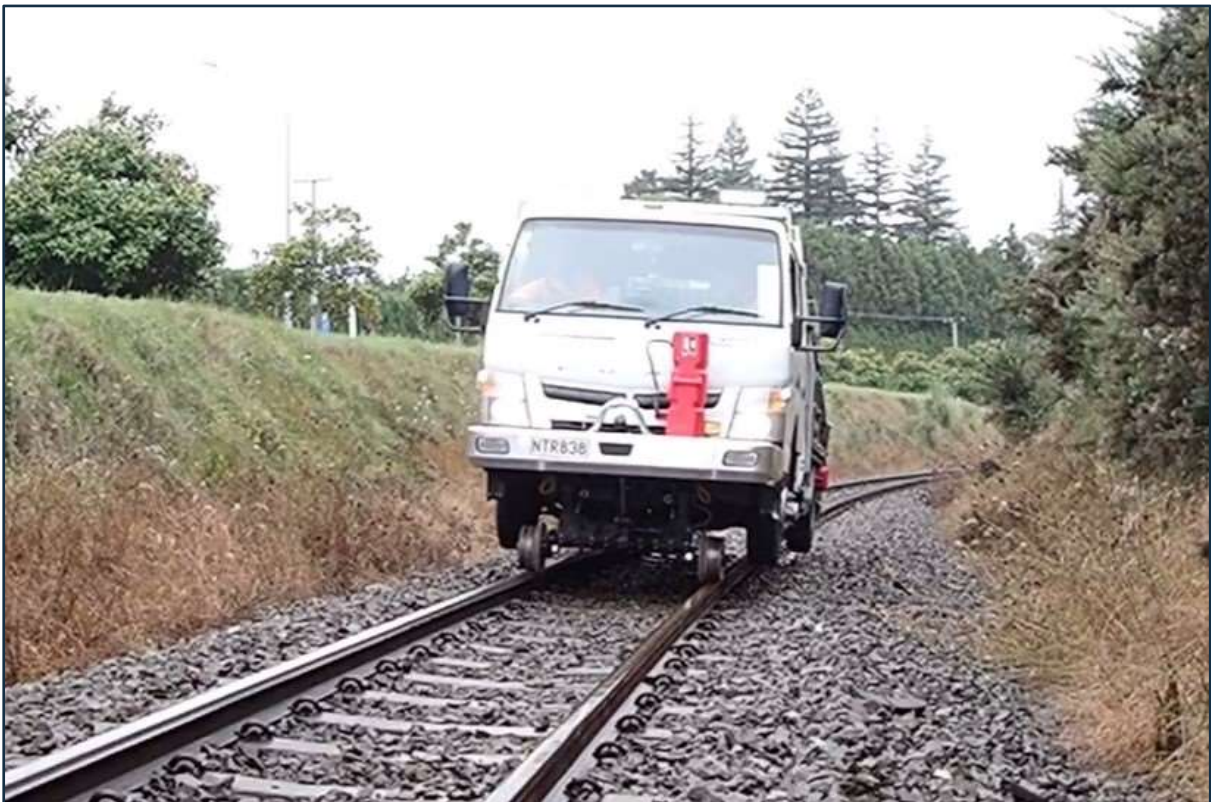
Figure 4: A Hi-Rail vehicle travelling in rail mode

² A vehicle fitted with retractable rail wheels that can travel on both road and rail. When travelling in rail mode the front road wheels are not in contact with the ground and the vehicle is unable to be steered in the manner of a road vehicle (see Figure 4).

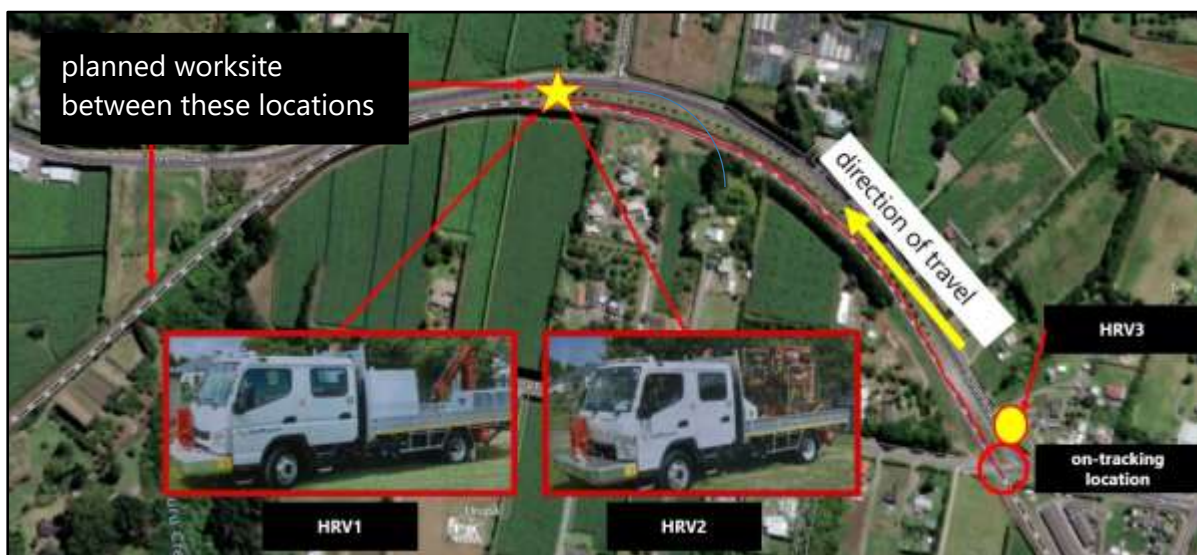
Figure 5: Map of accident site

- 2.10. Because of the wet weather conditions at the time and of also travelling in convoy, the HRVs should have been travelling at no more than 30 kilometres per hour (km/h), and at such a speed that they would have been able to stop within half the clear distance that could be seen ahead.¹¹

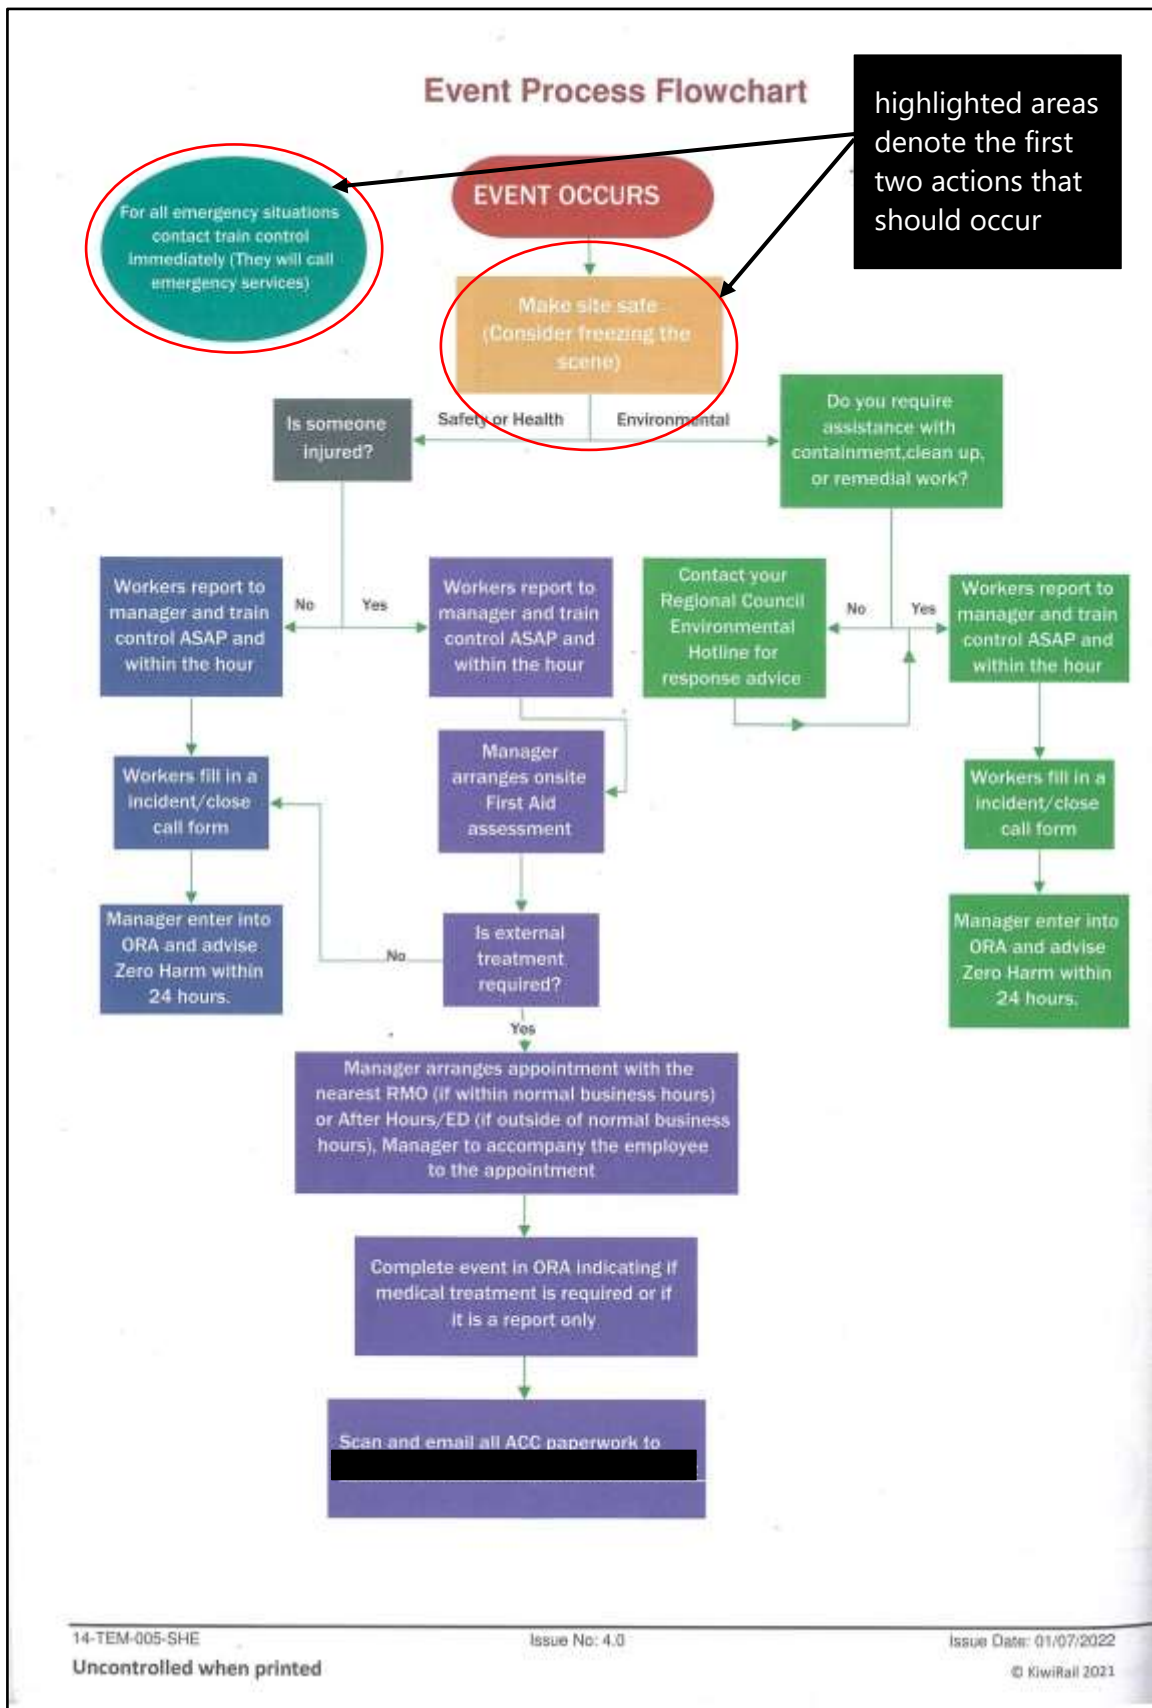
Figure 9: Event process flowchart included in KiwiRail TS90 Job Plan Book

- 3.44. During their interview the Ganger could not recall being trained to freeze²⁰ an accident site and was unable to describe the process or where to find the procedure.
- 3.45. The procedure for what actions to take following an incident are provided in the back pages of KiwiRail's 'TS90' book – the Job Plan book that the Ganger had briefed the work gang from about 10 minutes before the accident (see Figure 9).
