Transport Accident  
Investigation  
Commission

# **Final report**

***Rail inquiry RO-2023-102***  
***Freight train 360***  
***Derailment***  
***Te Puke***  
***29 January 2023***

**June 2024**

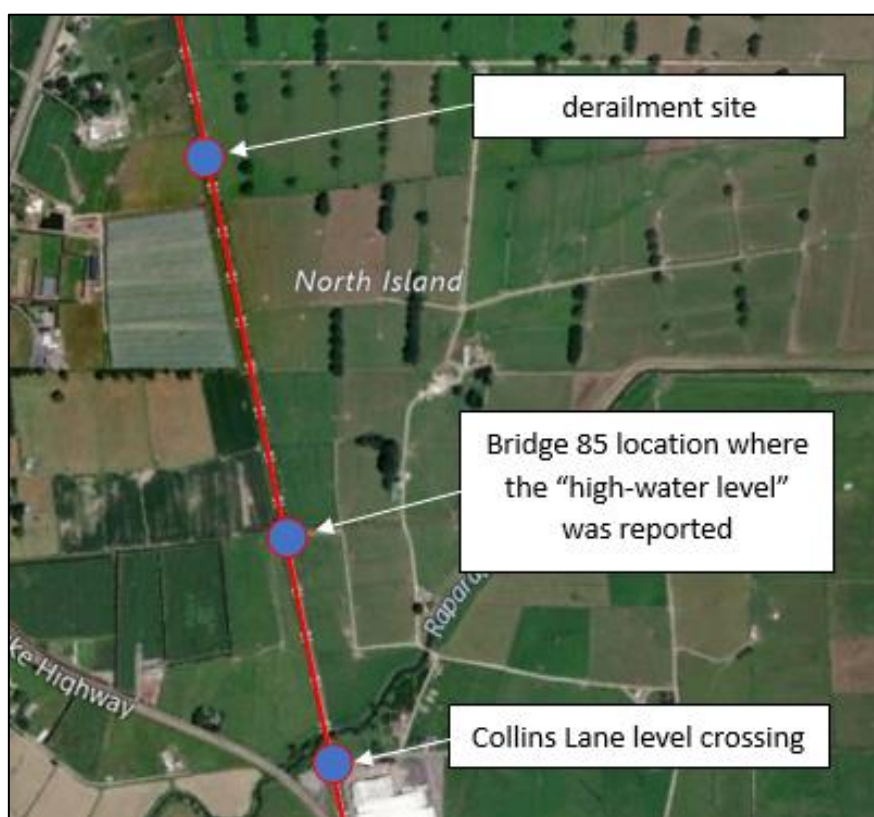
**Figure 4: Aerial map showing the location of bridge 85**

- 2.11. On 28 January at about 0630, the crew<sup>14</sup> of train 385 (the crew) observed a significantly high water level as they crossed rail bridge 85 north of Te Puke (see Figure 4).

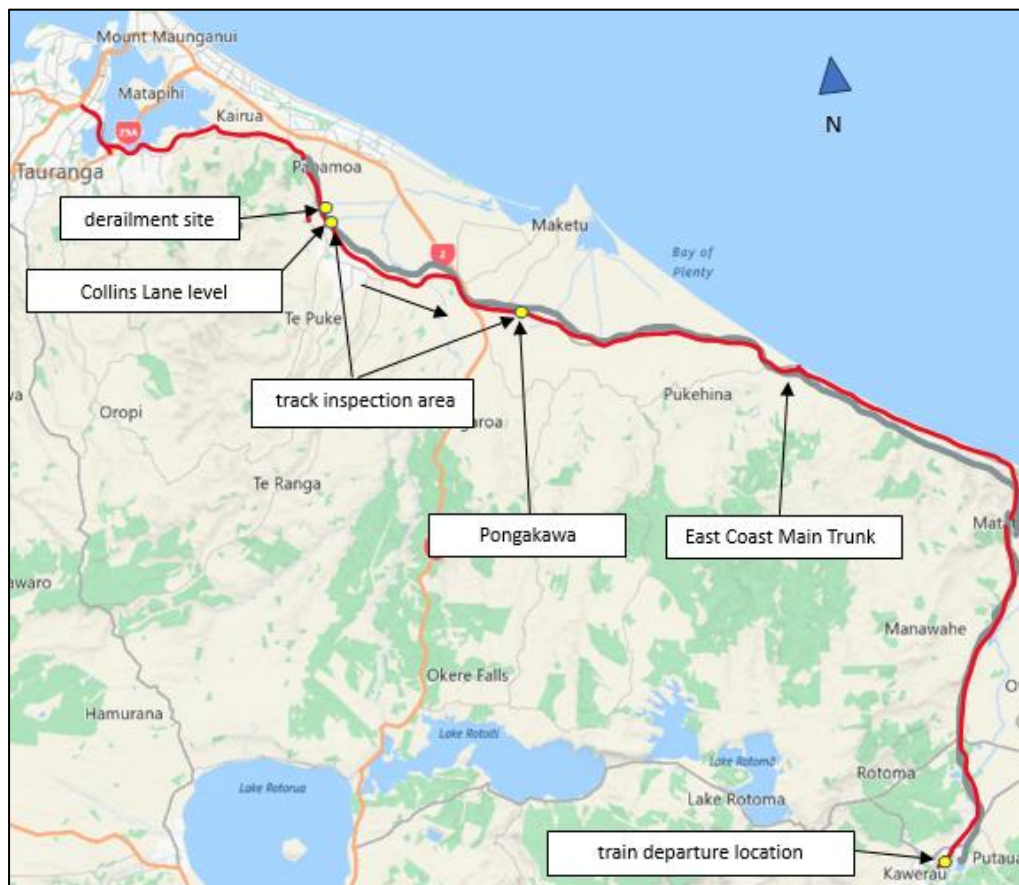
**Figure 5: Map of the ECMT between Tauranga and Kauerua**

- 3.33. Based on the information received, the track inspector started the inspection 2 km away from the observed high water level at bridge 85 and inspected an area in the opposite direction (see Figure 5).

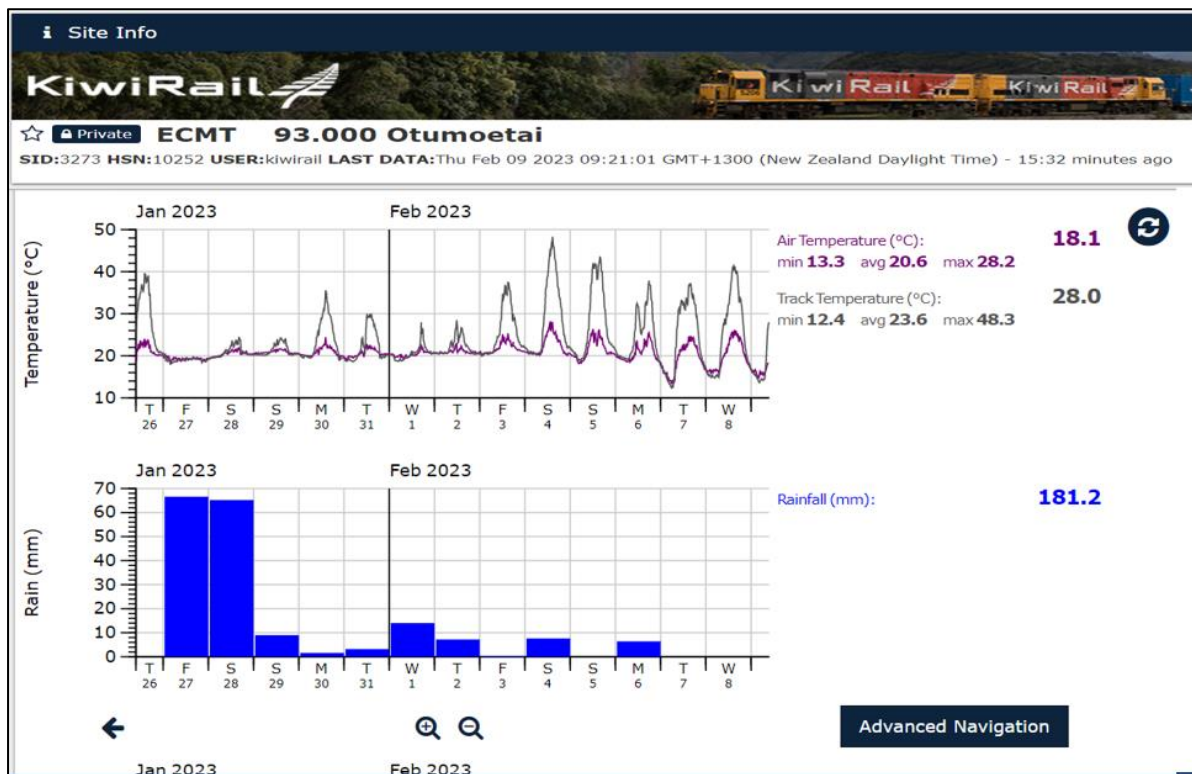
**Figure 8: Rain and temperature data collected on the ECMT at Otūmoetai, near the accident site**  
(Credit: KiwiRail)

- 2.39. The Bay of Plenty region had experienced heavy rainfall, a total volume of 131.8 mm in the two-day period prior to the train derailment (see Figure 8).
- 2.40. The meteorological information received by KiwiRail is detailed in paragraphs 2.1 to 2.10.

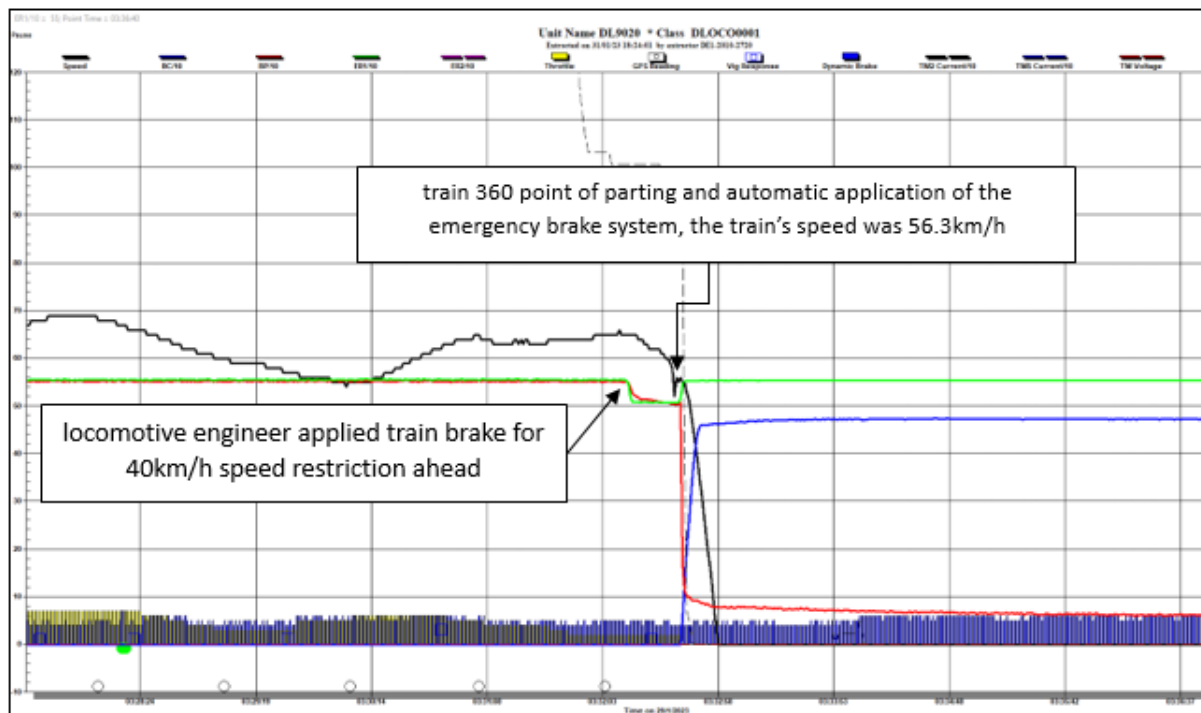
**Figure 9: Tranzlog data for train 360**

- 2.41. The locomotive was fitted with a Tranzlog data recorder. The Tranzlog download was obtained by the Transport Accident Investigation Commission (the Commission) and the verified data was used in this report (see Figure 9).

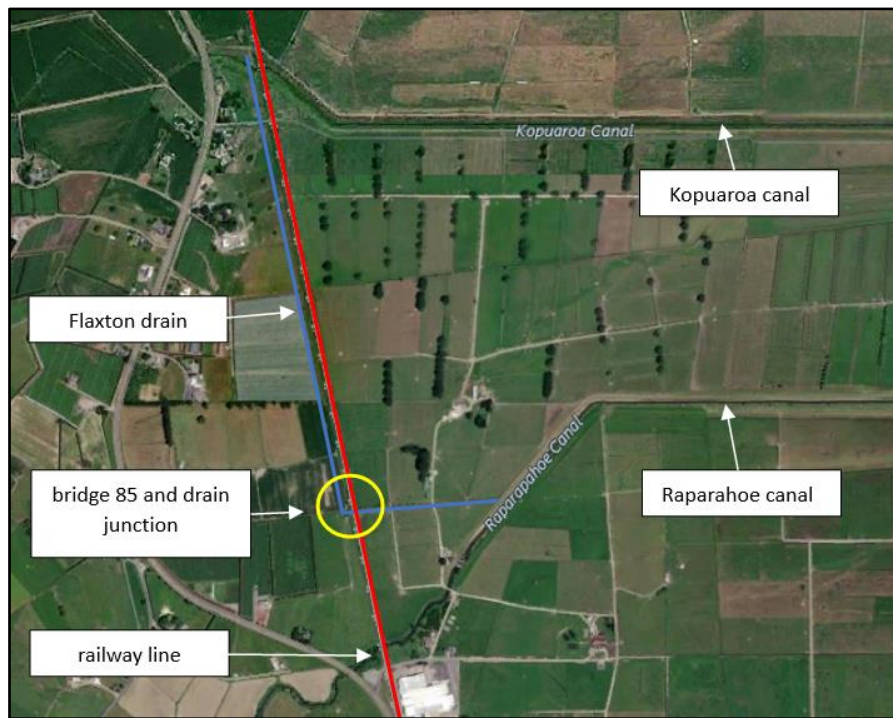
**Figure 20: Locations of drains and rail infrastructure**

- 3.35. Effective maintenance plans are a vital component of ensuring that infrastructure remains fit for purpose, particularly when it can be adversely affected by weather.
- 3.36. The Bay of Plenty Regional Council owned the drainage system adjacent to the section of rail corridor where the accident occurred. The drainage system was part of the Kaituna river catchment control scheme, which included the Flaxton drain (1308 m long) and the Collins drain (442 m long). Both drains flowed into a canal system (see Figure 20).
